Re: Catskill Mountain Railroad Condition Report

HDR conducted a track inspection on the behalf of Ulster County to determine compliance with Code of Federal Regulations (CFR) Title 49, Part 213, Subpart A to F, Class 1 and Non-Class Specific Standards on the Catskill Mountain Railroad between Downs Street in Kingston, NY and Bridge Street in Phoenicia, NY. In addition, this inspection was performed to determine if the Lessee Operator is in compliance with its lease requirements in regards to track and right of way maintenance.

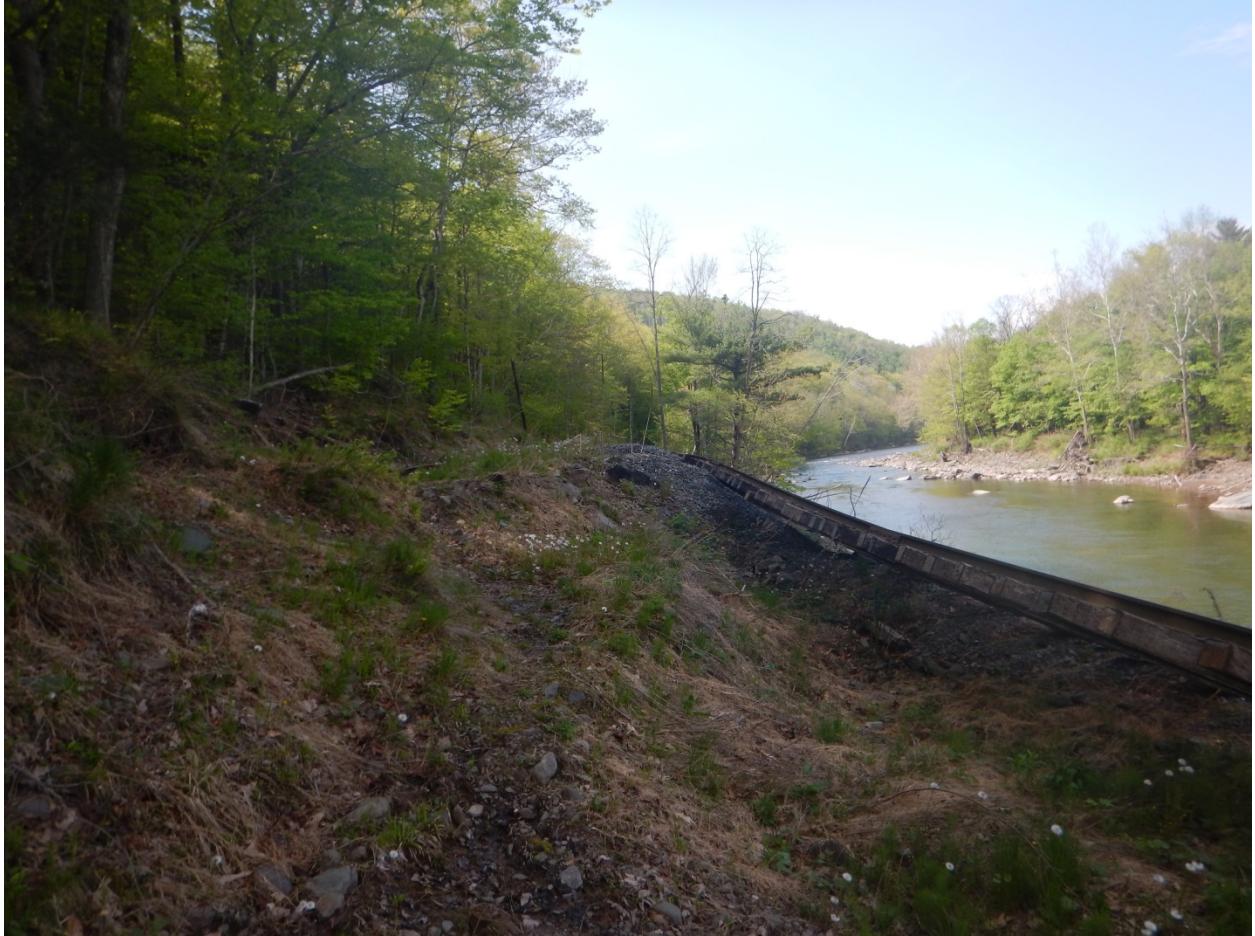
Example of a washout along a riverbank. One possible mechanism for such a failure is stormwater runoff infiltrating into the roadbed. With the added weight, the soil becomes unstable and shifts. Warning signs of such conditions include observing track surface and alignment irregularities. Best practices to prevent such failures include maintaining ditches and culverts to allow surface water to flow away from the roadbed.

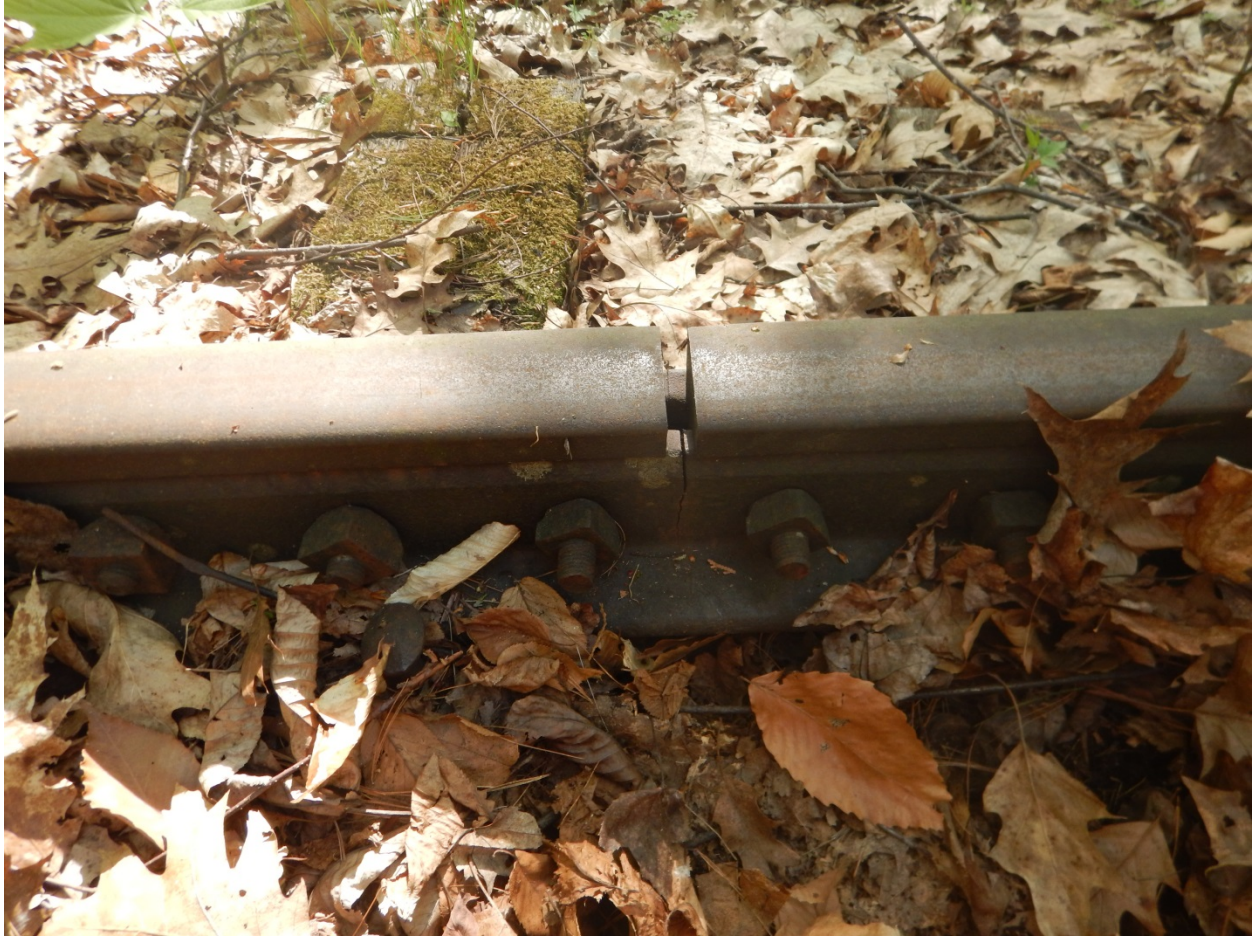
Example of a center-cracked joint bar. Such a defect is not permitted in Class 1 track as described in Title 49, Part 213, Section 121, Paragraph (b). This photograph was taken in an area that currently does not experience train operations. Proper remedial action includes replacing the cracked joint bar.

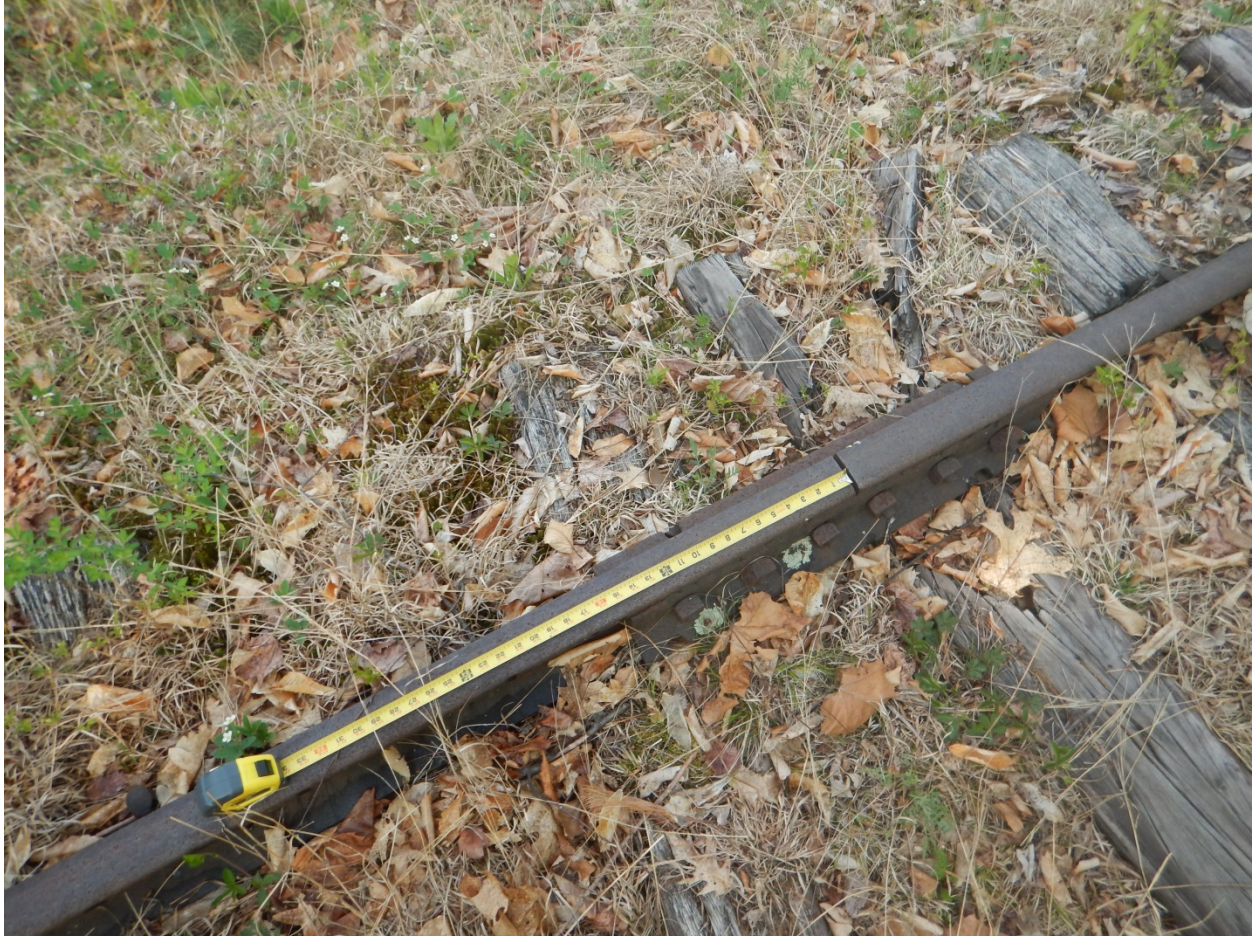
Example of a joint tie defect. According to Title 49, Part 213, Section 109, Paragraph (e), rail joints must be supported by one (1) crosstie that meets the specifications in paragraphs (c) and (d) of this section within 24" of the center of the joint. The three (3) ties within this envelope do not meet the specifications because they are broken through, split so ballast may work through, and are split so that the crosstie will not hold rail fasteners (spikes).

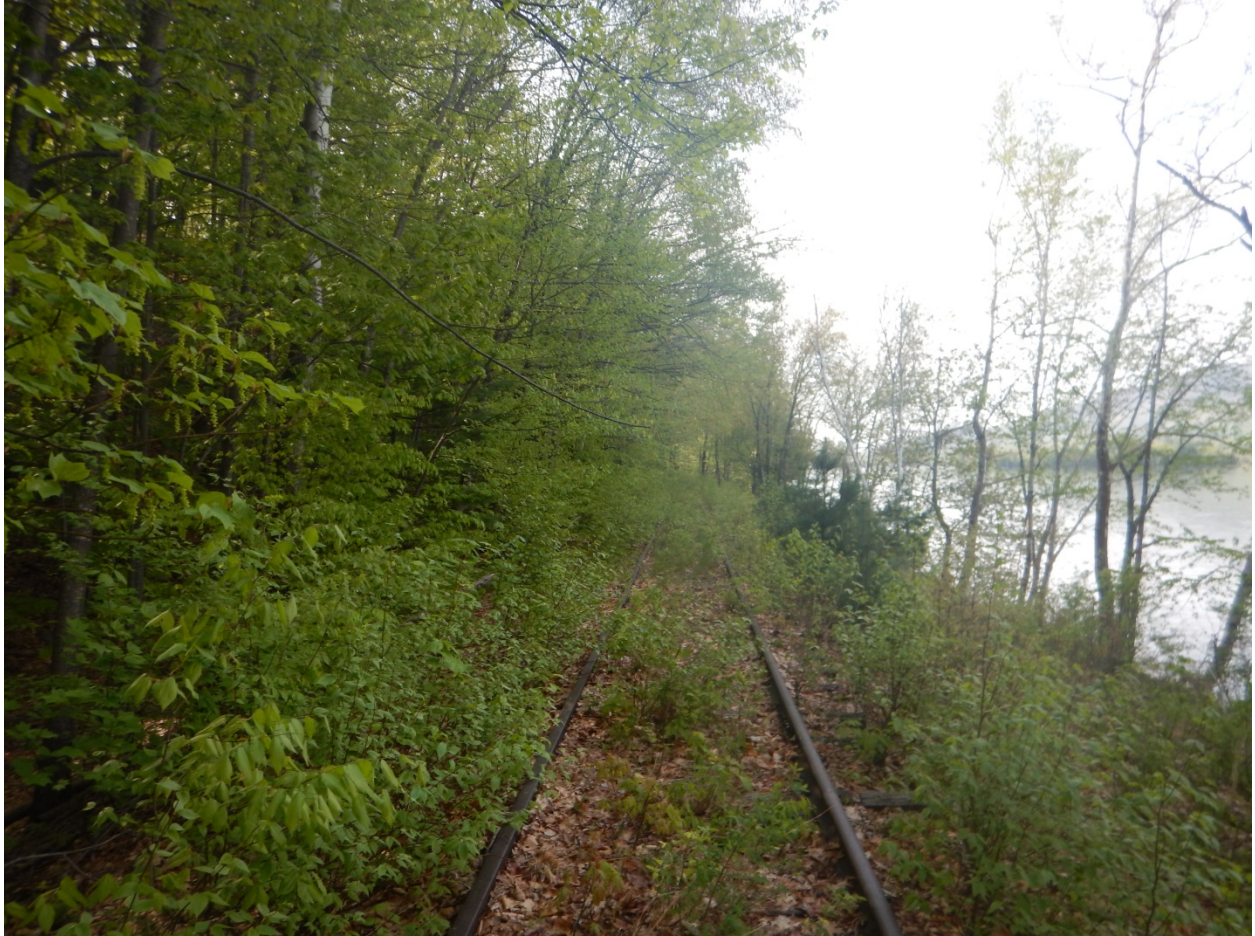
Example of typical vegetation conditions along sections of the Corridor that are not operated on. The Operating Lease requires that the corridor be free of brush, papers, and trash. In addition, Title 49, Part 213, Section 37 has requirements that vegetation be maintained. This example would hinder a railroad employee from performing their trackside duties (i.e. inspecting a passing train from the side of the tracks, walking along the side of a train, or clearing the tracks for a passing train).

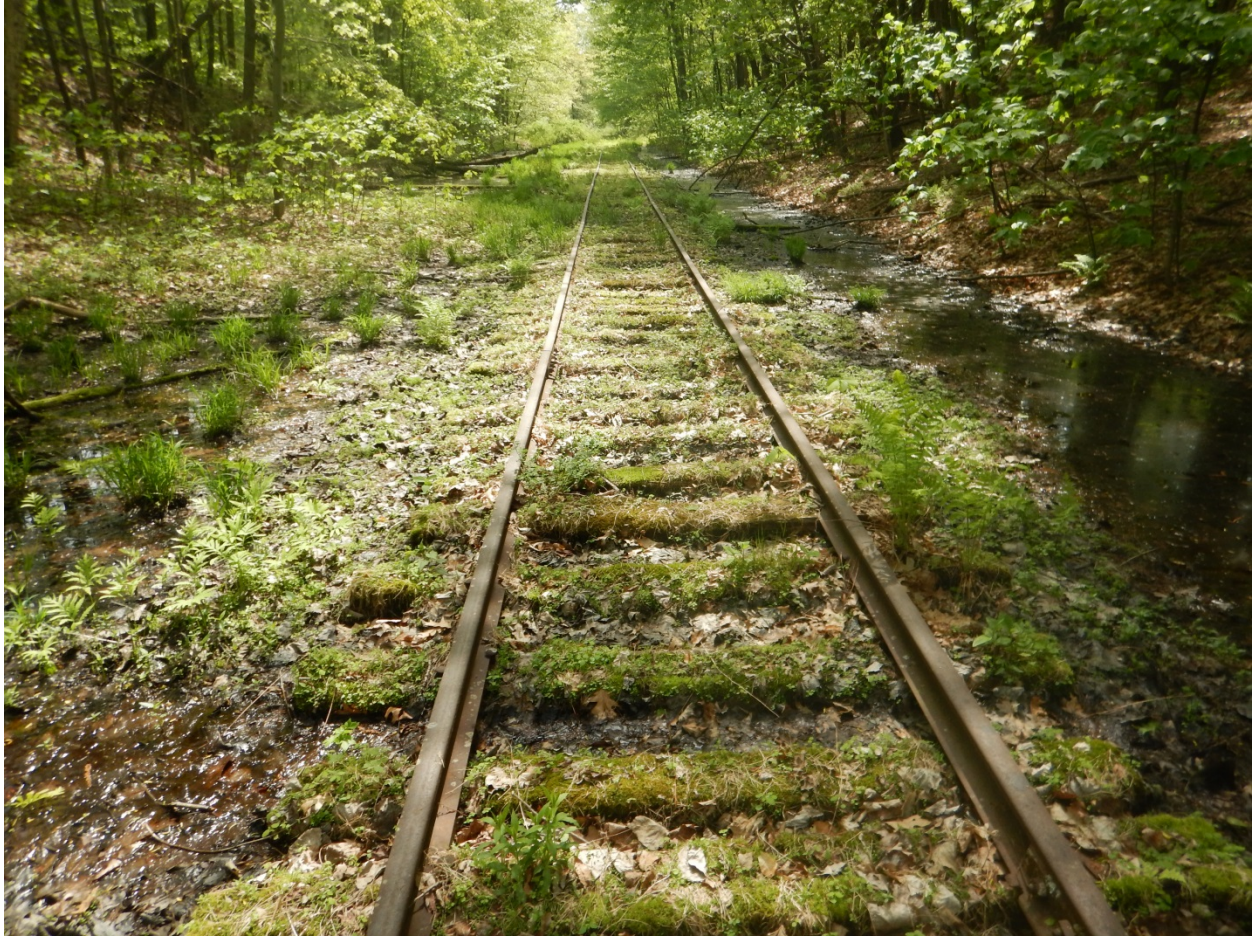
Example of a fouled ballast condition caused by poor drainage. Title 49, Part 213, Section 33 requires that each drainage or other water carrying facility under or immediately adjacent to the roadbed be maintained and kept free of obstruction, to accommodate expected water flow for the area concerned. Since the ditches have become fouled with leaves and branches, water has accumulated in this area causing the roadbed to become saturated. If this section of track were to be operated on, this would be a hazard because the roadbed has less structural stability to maintain proper alignment and surface.

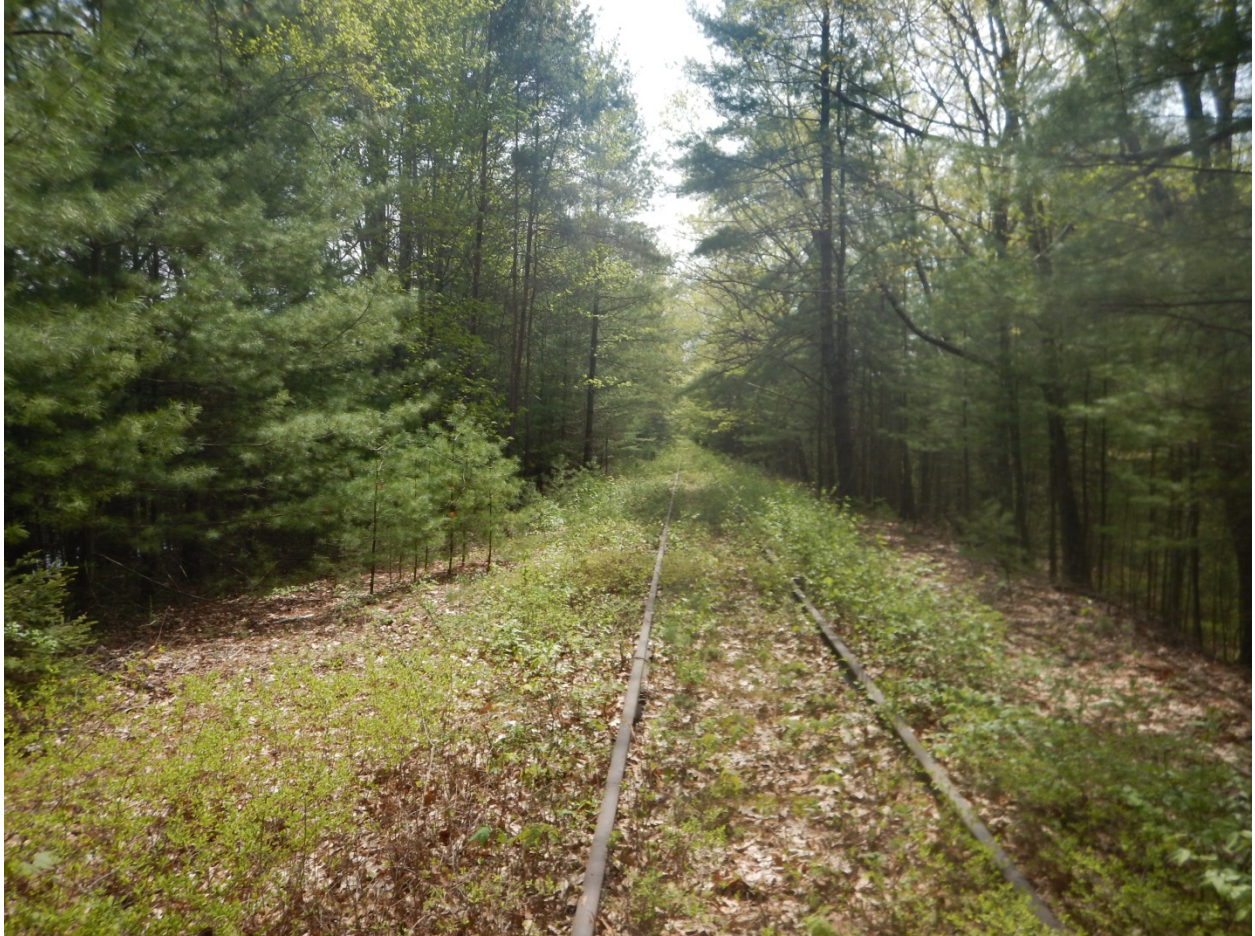
Example of a location where brush is growing within the right of way. White pines and other undergrowth are developing inside the gage of the track. This hinders a track inspector's ability to properly inspect track.

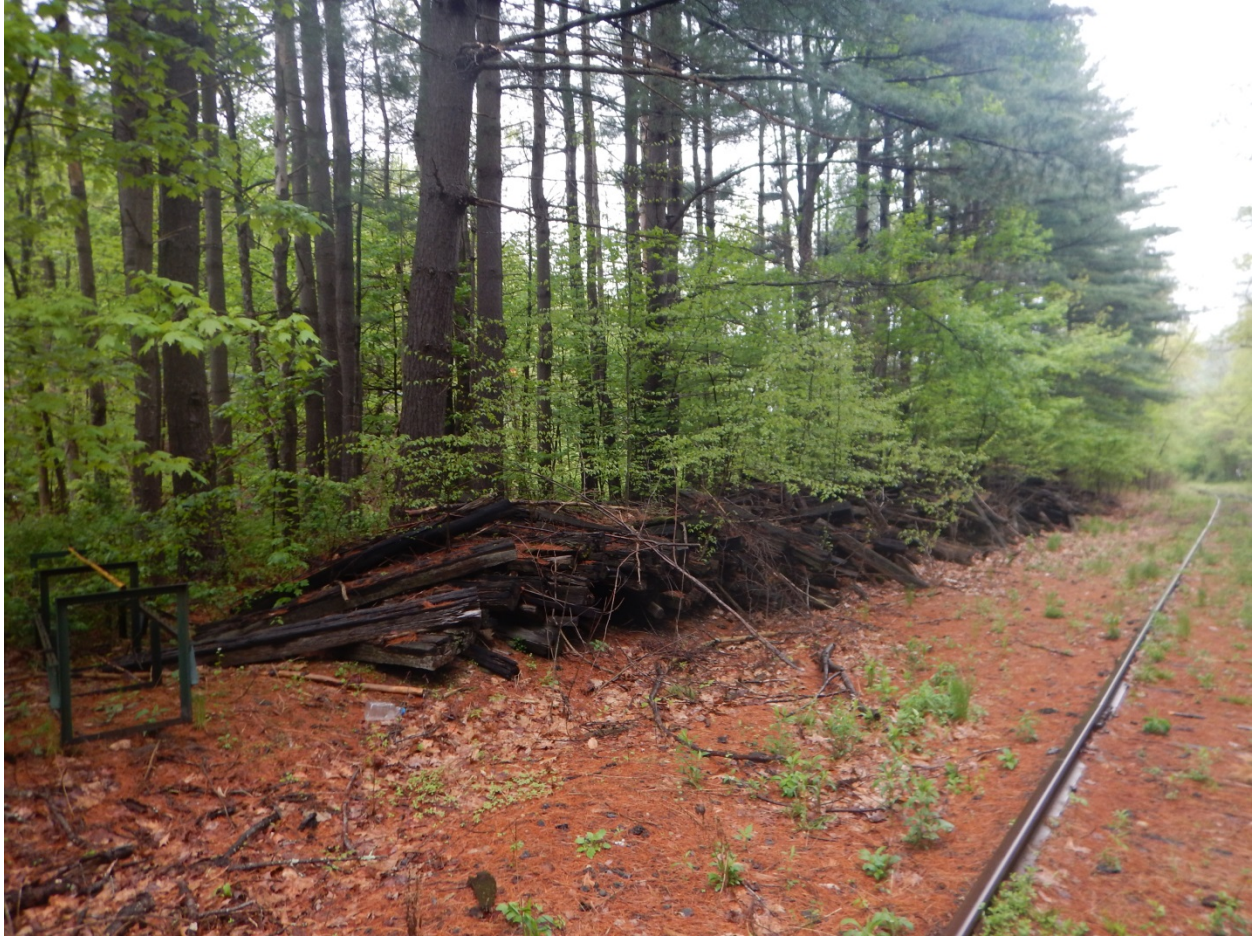
Example of tie piles left along the right of way. Ties should be disposed of at an approved facility.

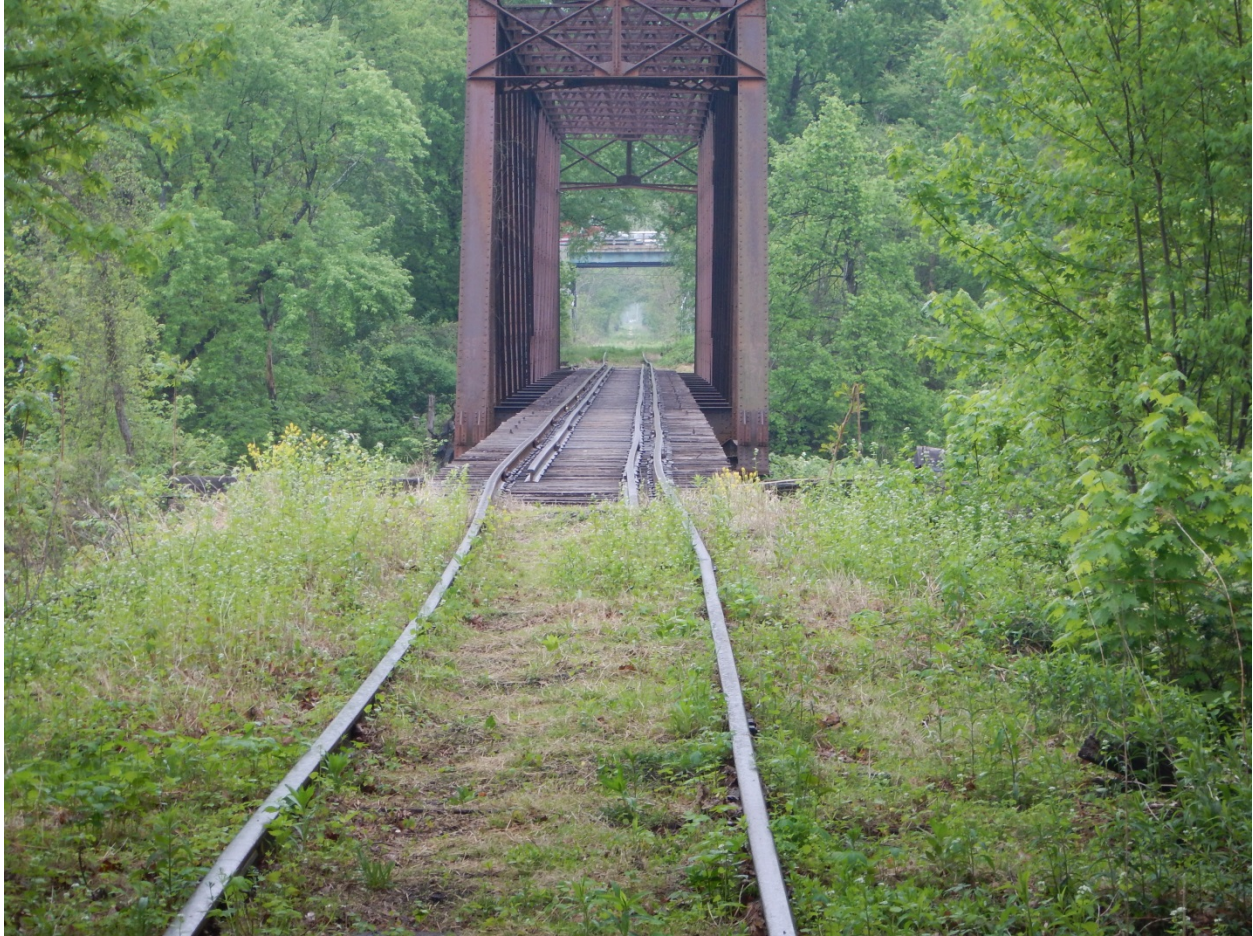
Eastward photograph showing alignment deviations on both approaches of the C9 Bridge. HDR advised the County to cease operations over this bridge until the structure can be evaluated. HDR Track Inspectors observed that the concrete abutments have shifted.

Upon approaching the bridge, it was visually determined that there is an alignment deviation at the east approach of the through truss span of the bridge. An alignment deviation at such a location may indicate that the bridge superstructure is shifting. A more thorough inspection was conducted on May 15, 2014 and it was determined that the eastern retaining wall has cracked and shifted, allowing the roadbed to become unstable at the East Approach.

HDR has identified two (2) issues which may potentially pose a hazard to railroad operations or the general public in the vicinity of the C9 Bridge. In order to ensure the safety of the general public, HDR recommends that operations cease until a Structural Engineering Review is completed.

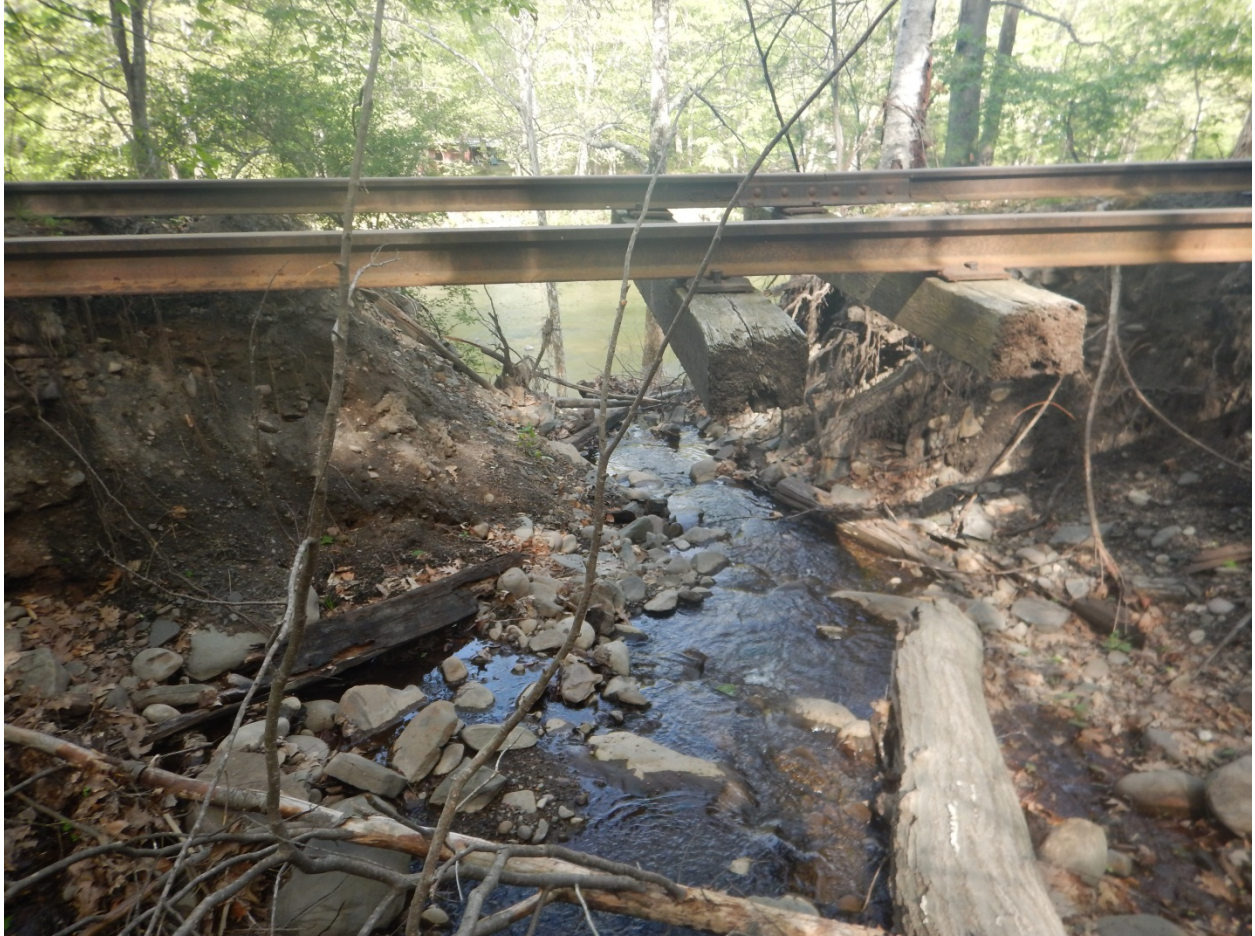
Example of a washout which may have been caused by a blocked culvert. Allowing debris to build up around culverts can cause the drainage path to be redirected, causing the roadbed and ballast section to be washed out.

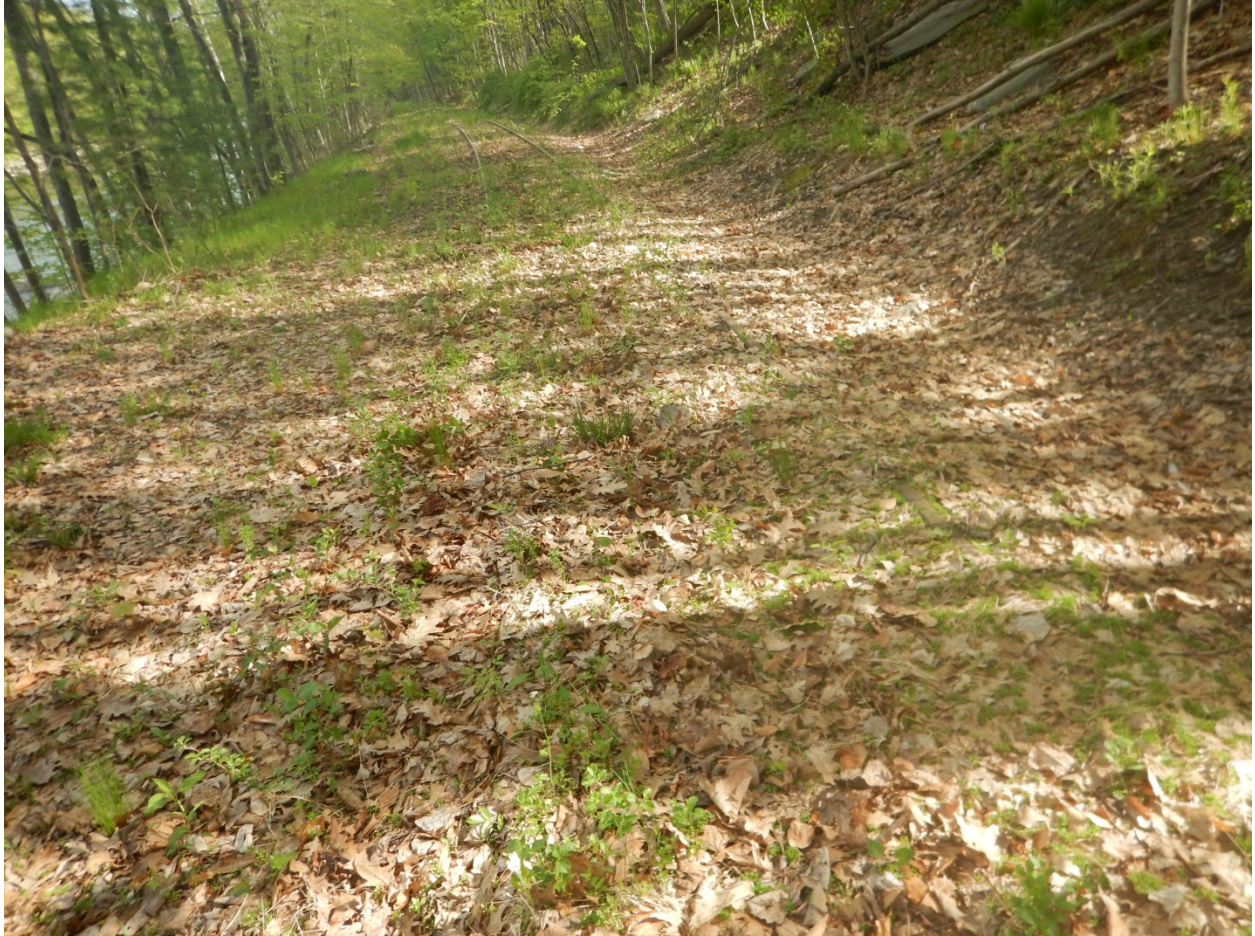
Location where a drainage or water carrying facility is not maintained to accommodate expected water flow. As stormwater accumulated, sediment deposited on the roadbed. Routine ditch maintenance would keep sediment from accumulating.

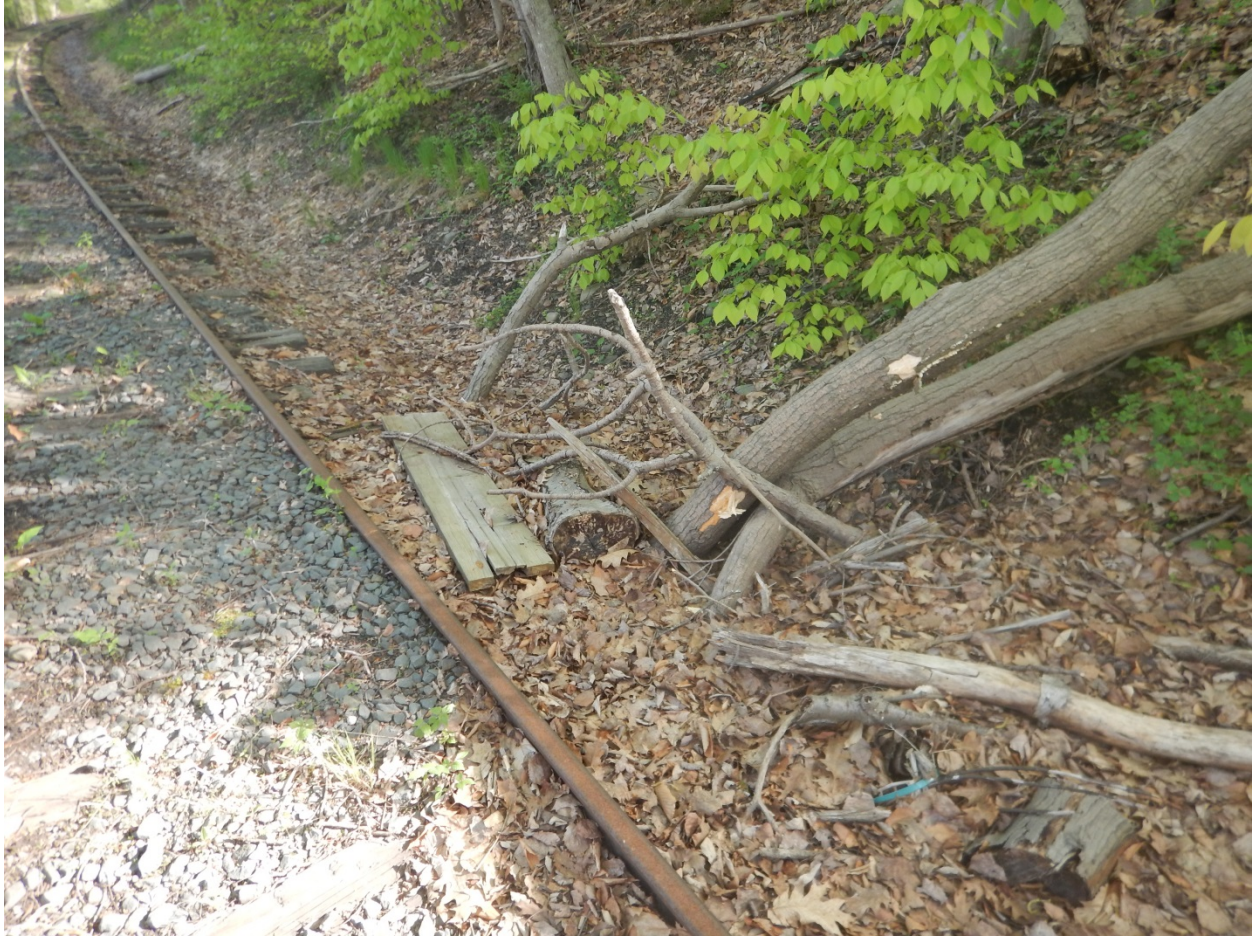
Example of debris accumulating in a ditch.

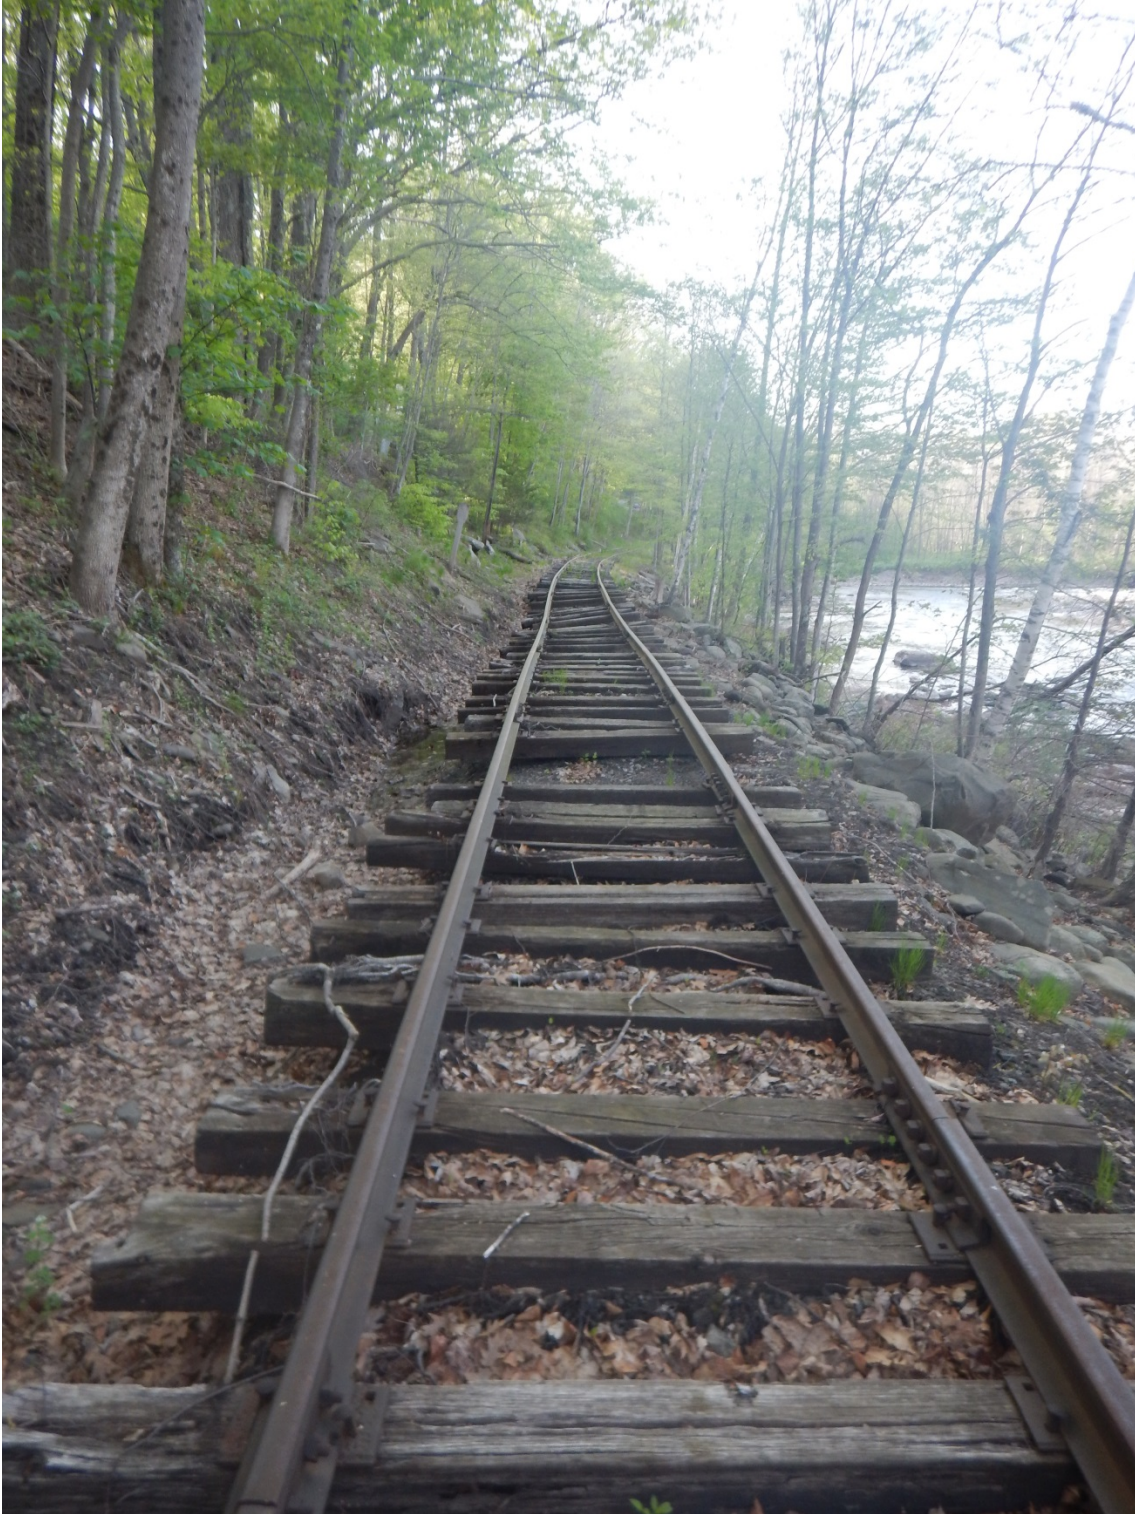
Example of a washout caused by a ditch becoming flooded from heavy rainfall. Stormwater that could not flow naturally to a culvert would flow laterally over the track structure, washing away ballast. The final result of this would leave the track in inoperable condition.

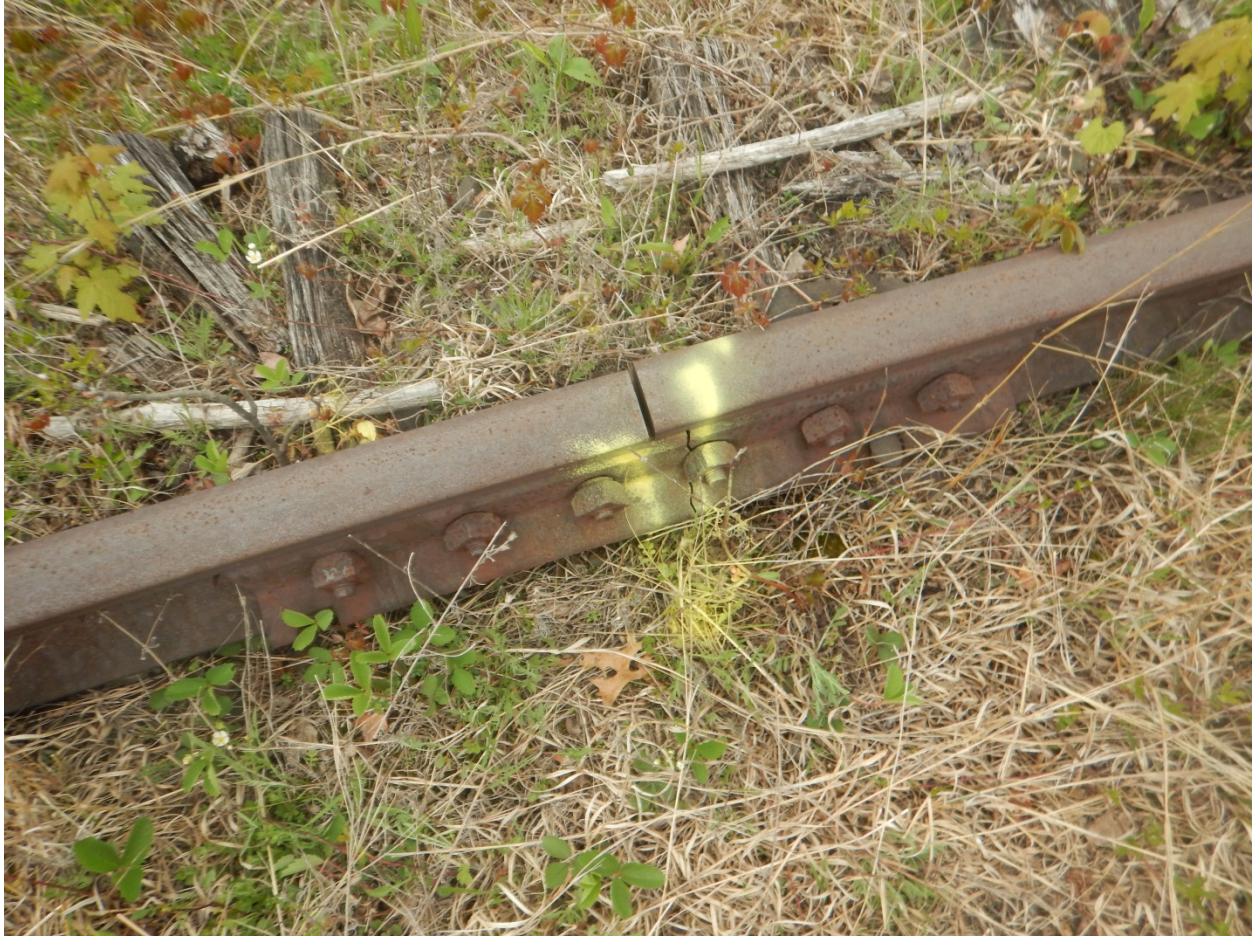
Example of a center-cracked joint bar with a joint tie defect. Center cracked joint bars can be caused by fatigue. Such fatigue may be caused by excessive bending stress. The intent of the joint tie regulations is to ensure that a joint is supported, thereby minimizing vertical bending stresses.

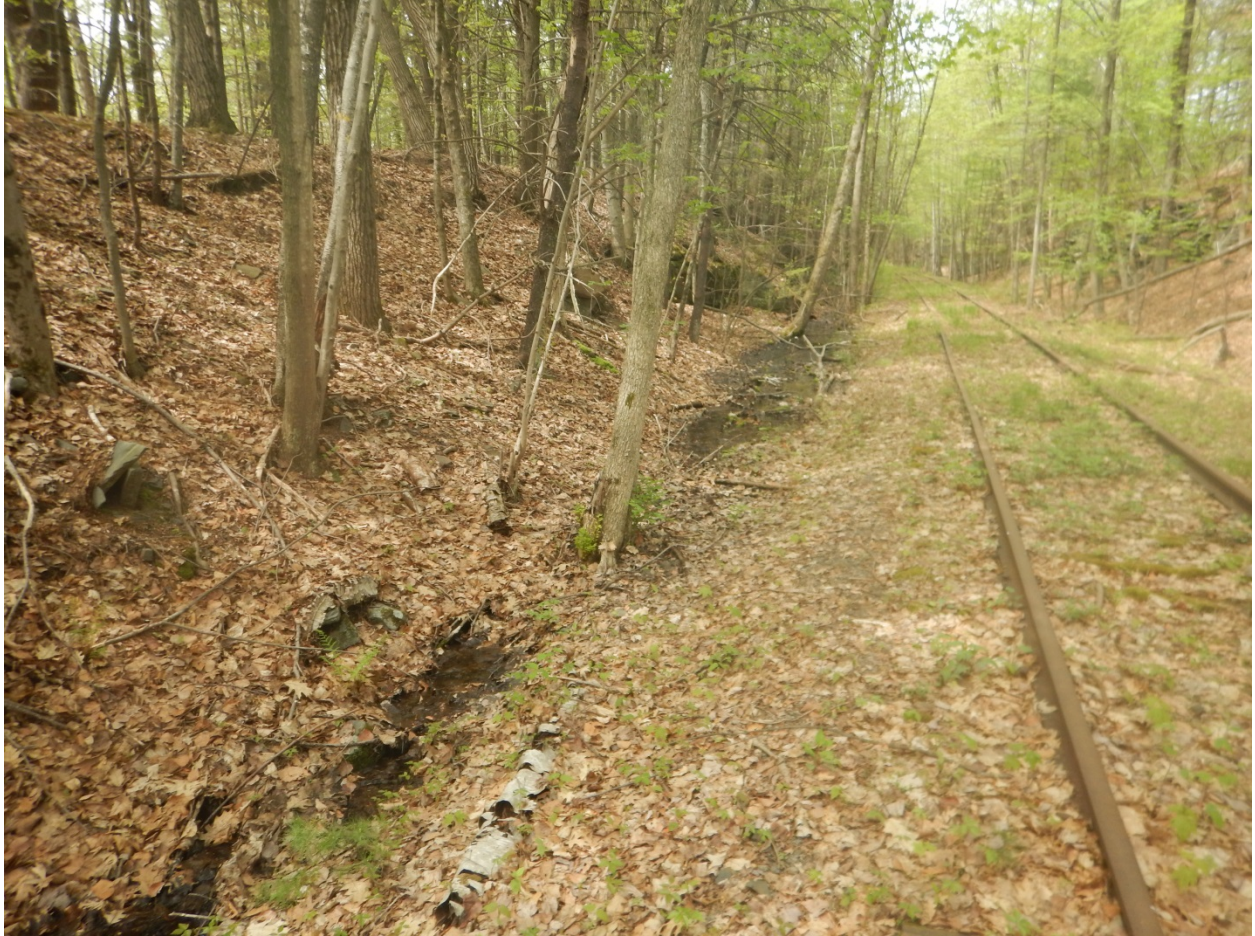
Example of a ditch where debris and sediment have accumulated over time. Note the trees that have grown in the area. Routine ditch maintenance ensures proper stormwater flow and prevents vegetation from growing and fouling the waterway.

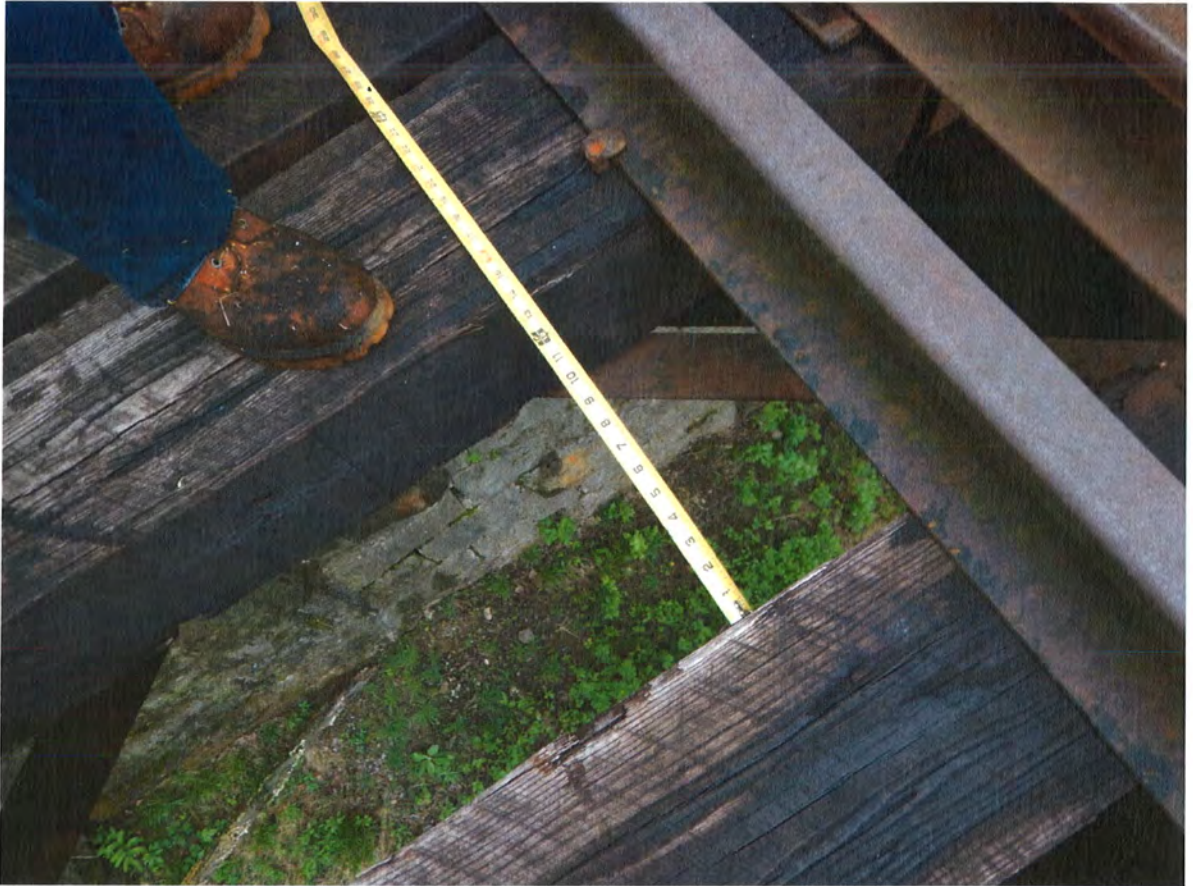
Additionally, HDR inspected the bridge deck and noted that the recently installed bridge timbers have shifted longitudinally. This shifting has allowed gaps exceeding 14 inches to form between bridge timbers. This would allow a person to be able to fall through the bridge deck, which fails to comply with OSHA regulation 1925.501(b)(4)(i) which states, "Each employee on walking/working surfaces shall be protected from falling through holes (including skylights) more than 6 feet (1.8 m) above lower levels, by personal fall arrest systems, covers, or guardrail systems erected around such holes."

Photograph showing longitudinal shifting of a bridge timber, creating a condition where a person could fall through.

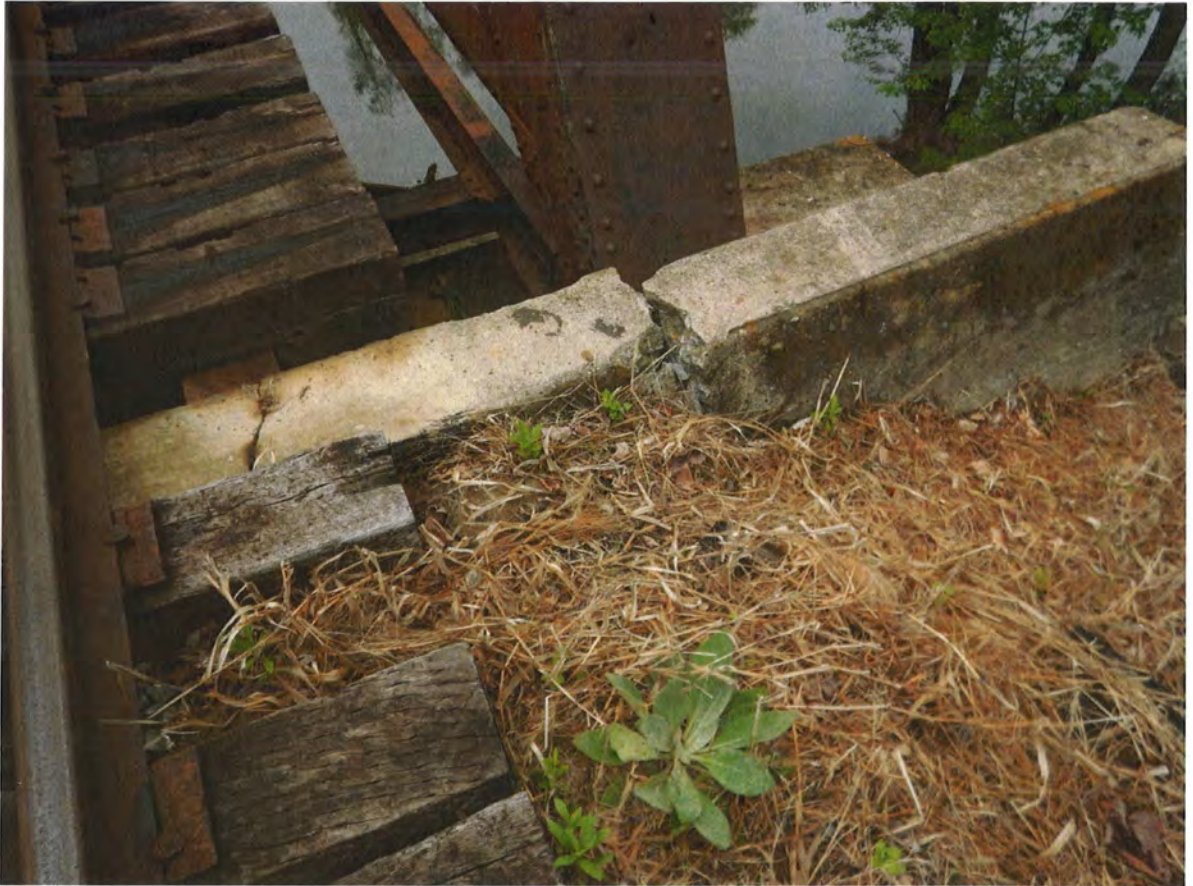
Photograph showing the eastern bridge abutment. The movement has allowed the roadbed to destabilize which is non-compliant with FRA Rule 213.103(a).

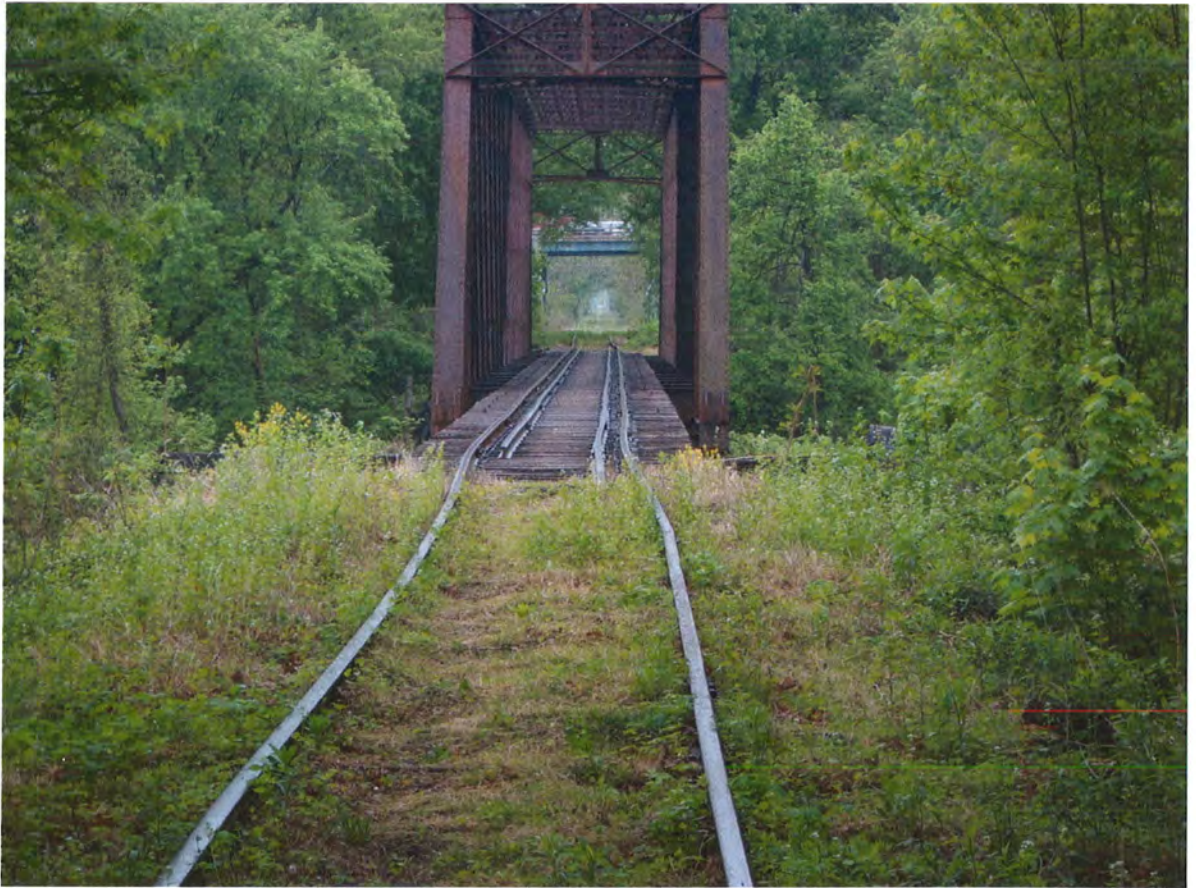
Eastward photograph showing the alignment deviations on both approaches.
