Re: Catskill Mountain Railroad Condition Report

HDR conducted a track inspection on the behalf of Ulster County to determine compliance with Code of Federal Regulations (CFR) Title 49, Part 213, Subpart A to F, Class 1 and Non-Class Specific Standards on the Catskill Mountain Railroad between Downs Street in Kingston, NY and Bridge Street in Phoenicia, NY. In addition, this inspection was performed to determine if the Lessee Operator is in compliance with its lease requirements in regards to track and right of way maintenance.

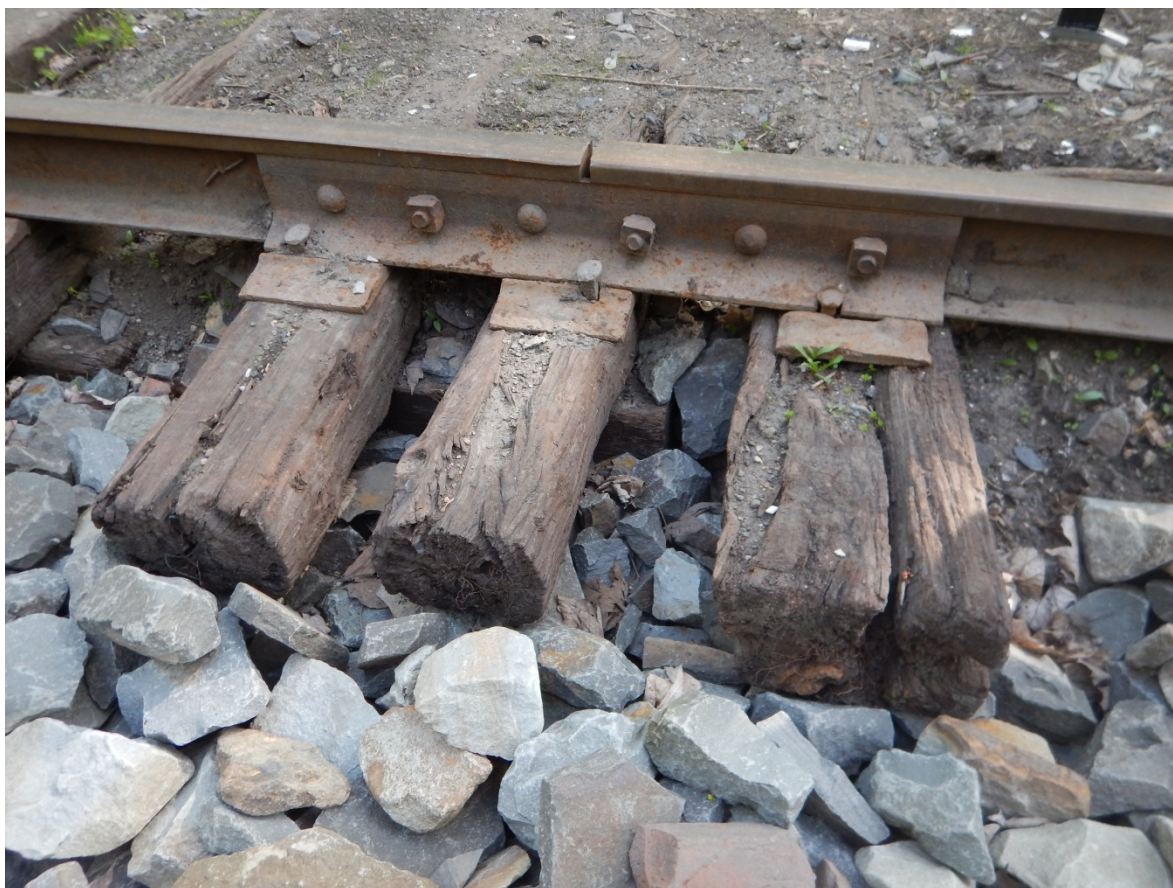
Photo # 440

Photo #	Location		Defect Description	Defect Section
	Latitude	Longitude		
440	N 41d 55m 59.29s	W 74d 0m 33.73s	Insufficient ballast	§213.103(a)
455	N 41d 56m 13.00s	W 74d 1m 16.33s	Center cracked joint bar (jointed track)	§213.121(c)
497	N 41d 56m 32.21s	W 74d 2m 31.13s	Center cracked joint bar (jointed track)	§213.121(c)
1018	N 42d 2m 19.31s	W 74d 16m 54.47s	3-1/2" difference in crosslevel in 62 feet	§213.63(a)
1026	N 42d 2m 42.73s	W 74d 17m 11.56s	No effective support ties within the prescribed distance from a joint	§213.109(e)(1)
1027	N 42d 2m 41.92s	W 74d 17m 12.49s	No effective support ties within the prescribed distance from a joint	§213.109(e)(1)
1028	N 42d 2m 44.30s	W 74d 17m 13.83s	Improper fit between switch point and stock rail	§213.135(b)
1034	N 42d 2m 49.00s	W 74d 17m 16.97s	Loose joint bars (jointed track)	§213.121(f)
1047	N 42d 3m 15.41s	W 74d 17m 38.46s	No effective support ties within the prescribed distance from a joint	§213.109(e)(1)

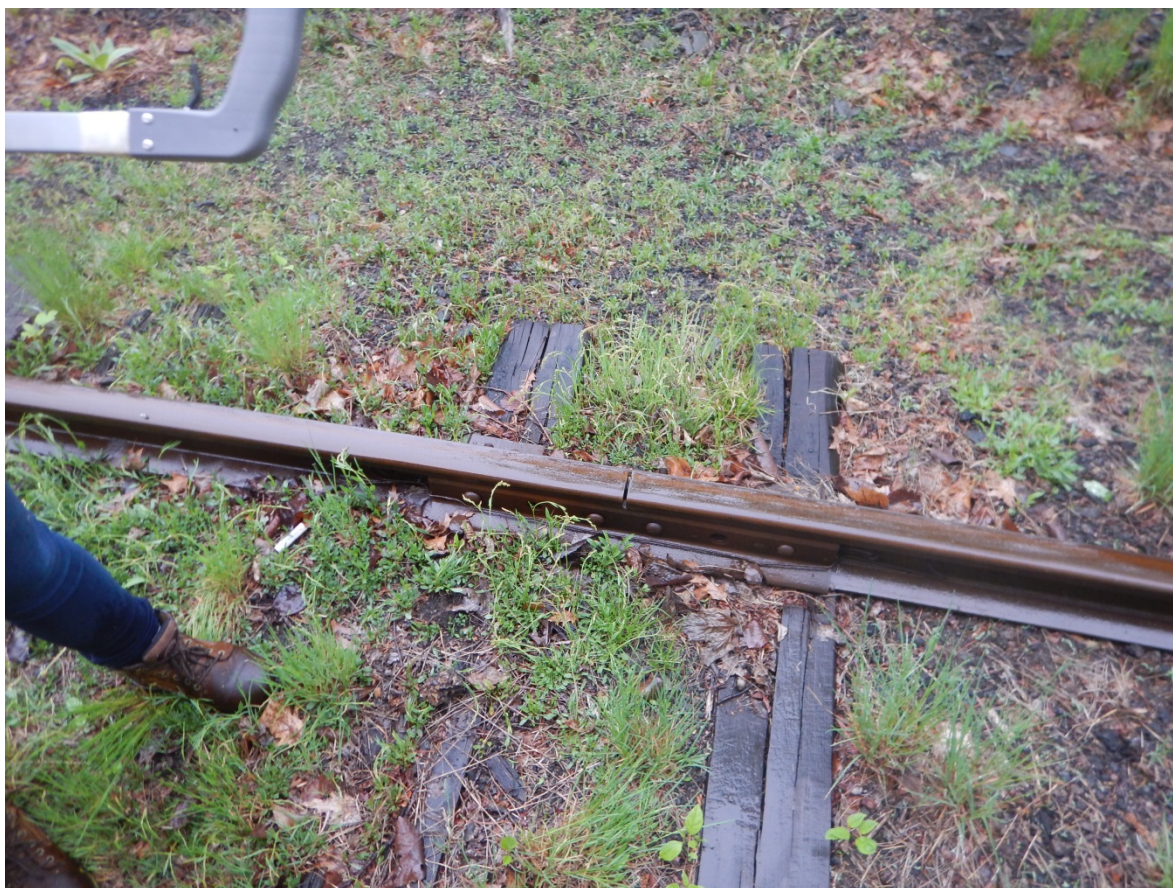
Photo # 1050

1050	N 42d 3m 19.75s	W 74d 17m 48.15s	No effective support ties within the prescribed distance from a joint	§213.109(e)(1)
1051	N 42d 3m 20.08s	W 74d 17m 47.94s	No effective support ties within the prescribed distance from a joint	§213.109(e)(1)
1059	N 42d 3m 28.25s	W 74d 18m 6.94s	No effective support ties within the prescribed distance from a joint	§213.109(e)(1)
