Re: 2015 Follow-up Inspection of the Ulster County Rail Corridor

HDR Engineering, Inc. (HDR) conducted a follow-up track inspection on behalf of Ulster County to determine compliance with Title 49, Part 213, Subpart A to F for Class 1 and Non-Class Specific Standards (hereafter Track Safety Standards) as required per agreement with the Catskill Mountain Railroad (CMRR). Inspections were conducted on foot on the Ulster and Delaware Corridor (hereafter the Corridor) between Downs Street in Kingston, NY and Bridge Street in Phoenicia, NY with two (2) HDR inspectors on Thursday, September 3 and Friday, September 4, 2015.

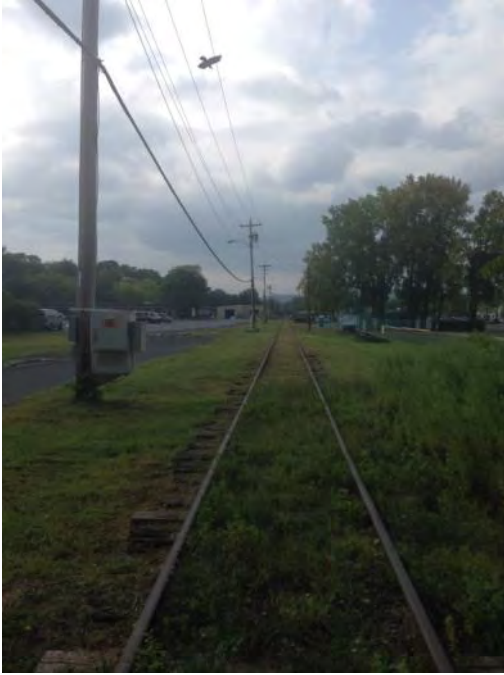
1.1 Recently Mowed Vegetation

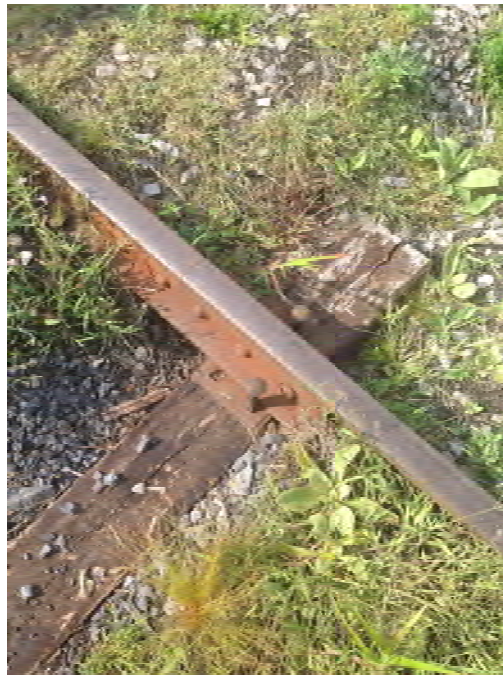
1.2 Tie Condition Observed

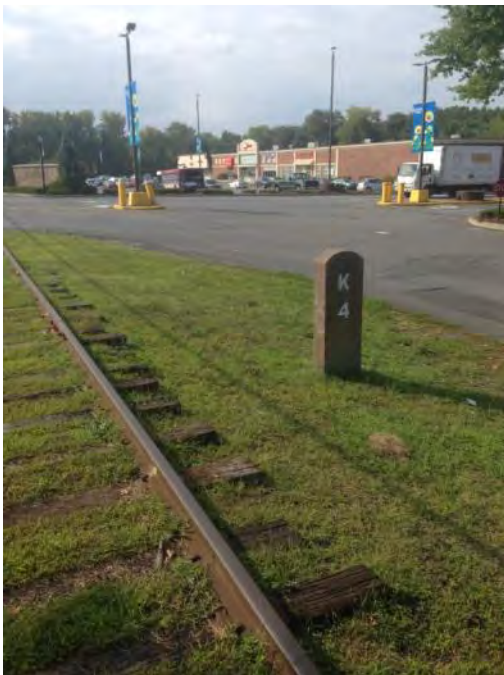
1.5 Vegetation Observed at Milepost 4

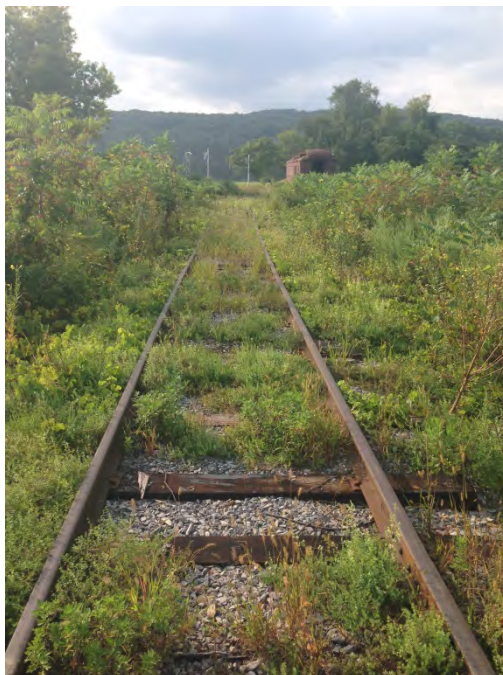
1.4 Tie Condition Generally Meets Class 1

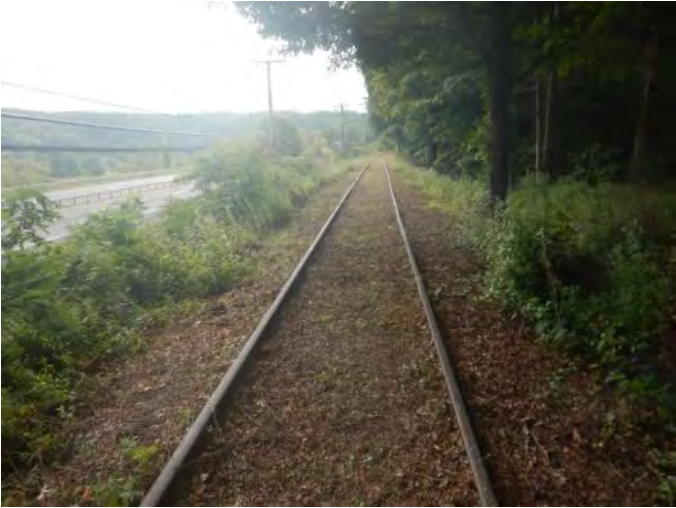
2.1 Vegetation Maintained to Class 1

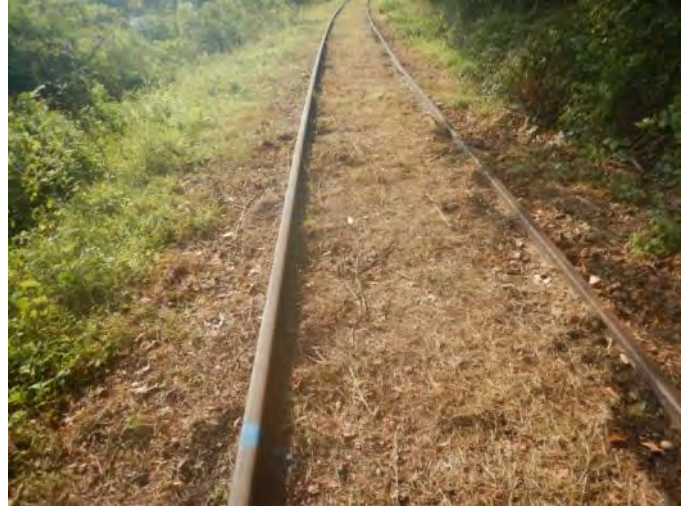
2.2 Tie Condition Generally Meets Class 1

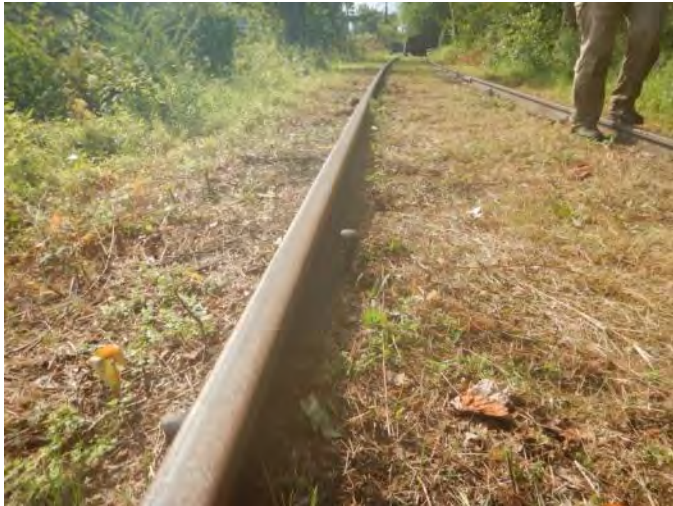
2.3 No effective supports ties within the prescribed distance from a joint (§213.109(e) (1))

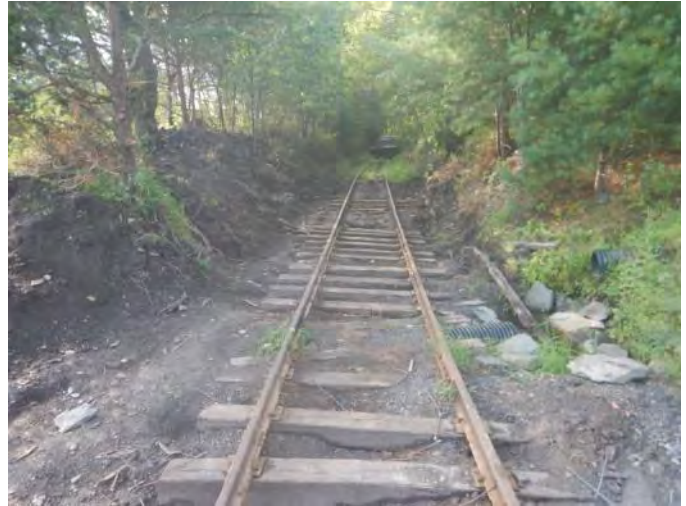
2.4 Tie Condition Generally Meets Class 1. Insufficient ballast (§213.103(a))

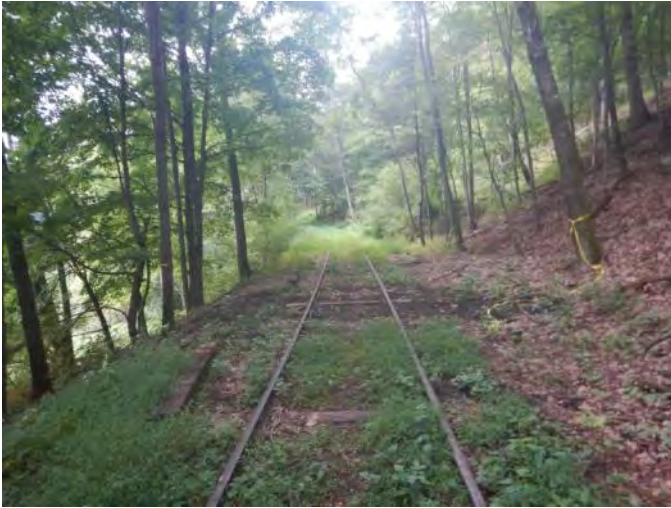
3.1 Recently Changed Ties To Meet Class 1. No Vegetation Management (\$213.37)

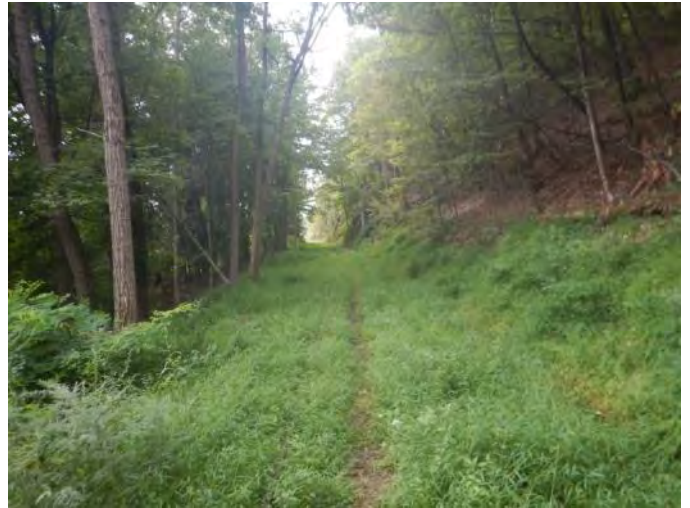
3.2 No Vegetation Management (\$213.37)

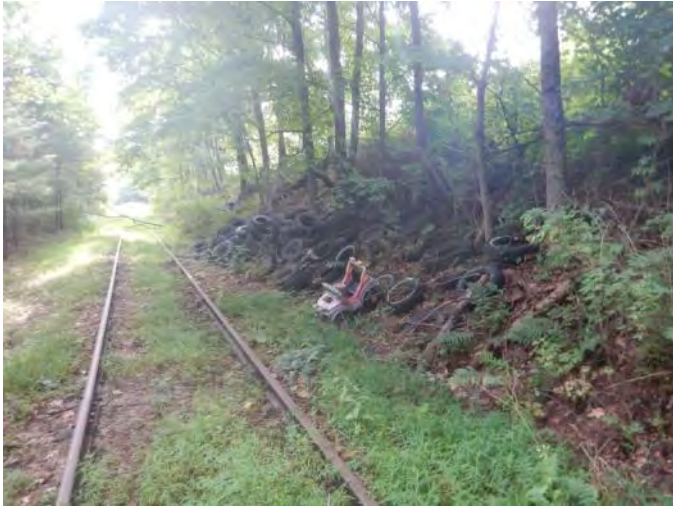
4.1 Previously Observed Tire Pile. Right Of Way Was Not Free Of Brush, Litter And Debris.

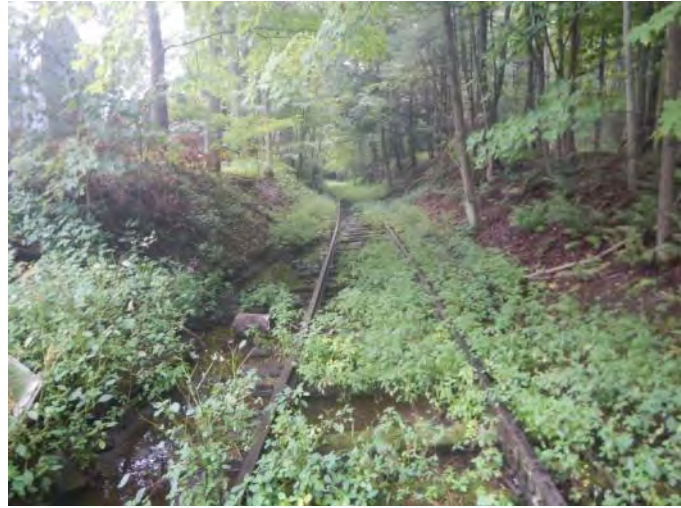
4.2 Poor Drainage And Defective Tie Condition (§213.33 and §213.109(e) (1))

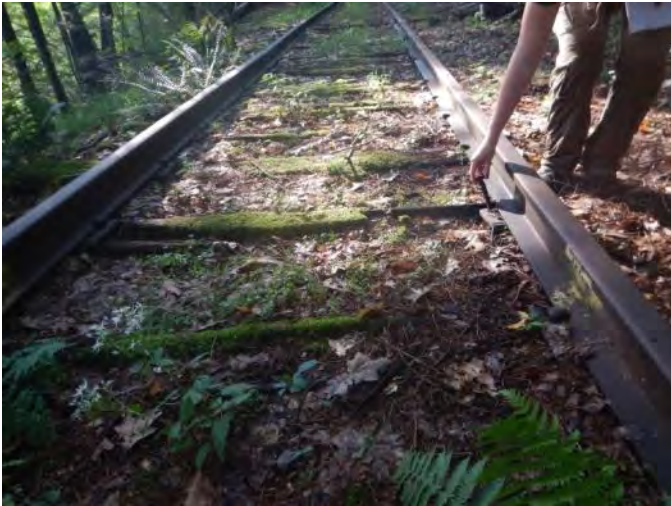
4.3 Defective Tie, Tie Unable To Hold Spike (§213.109(c) (2))

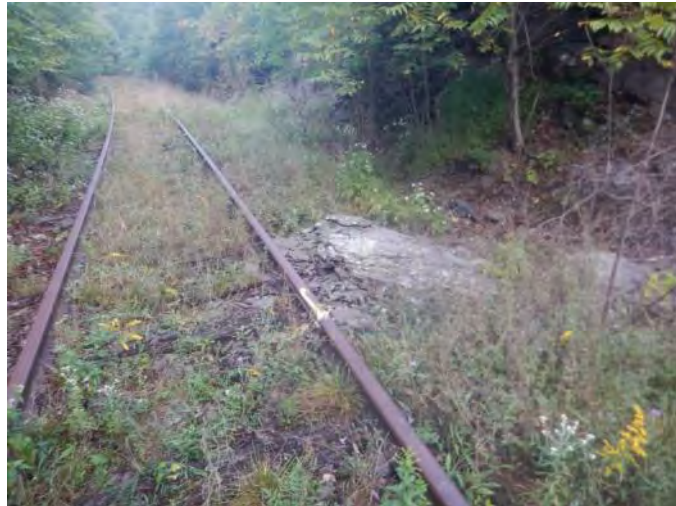
4.4 Rockslide Next To Joint Tie Defect (§213.109(e) (1))

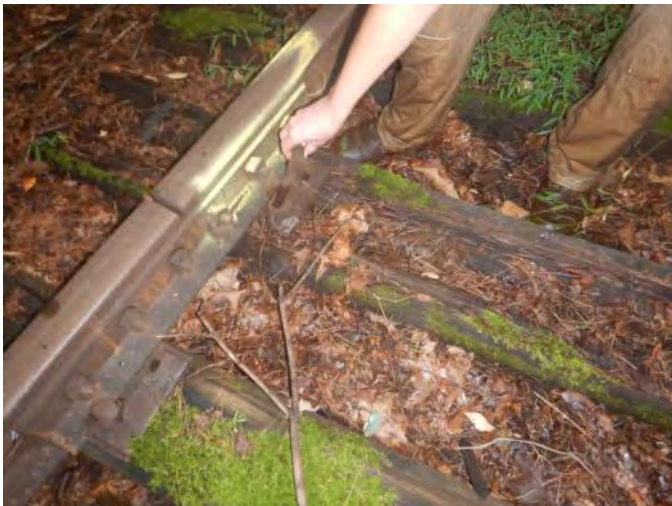
4.5 Previously Marked Joint Tie Defect, Tie Unable To Hold Spike – Defect Not Addressed (§213.109(c) (2))

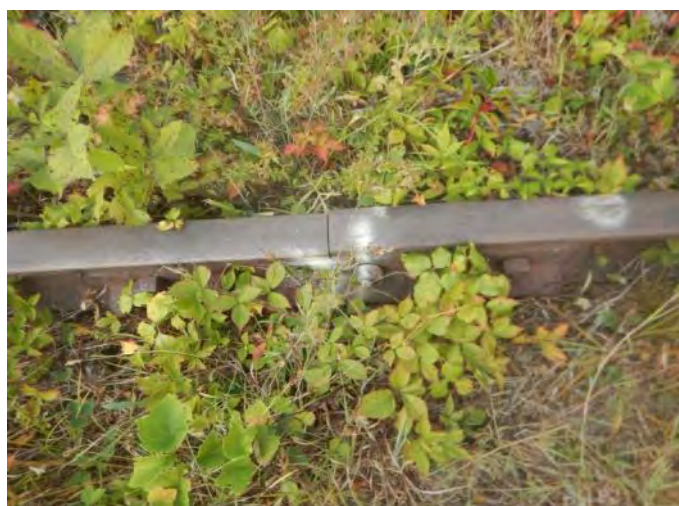
4.6 Previously Marked Center Cracked Joint Bar – Defect Not Addressed (§213.121(c))

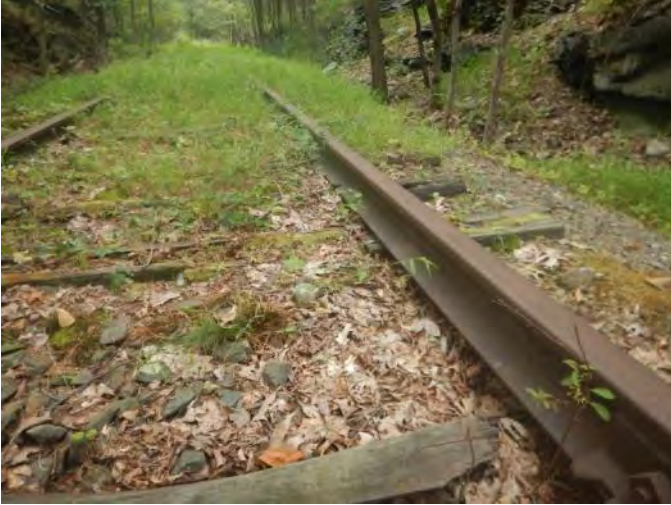
4.7 No Effective Support Ties Within The Prescribed Distance From A Joint (§213.109(e) (1))

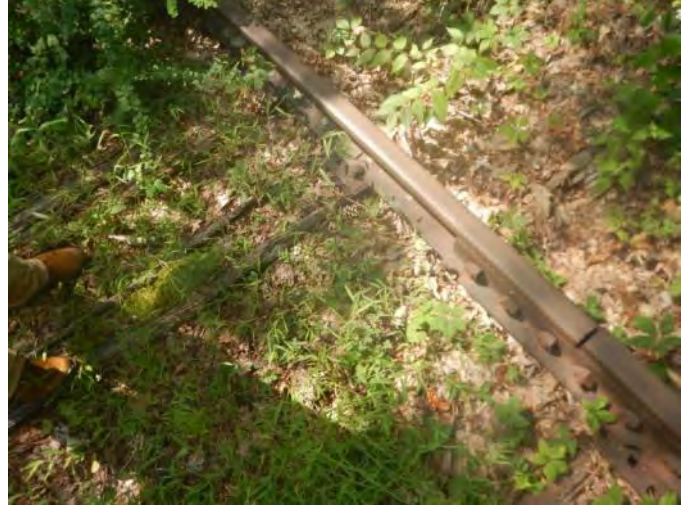
4.8 Defect Tie Condition (§213.109(e) (1))

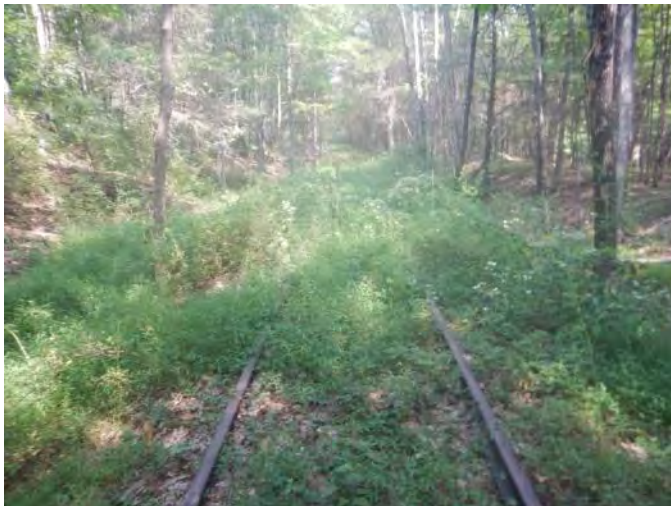
4.9 No Vegetation Management (§213.37)

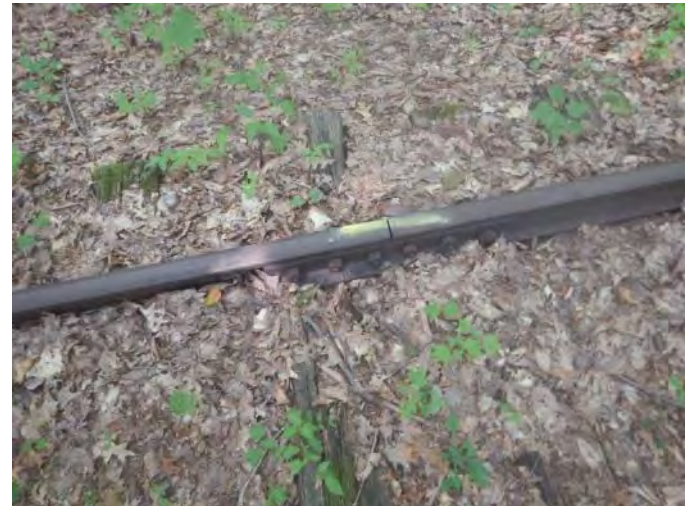
4.10 Previously Marked Joint Tie Defect, Tie Unable To Hold Spike – Defect Not Addressed (§213.109(c) (2))

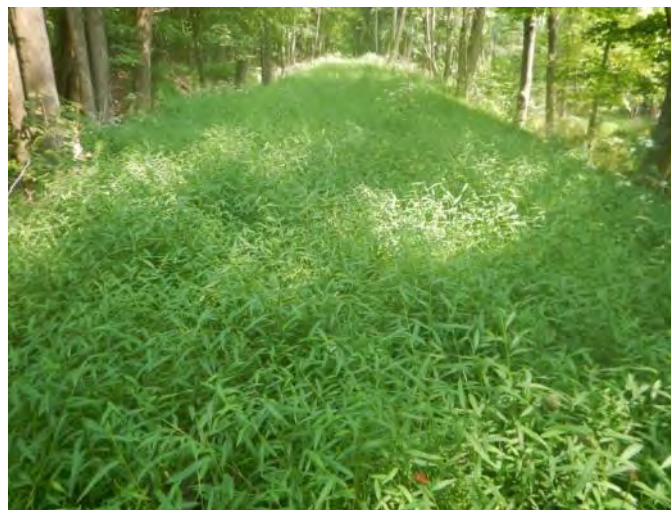
4.11 No Vegetation Management (§213.37), Difficult To Inspect

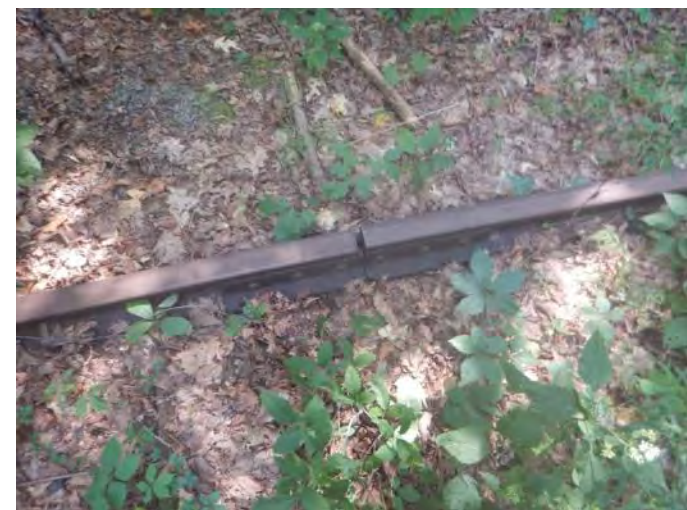
4.12 Center Cracked Joint Bar (§213.121(c))

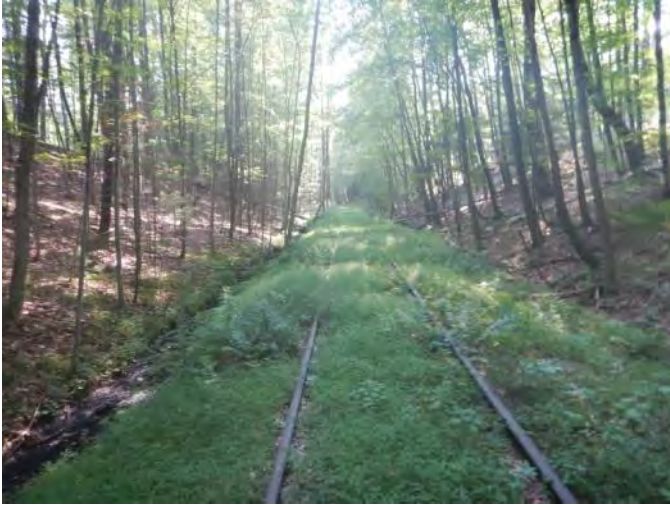
4.13 Poor Drainage And No Vegetation Management (§213.33 And §213.37)

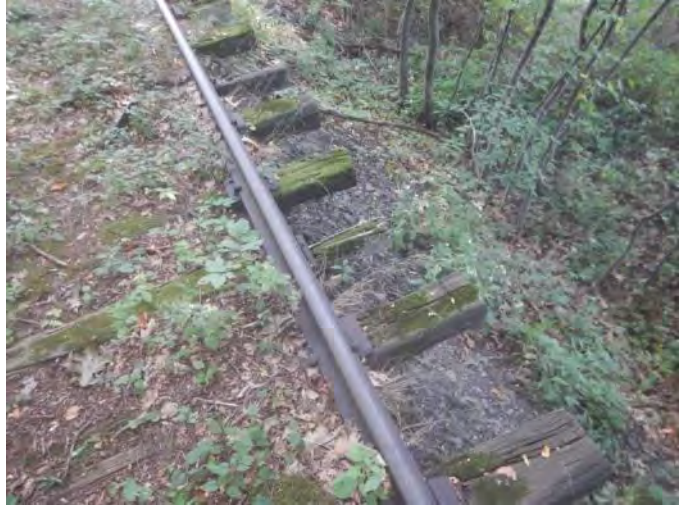
4.14 Poor Tie Condition and Insufficient Ballast (§213.109(e) (1) and §213.103(a))

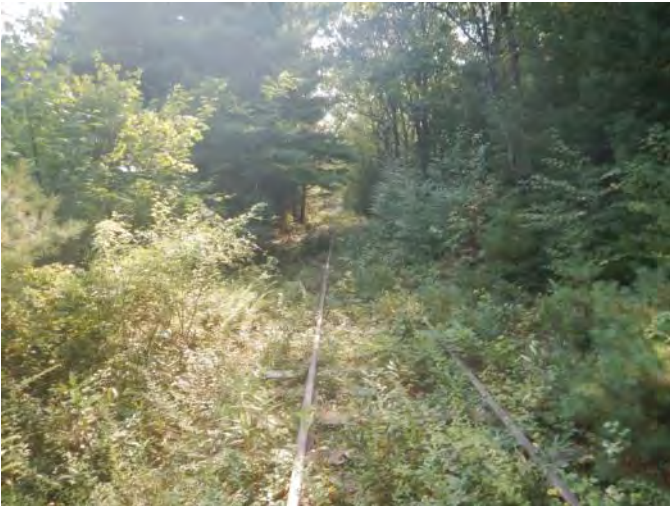
4.15 No Vegetation Management (§213.37)

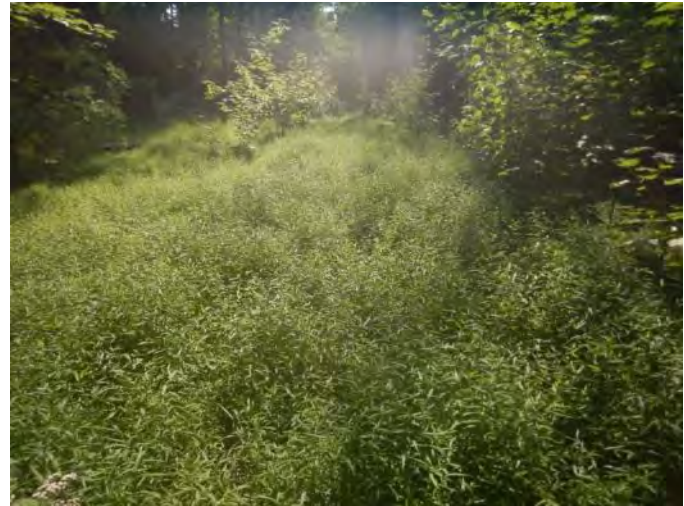
4.16 No Vegetation Management (§213.37), Difficult To Inspect

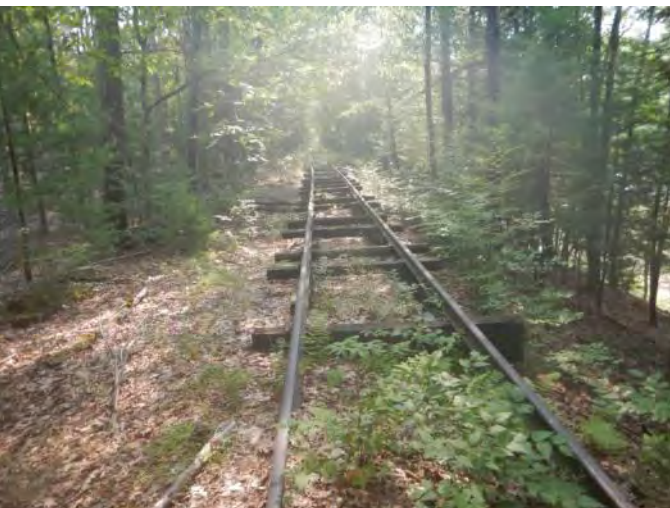
4.17 Washout, Insufficient Ballast (§213.103(a))

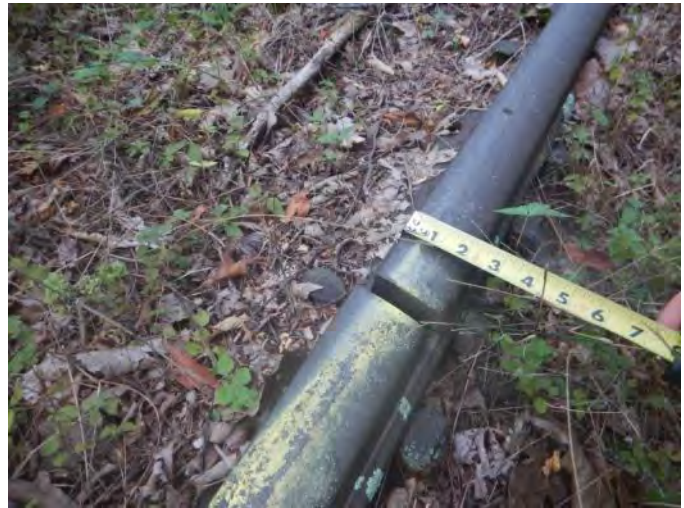
4.18 Rail End Mismatch (§213.115)

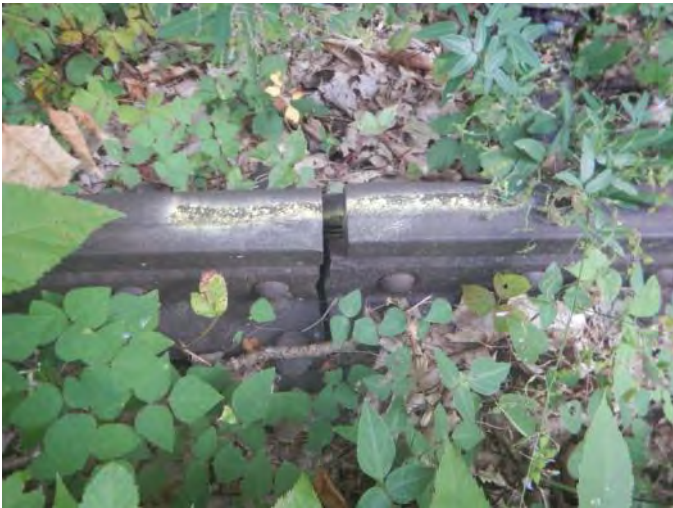
4.19 Previously Marked Center Cracked Joint Bar – Defect Not Addressed (§213.121(c))

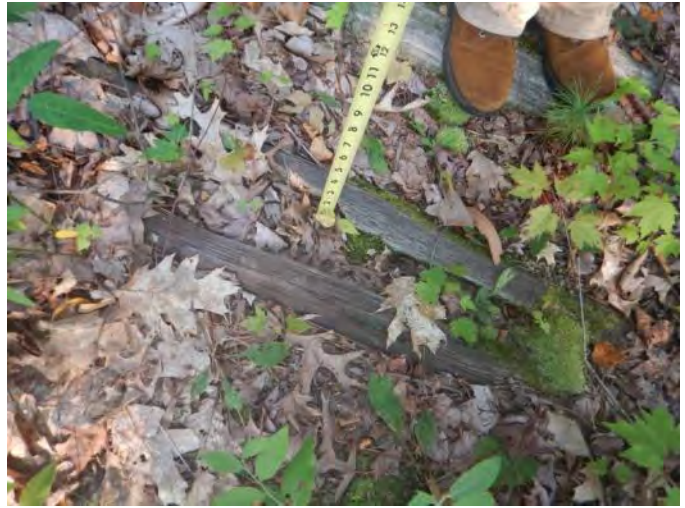
4.20 Detailed View of Deteriorated (§213.109(c) (3))

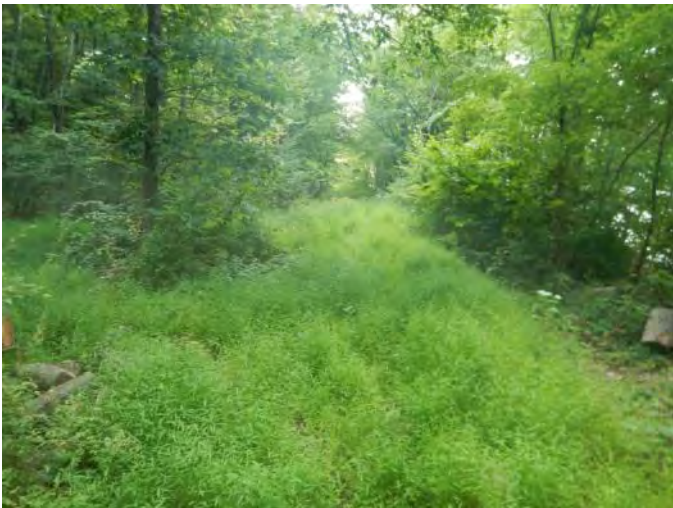
4.21 No Vegetation Management (§213.37), Difficult To Inspect

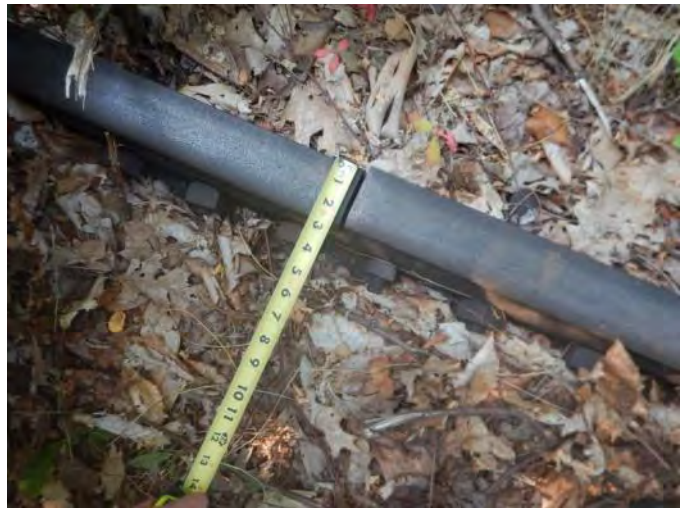
4.22 Rail End Mismatch (§213.115)

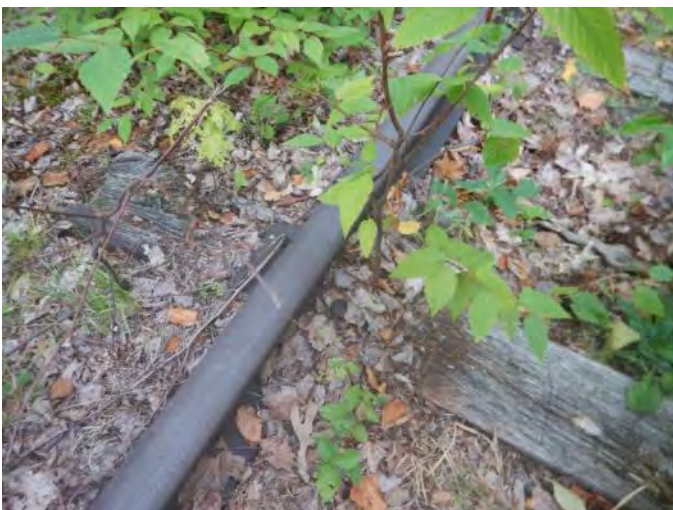
4.23 Defective Tie, Vegetation Growing Through Tie (§213.109(c) (2))

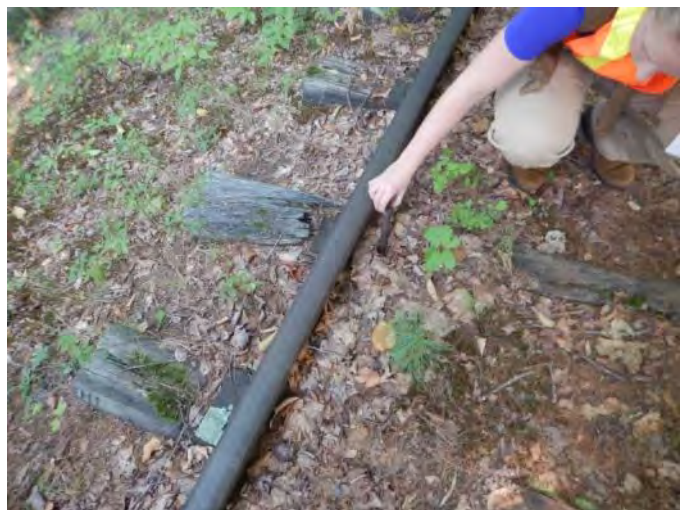
4.24 Defective Tie, Tie Unable To Hold Spike (§213.109(c) (2))

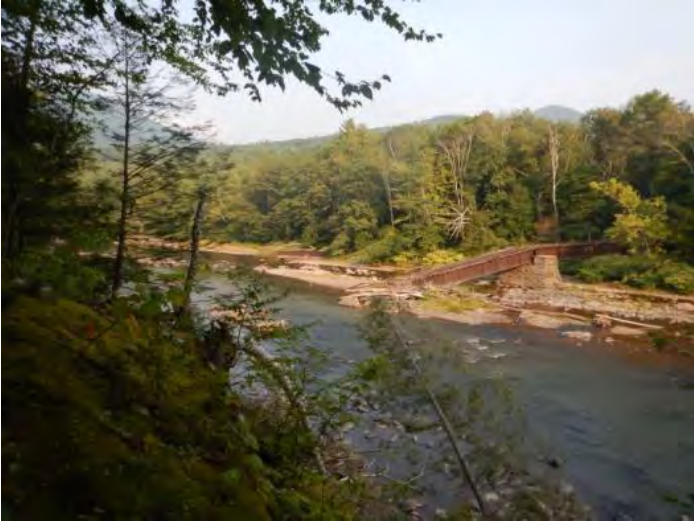
5.1 Failed Esopus Creek Trestle

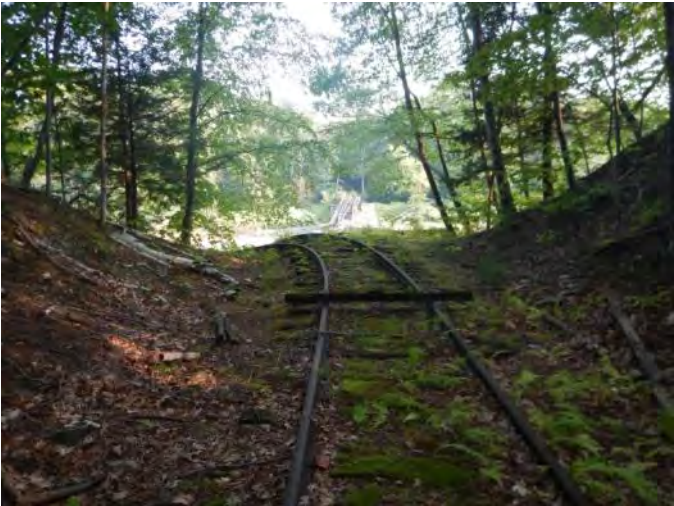
5.2 Poor Tie Condition On Espous Creek Trestle Approach (§213.109(e) (1))

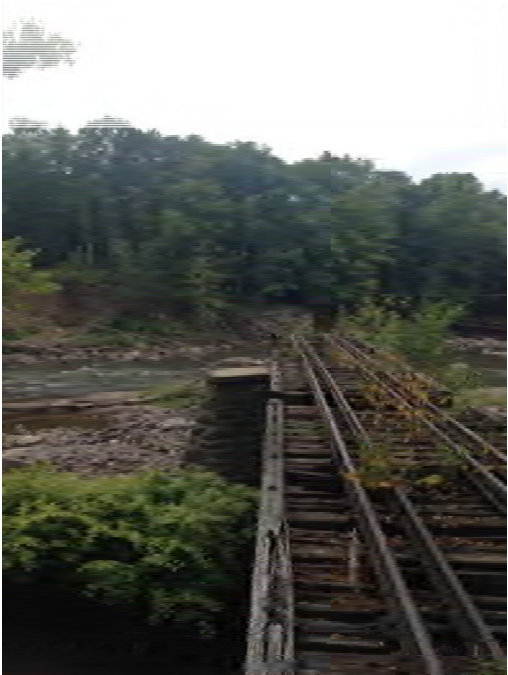
5.2 Poor Timber Condition On Espous Creek Trestle Approach (§213.109(e) (1))

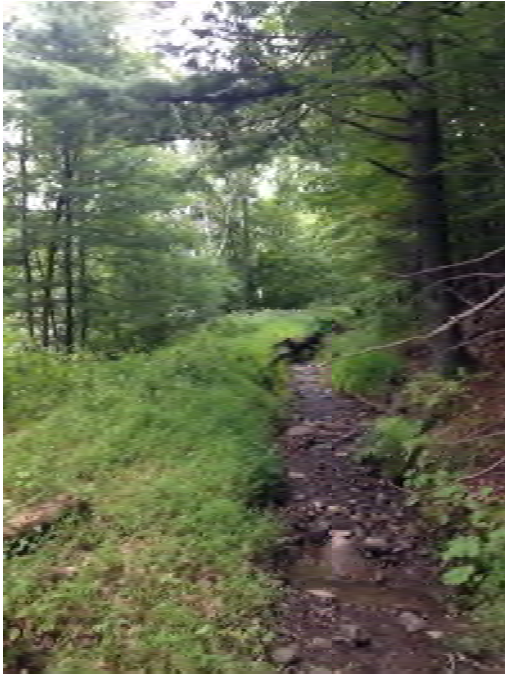
6.1 Poor Drainage And No Vegetation Management (§213.33 And §213.37)

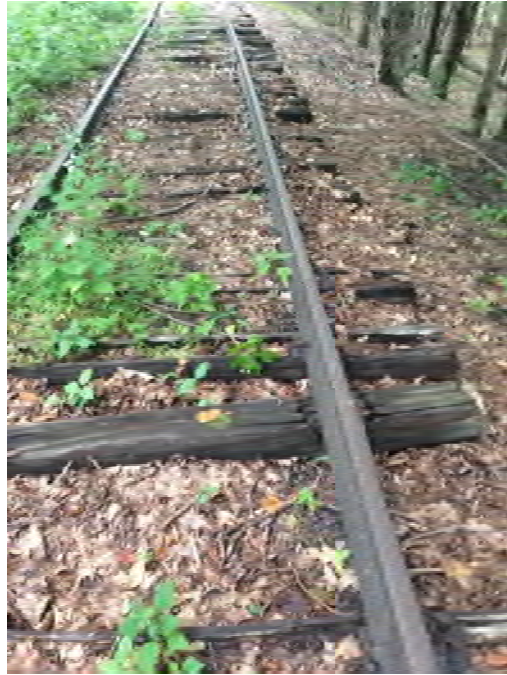
6.2 No Effective Support Ties Within The Prescribed Distance From A Joint (§213.109(e) (1))

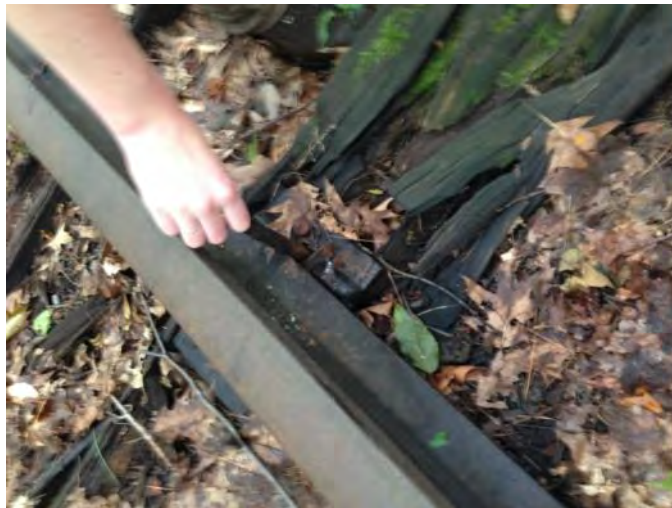
6.3 Defective Tie, Tie Unable To Hold Spike (§213.109(c) (2))

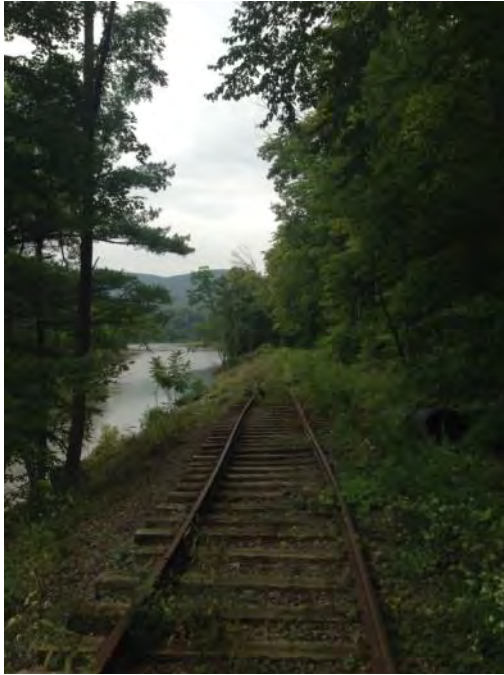
7.1 Washout, Insufficient Ballast (§213.103(a))

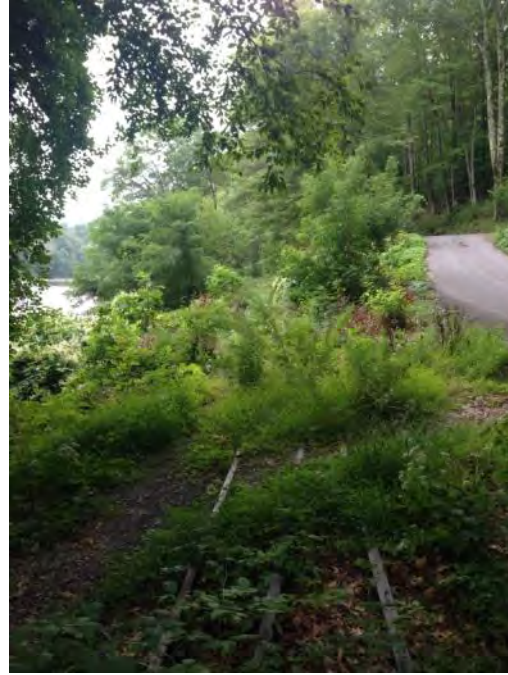
7.2 No Vegetation Management (§213.37)

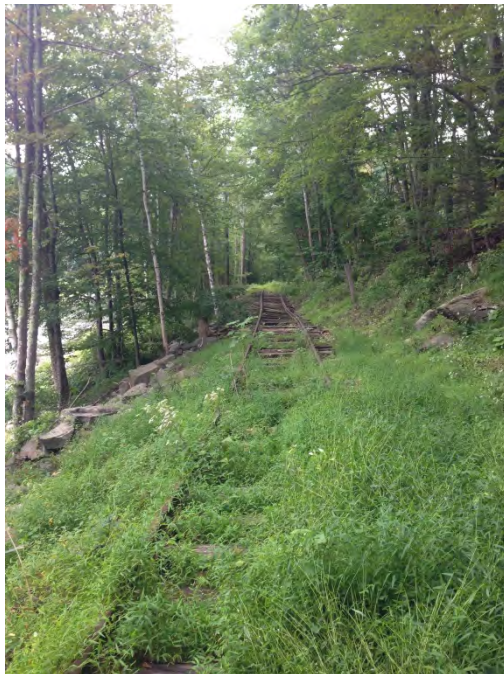
7.3 Washout, Insufficient Ballast (§213.103(a))

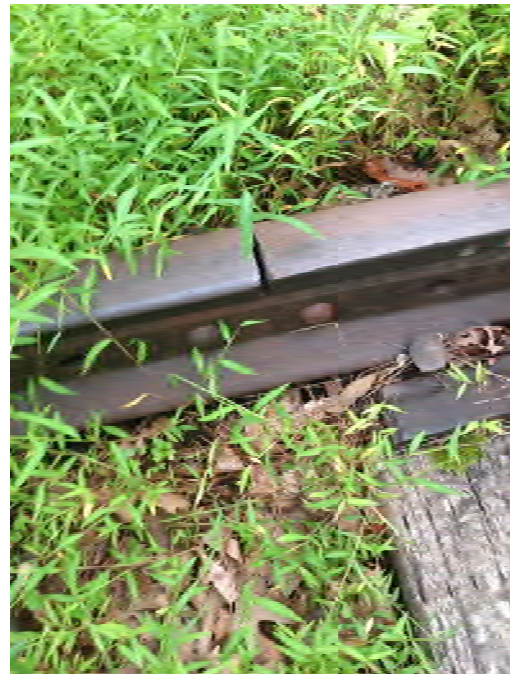
7.4 Center Cracked Joint Bar (§213.121(c))

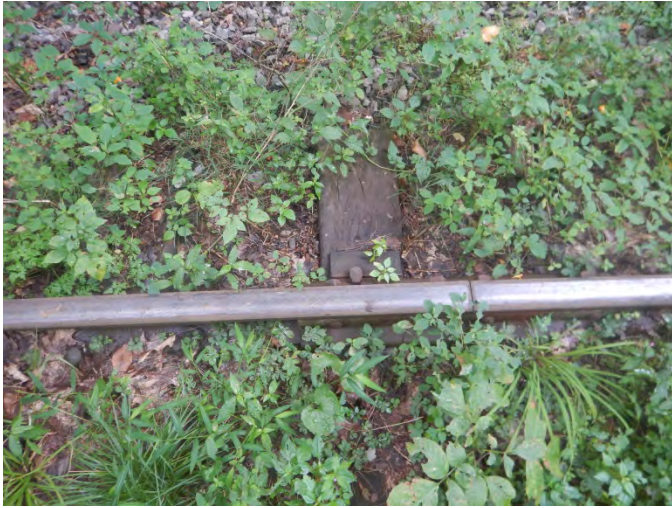
8.1 Tie Condition Generally Meets Class 1

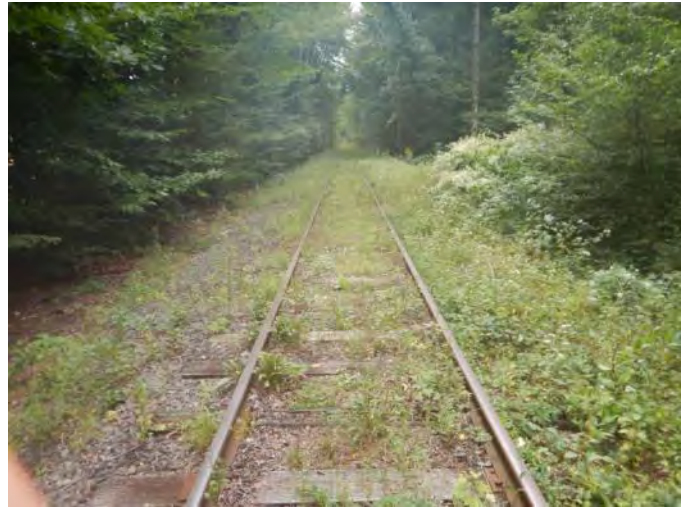
8.2 Tie Condition Generally Meets Class 1, Vegetation Defects Observed (§213.37)

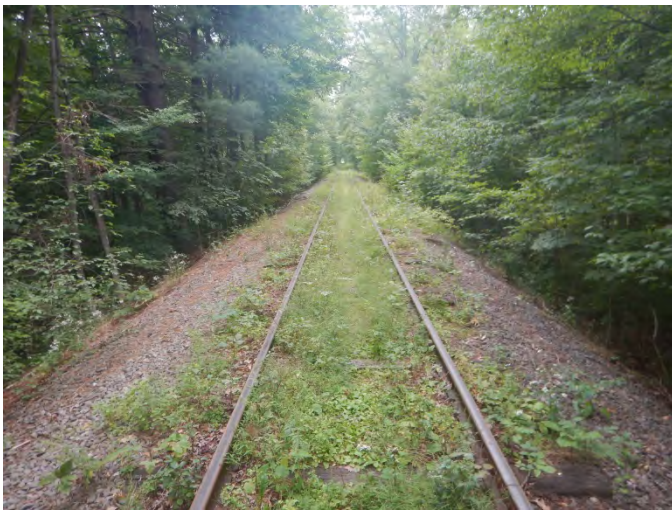
8.3 Tie Condition Generally Meets Class 1, Vegetation Defects Observed (§213.37)

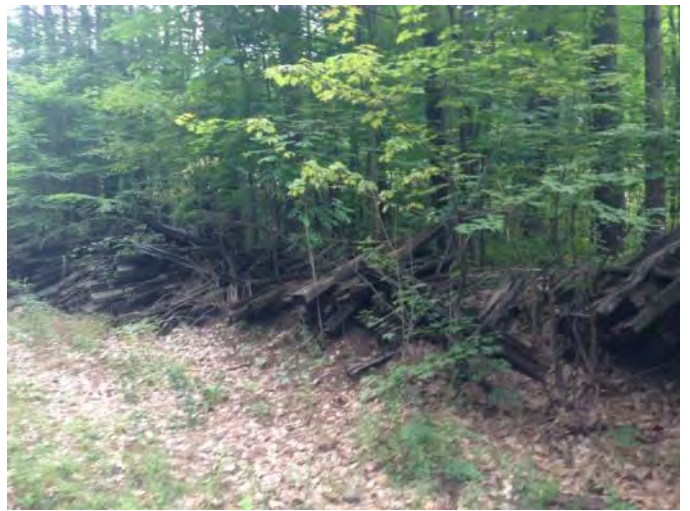
8.4 Previously Observed Tie Pile, Ties Should Be Disposed Of At An Approved Facility

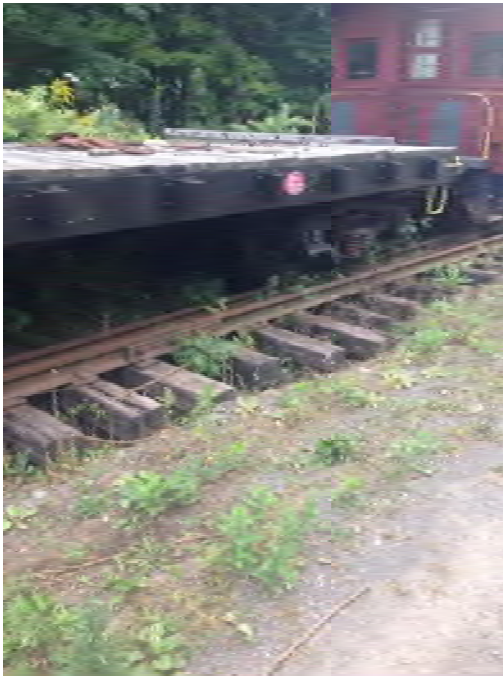
9.1 Poor Tie Condition and Insufficient Ballast (§213.109(e) (1) and §213.103(a))

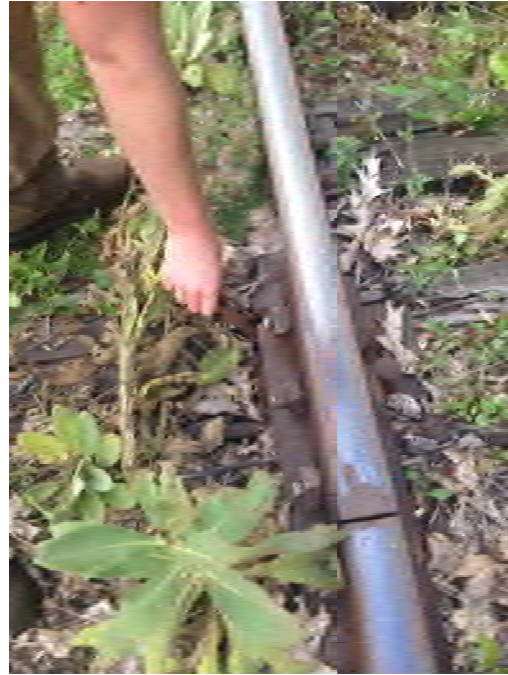
9.2 Defective Tie, Tie Unable To Hold Spike (§213.109(c) (2))

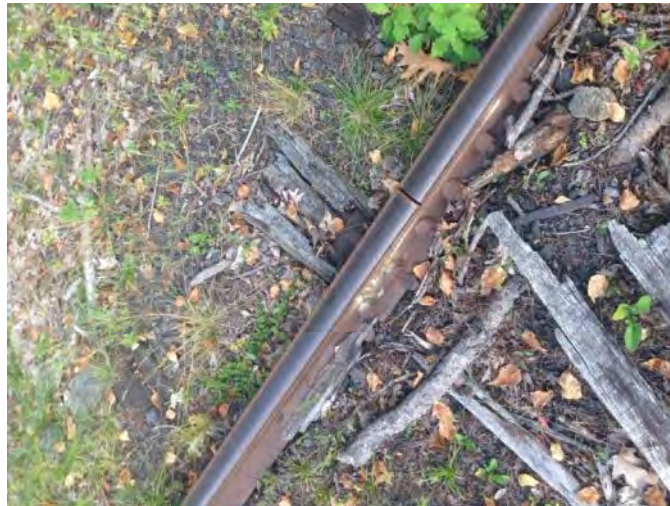
9.3 No Effective Support Ties Within The Prescribed Distance From A Joint (§213.109(e) (1))
