# **APPENDIX B: Existing Conditions**

**Route 9W Corridor Management Plan**  
**Towns of Marlborough and Lloyd**  
**Ulster County, NY**

## EXISTING CONDITIONS REPORT

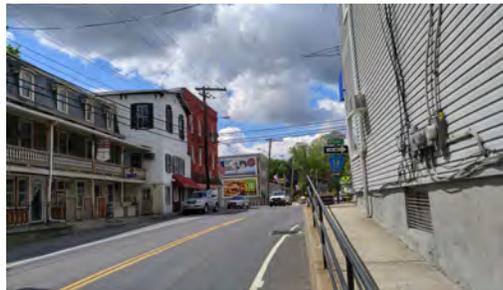
On the west side of 9W, there is no crosswalk across the Western Avenue intersection from south to north due to the sidewalk elevation sitting well above that of Route 9W on the north side of the road (Fig. 9). The sidewalk on the north side can be accessed via the on-street parking stalls on Western Avenue and is used as an outdoor seating area for adjacent businesses (Fig. 10 & 11). The sidewalk ramps down as it turns the corner around Western Avenue at Farmer's Insurance onto Route 9W (Fig. 12). A seven (7') foot shoulder borders the west side of Route 9W along the ramp.

**Figure 12: Sidewalk ramp and narrow shoulder on 9W southbound, looking south**

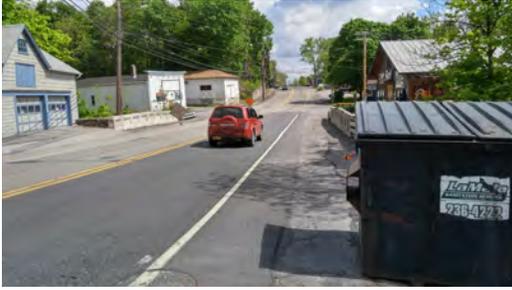
Approaching Dock Road from the south, the shoulder on the east side of 9W narrows to four (4') feet as it passes along several garages adjoining the commercial buildings lining the roadway (Fig. 13). Around Mile 0.25, to the south side of the bridge over Lattintown Creek falls, dumpsters are located just off the shoulder (Fig. 14). On the east side of the bridge, there is a three-and-a-half (3.5') foot maintained shoulder, plus seven (7') feet of additional pavement; but, it is unclear what is roadway maintained by the State versus adjoining property owners. To the north of the Lattintown

**Figure 14: Dumpster along shoulder south of Lattintown Creek bridge on 9W northbound, looking north**

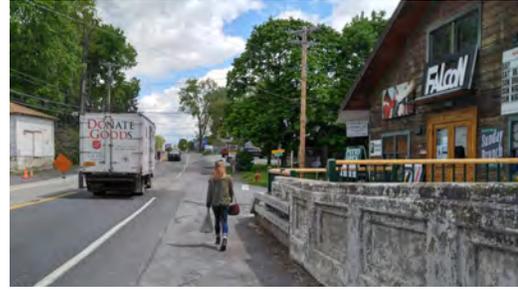
Creek bridge, the shoulder remains approximately the same width (Fig. 14 & 15).

**Figure 15: Pedestrian walking in shoulder over Lattintown Creek bridge in front of The Falcon on 9W northbound, looking north**

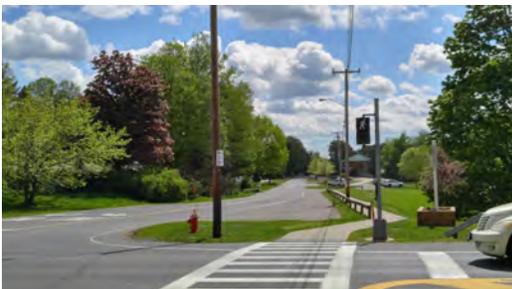
Figure 22: Countdown at crosswalk across 9W to Elementary School, looking east

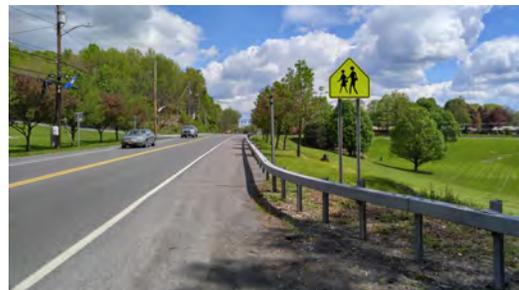
Figure 23: Signalized crosswalk across 9W to Elementary School, looking east

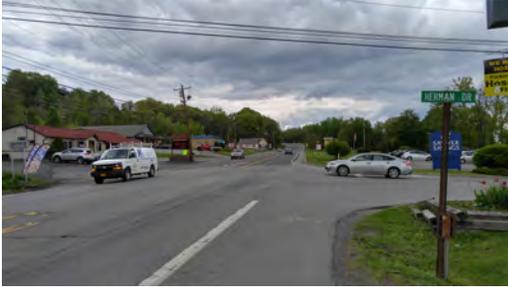
Figure 27: Pavement in fair condition at intersection of Herman Drive and 9W northbound, looking north

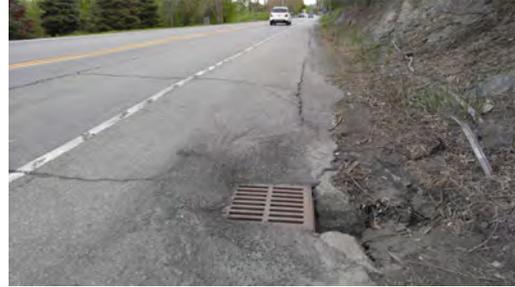
The shoulder along both sides of Route 9W from Young Avenue up to Purdy Avenue (west)/Hudson Banks (east) is approximately eight (8') feet in width and in good condition. North of Hudson Banks, the shoulder narrows to around five (5') feet and then becomes nine to ten (9-10') feet, with three to four (3-4') feet maintained and six (6') feet of gravel. Beyond the 40mph sign (approximately several hundred feet), the shoulder condition deteriorates and there are approximately four (4') feet of maintained shoulder adjacent to around eight (8') feet of broken pavement/gravel and potholes (Fig. 25). The shoulder varies along the east side from nine (9') feet at the southern end to five (5') feet at Riverview Drive and barely existent in between. It is mostly in poor condition/unmaintained with large potholes and broken up areas in this section. The west side of 9W up to James Street has an eight to eight-and-a-half (8-8.5') foot wide shoulder in fair condition, of which five (5') feet are paved. The property frontage along the west side is entirely paved with one large open curb cut/no access controls. The shoulder narrows slightly between James Street and Warren Street and an exposed grate and drainage pipe indicates deterioration due to drainage along the west side of the roadway (Fig. 28).

Figure 28: Pavement in fair condition; drainage grate in shoulder on 9W southbound south of Bixby Lane, looking south

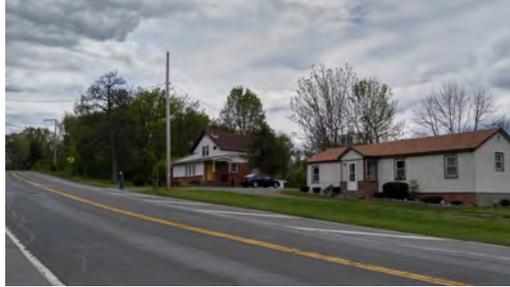
Figure 32: Cross-hatching to reduce roadway width on 9W southbound, looking southwest

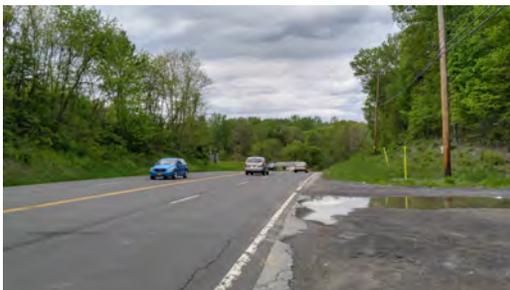
South Road at 9W (Fig. 34). There is a large area of ponding on the east side of the road halfway between Old Indian Road and Willow Tree Road at Mile 3.25 across from Ship Lantern Inn (Fig. 35 & 36).

**Figure 36: High-speed area with no shoulders, looking north across from Ship Lantern Inn**

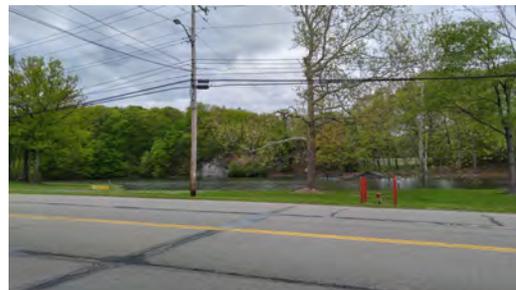
**Figure 37: Cluett Schantz Memorial Park on 9W southbound, looking west toward park**

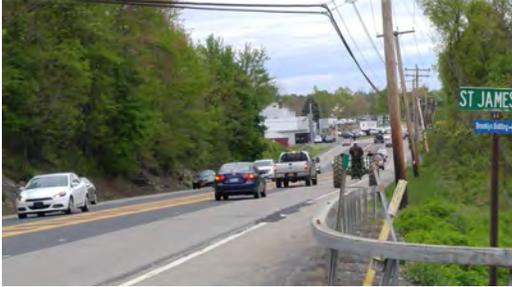
The east shoulder is seven (7') feet wide south of Saint James Road and 6.5 feet to the north of Saint James Road (Fig. 38). The shoulder on the western side of 9W in this location is 12.5 feet to the south and seven (7') feet to the north. The west side decreases gradually to five (5') feet in width at Milton Turnpike and the east side increases to around 8.5 feet wide. There is a left-turn lane from the southbound side onto South Road near the Town of Marlborough Town Hall, as well as left-turn lanes from both directions onto Milton Turnpike at the signalized four-road intersection. There are no crosswalks, push buttons or ADA improvements at the Milton Turnpike intersection (Fig. 39).

Figure 38: Slightly wider shoulder in fair condition; road narrows to one lane, shared with tractor on 9W northbound, looking north

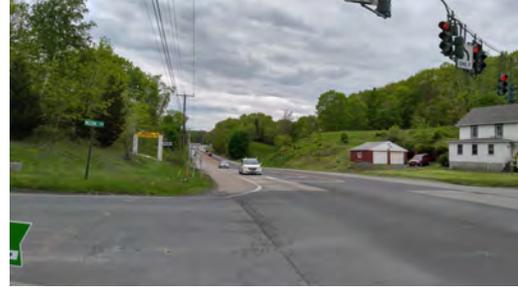
Figure 39: One northbound and southbound lane and left-turn lane onto Milton Turnpike on 9W northbound, looking north

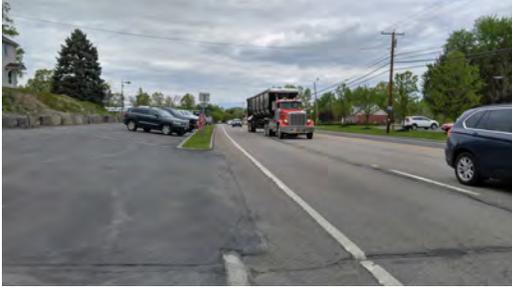
From the traffic light at Milton Turnpike to the north, there is a four (4') foot shoulder on the west (southbound) side of Route 9W, two northbound travel lanes, and a left-turn lane (Fig. 40). The east (northbound) side has an eight-and-a-half (8.5') foot shoulder in fair condition with cross-hatching along the front of Stewart's Shop. The roadway becomes two lanes (one lane in each direction) north of Stewart's.

**Figure 40: Young's Auto, three travel lanes and minimal shoulder on 9W southbound at Milton Turnpike, looking north**

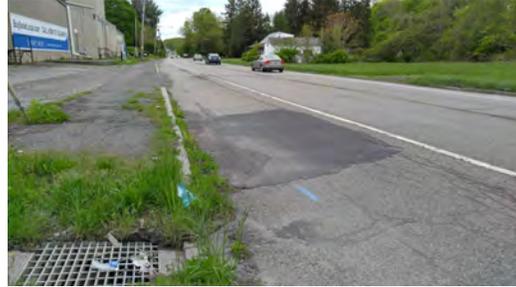
The shoulders remain in fair to good condition north of Milton Turnpike. At New Road, the shoulders are generally eight (8') feet on both sides of the corridor (Fig. 42). The shoulder width increases south of Mahoney Road to eight-and-a-half (8.5') feet on the west side and eleven (11') feet on the east. The east (northbound) shoulder is consistently ten feet (10') wide north of Mahoney Road (Fig. 41).

**Figure 41: Wide shoulder in fair condition at Mahoney Road, looking south**

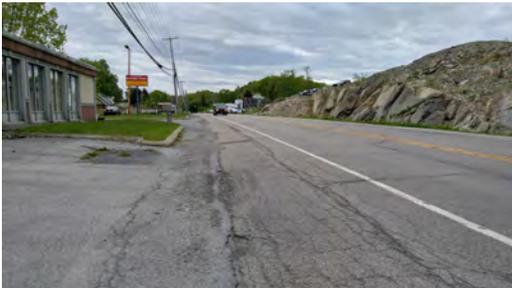
**Figure 42: Open curb cut on 9W northbound at New Road, looking south**

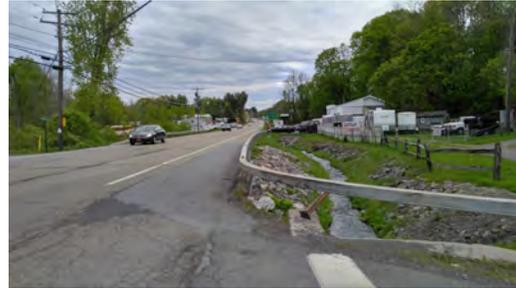
**Figure 43: Shoulder in fair condition and guardrail at edge with ditch/creek below on 9W southbound at Perkinsville Road, looking south**

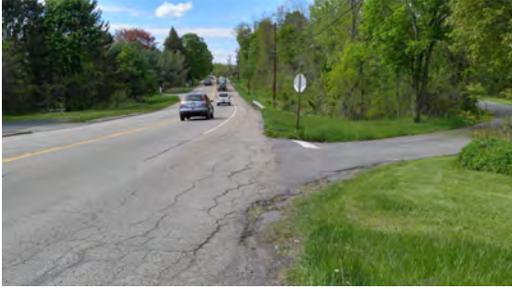
Figure 45: 9W northbound at south Sam Williams Road, looking north

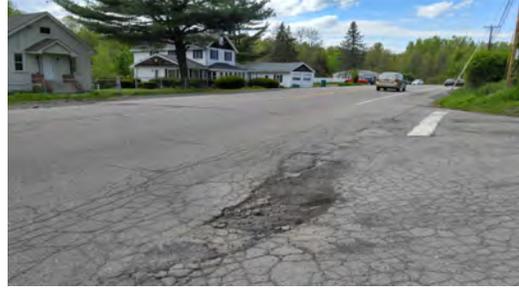
At the northern border of Marlborough with Lloyd, the shoulders are eight-and-a-half to nine (8.5-9') feet on the west side and seven-and-a-half to eight (7.5-8') feet on the east side in fair to poor condition, with some broken pavement and sloped areas that reduce the effective size of the shoulder. North of Perkinsville Road/North Road, the shoulder is ten (10') feet wide along the east side of 9W and eight-and-a-half (8.5') feet wide on the west side of the corridor and is generally in fair condition. The shoulders between Mackey Road and Bluepoint Road range from approximately seven-and-a-half (7.5') feet wide to ten-and-a-half (10.5') feet wide and are generally in fair condition, with small areas deteriorating to poor conditions (Fig. 46 & 47).

Figure 46: Moderately breaking and cracking pavement in shoulder on 9W northbound at Blue Point Road, looking north

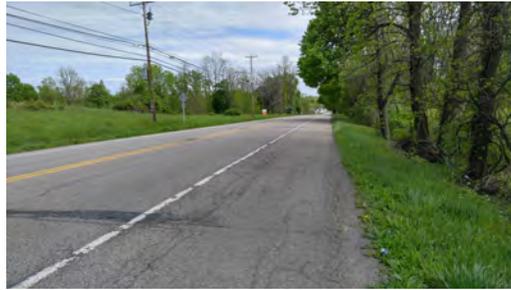
Figure 47: Wide shoulder in fair condition on 9W southbound at Blue Point Road, looking south
