**Ulster County Rail Trail Project – Ashokan Reservoir Section
 (“Ashokan Rail Trail”)**

Feasibility Study

July 2015

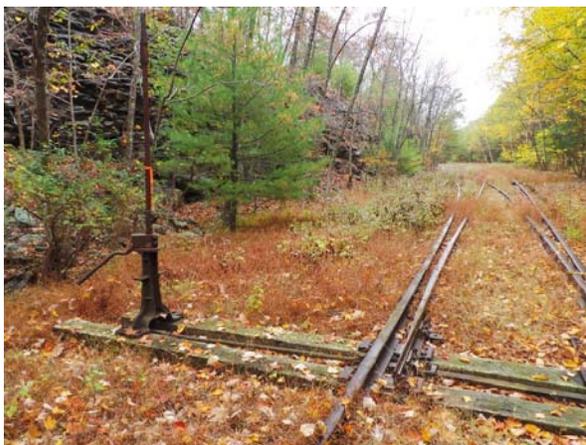
Photo 1-1– Example of Remaining Railroad Track Infrastructure – Segment 1

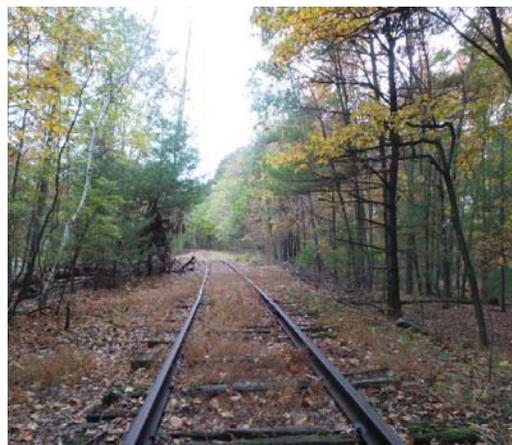
Photo 1-2 – Existing Rail Infrastructure Conditions – Segment 1

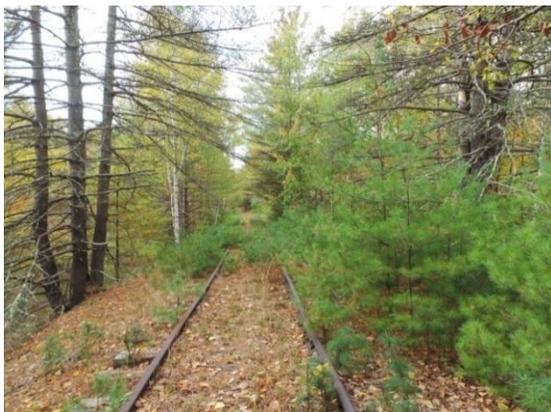
Photo 1-3 – Minor Tree Growth

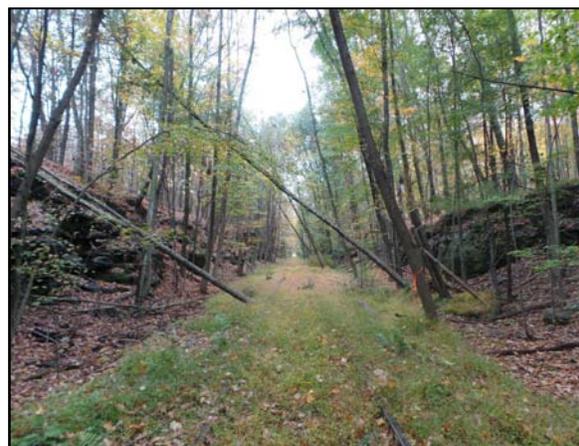
Side Slopes: The side slopes through the segment varied from 5 feet to 30 feet in height, terminating into either a valley (shown in Figure 5) or a rock cut section shown in Photo 1-4. The rock sections range from approximately 5 feet to approximately 40 feet in height. The side slopes generally sloped downward at a rate of 2 feet horizontal to 1 feet vertical (2:1). Depending on the final design chosen, the side slopes in this segment should not require any repairs with the exception of the two areas have experienced rock slides, located at station 603+75 and at station 672+00 (See Appendix A). These areas will likely require a geological assessment and might need designed stabilization to reduce the chance of future rock slides.

Photo 1-4 – Rock Cut Section

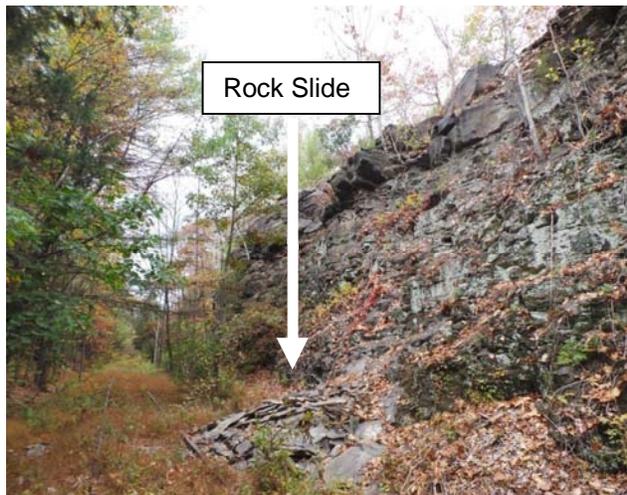
Photo 1-5
Rock Slide in Segment 1

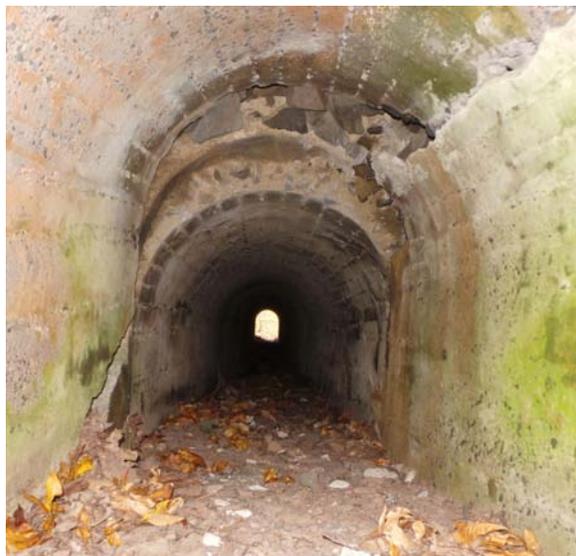
The remaining two (2) concrete culverts are in poor condition and will require major repair or full replacement to restore functionality. These include the culvert located at station 620+00 which will require significant repair to the headwall and to repair the separation of two sections. The other damaged culvert is located at station 647+75 where significant erosion and scour of the concrete bottom has compromised the integrity of the entire structure. These large culverts are approximately 8 feet tall by 8 feet wide. The drainage ditches/swales are generally still discernible and will require some minor excavation and debris removal to restore flow and capacity. The two (2) separate culverts shown below exhibit significantly different internal conditions.

Photo 1-6
Separation and Structural Damage Inside Culvert
RR Tracks Directly above Damaged Section

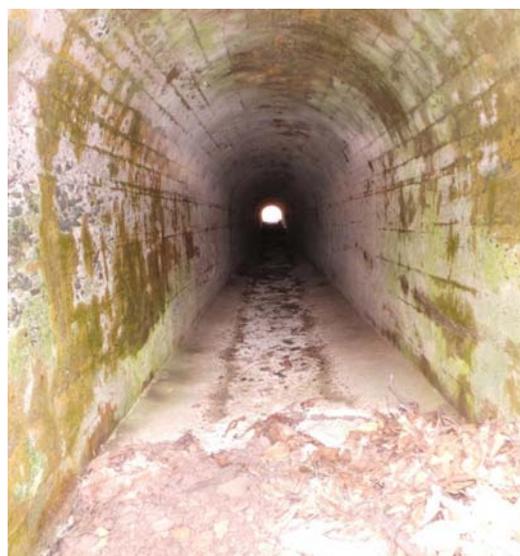
Photo 1-7
Only Minor Restoration and Maintenance
Required Internally

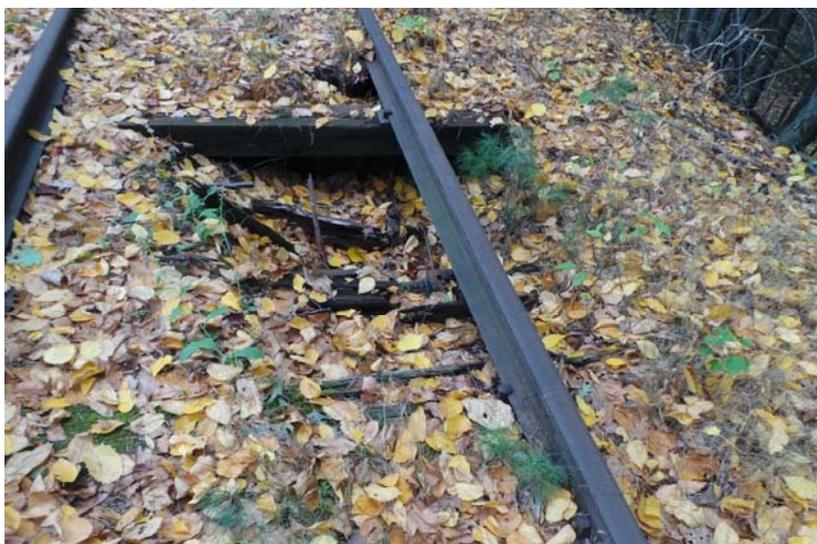
With the exception of one location, a 3 feet wide by 3 feet long by 1 feet deep sinkhole, the ballast throughout this segment remains intact. The steel rails remain barely fastened to the deteriorated wooden ties. In the lower lying areas of Segment 2, what remains of the wooden ties

Photo 2-1
Ballast Loss and Severely Rotted Ties

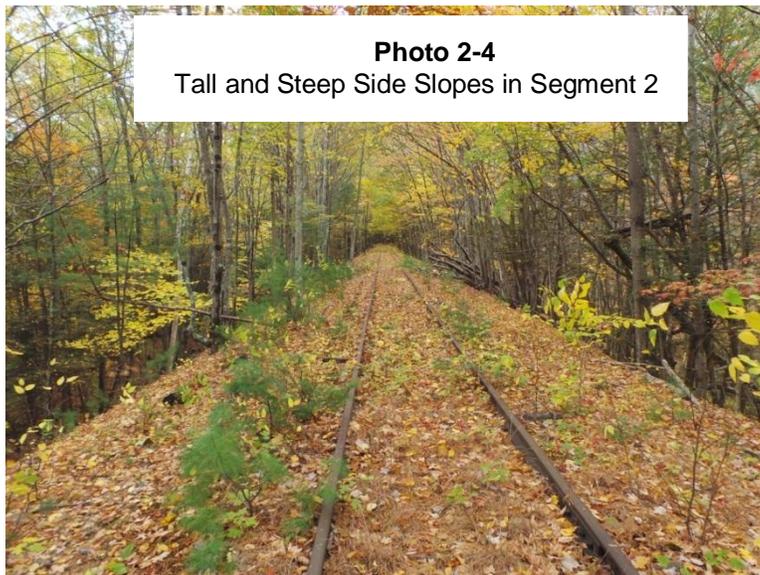
Side slopes: Side slopes throughout this segment varied between 40 foot tall embankments that terminated into valleys, to earth cut slopes approximately 45 feet high land adjacent to the railroad corridor. This segment, although primarily comprised of steep slopes also exhibited isolated areas that were relatively flat. In this segment, most of the trail will likely require the installation of a pedestrian/bicycle barrier to shield users from the high and steep slopes. The flattening of slopes by adding material is a form of mitigation that can reduce railing installation. In locations with easy access, this is often more desirable than installing railing, however, given the remoteness of these locations, trucking in material could prove more costly both environmentally and fiscally. These and other options should be investigated and developed in greater detail during the design and public input process.

Photo 2-4
Tall and Steep Side Slopes in Segment 2

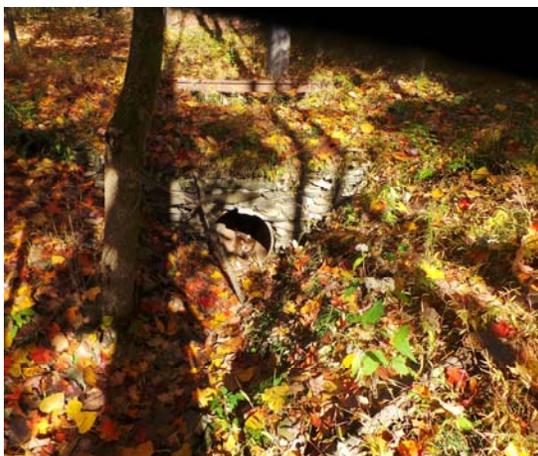
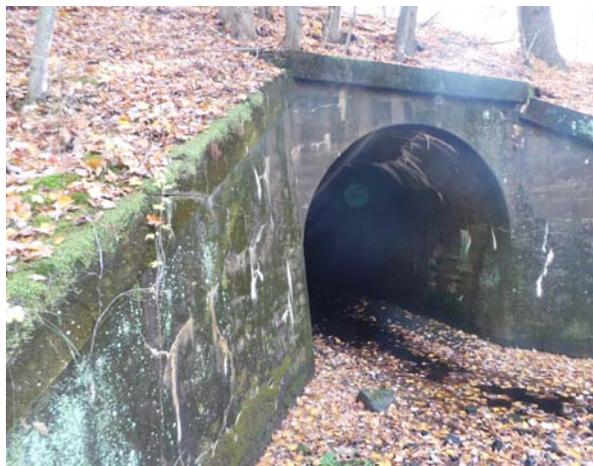
Photos 2-5 and 2-6

Minor and Major Culvert Headwalls in Good Overall Condition – Segment 2

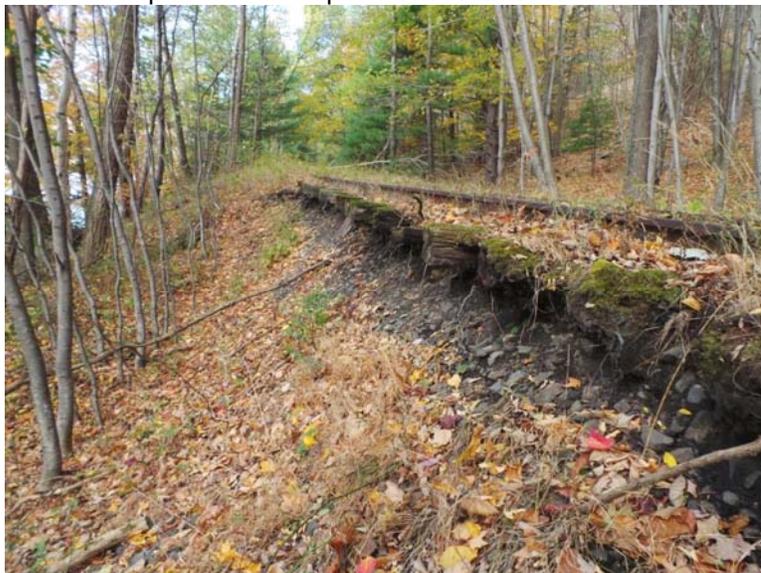
Photo 4-1

Overall the side slopes appear to be stable with one notable exception, shown below in photo 4-1, where the embankment has eroded away presumably into the Ashokan Reservoir, leaving the edges of the wooden ties suspended in the air for an approximately 50 feet long section. This is located at station 1023+50.

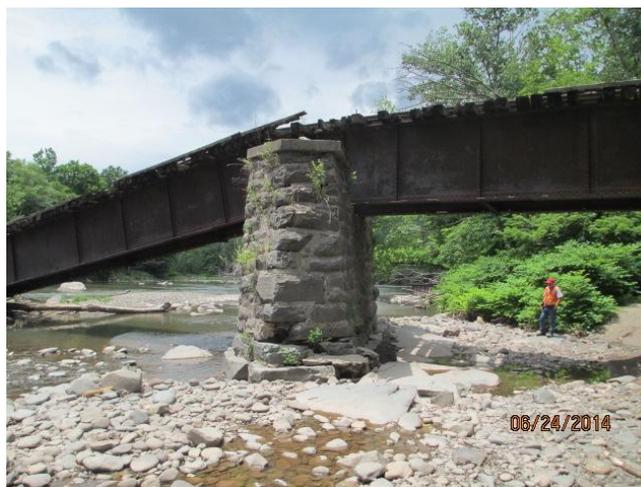
Boiceville Railroad Trestle previously spanned 294 feet across the Esopus Creek. During Hurricane Irene and Tropical Storm Lee, which brought heavy rains to the area, flood waters of the Esopus Creek destroyed most sections of the Boiceville Trestle. Only one of the four sections of the trestle remains in place. Photo 5-2 below shows another view of the remains of the Boiceville Railroad Trestle. Replacement of the structure with some type of crossing will be necessary to make the connection to NYS Route 28A.

Photo 5-2 – In the background, remnants of the Boiceville Railroad Trestle over the Esopus Creek

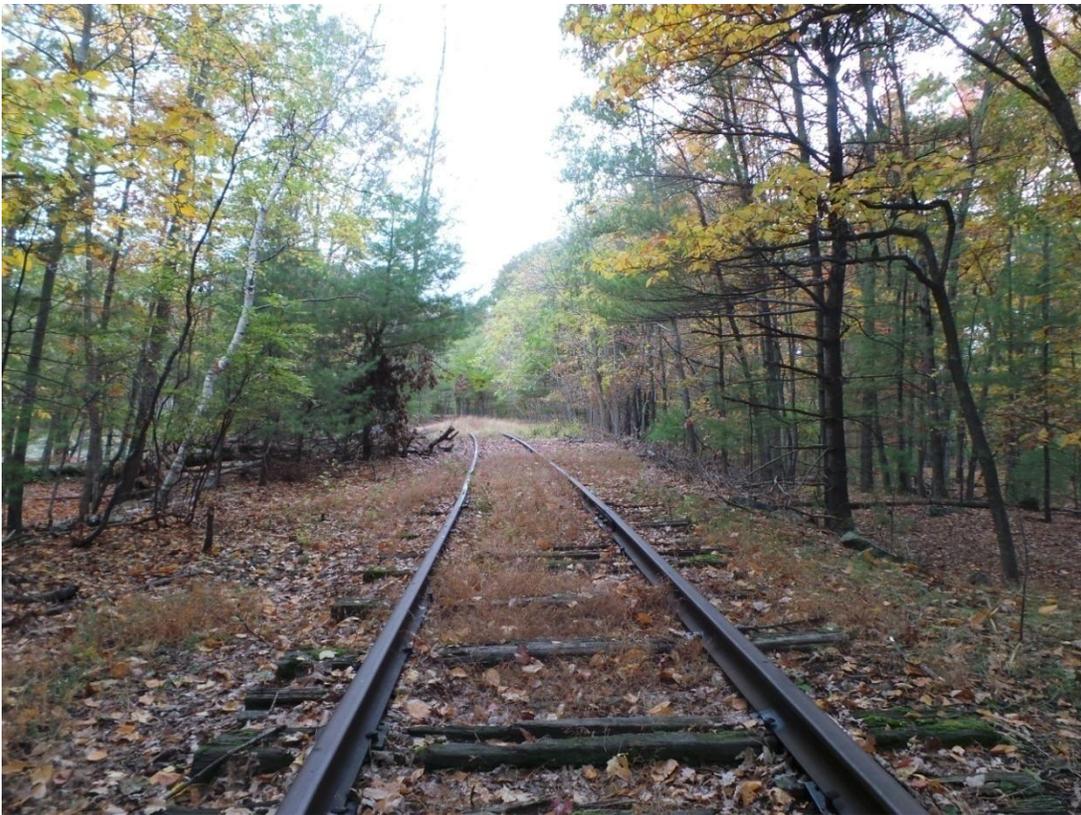
Photo 102 –Existing Rail System Conditions

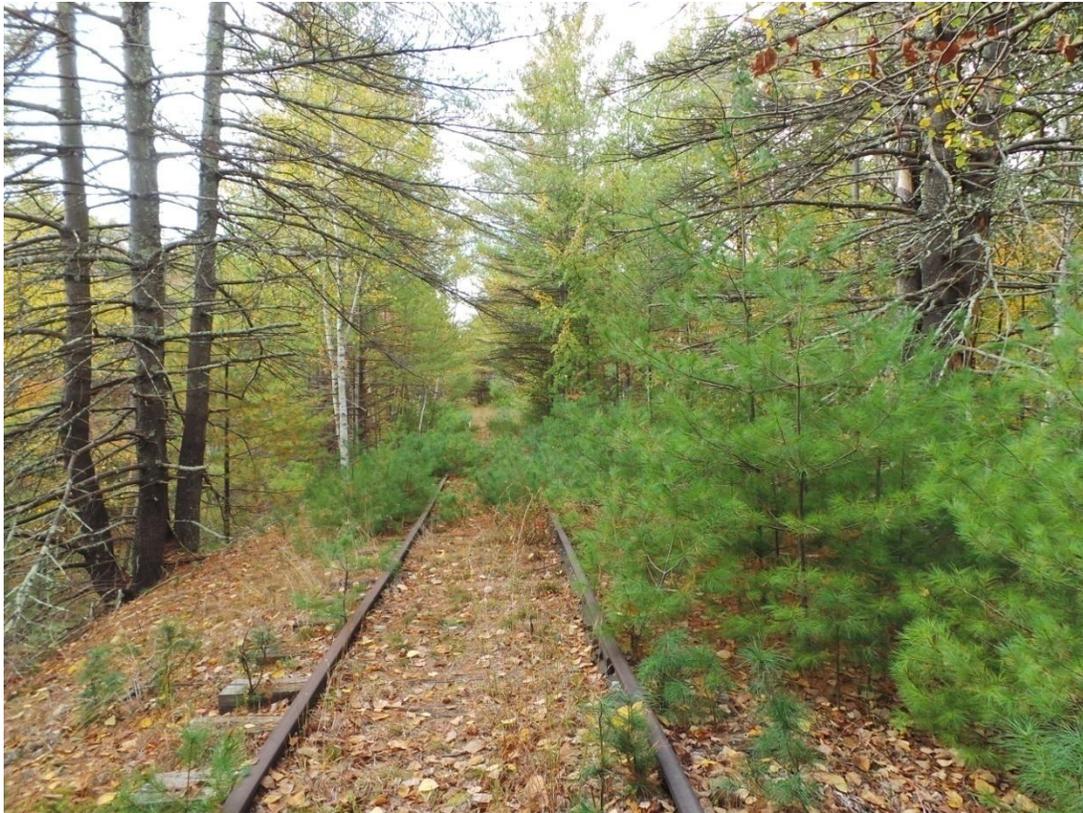
Photo 103 – minor pine tree growth on rail bed and embankment

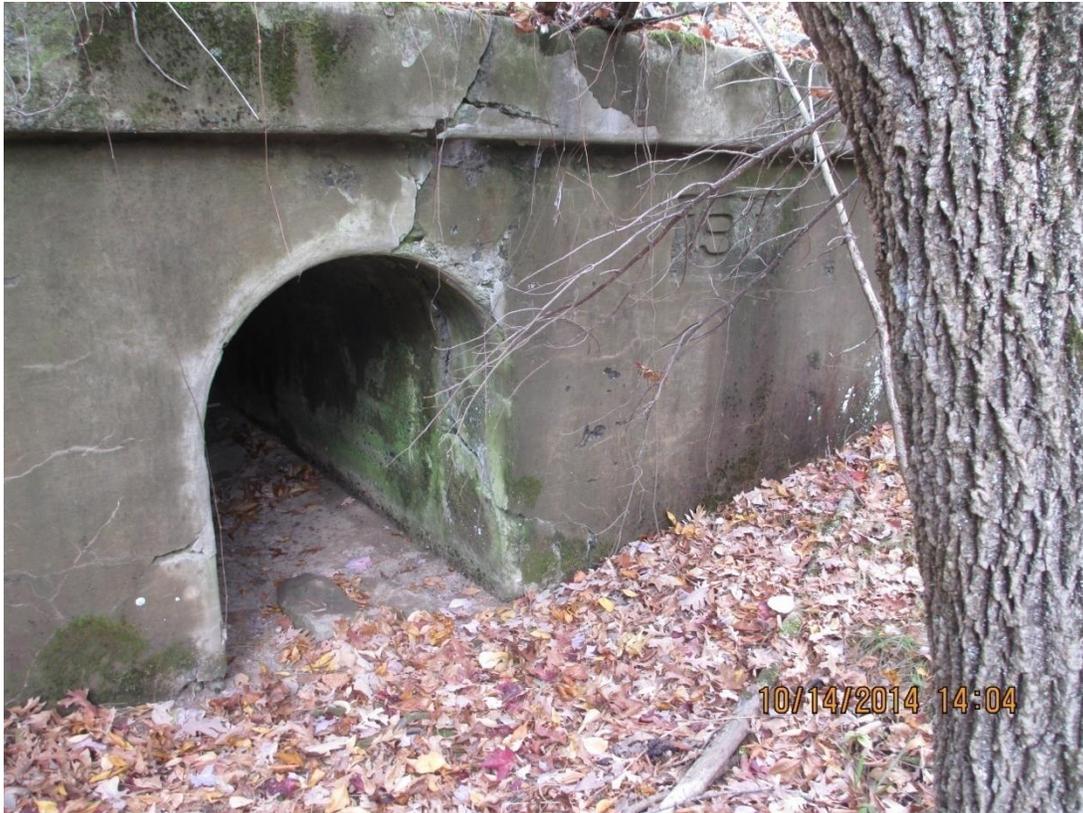
Photo 109 – Damaged culvert headwall

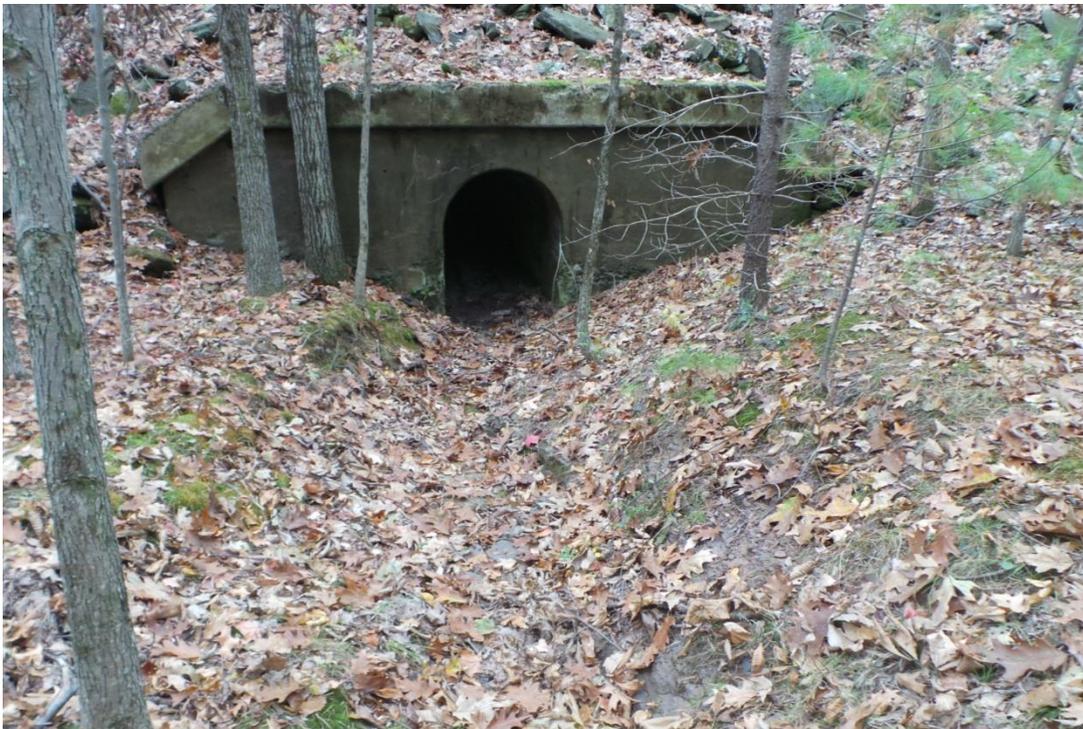
Photo 110 – Acceptable culvert headwall condition

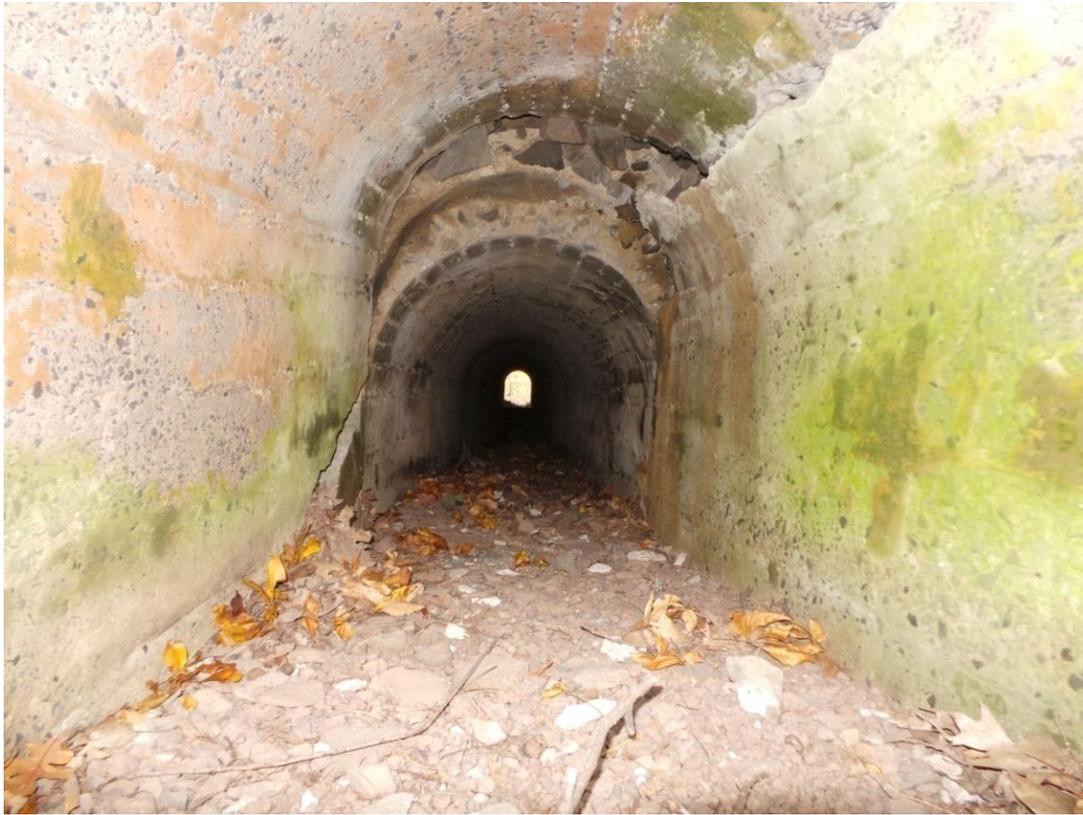
Photo 111 – Damaged culvert

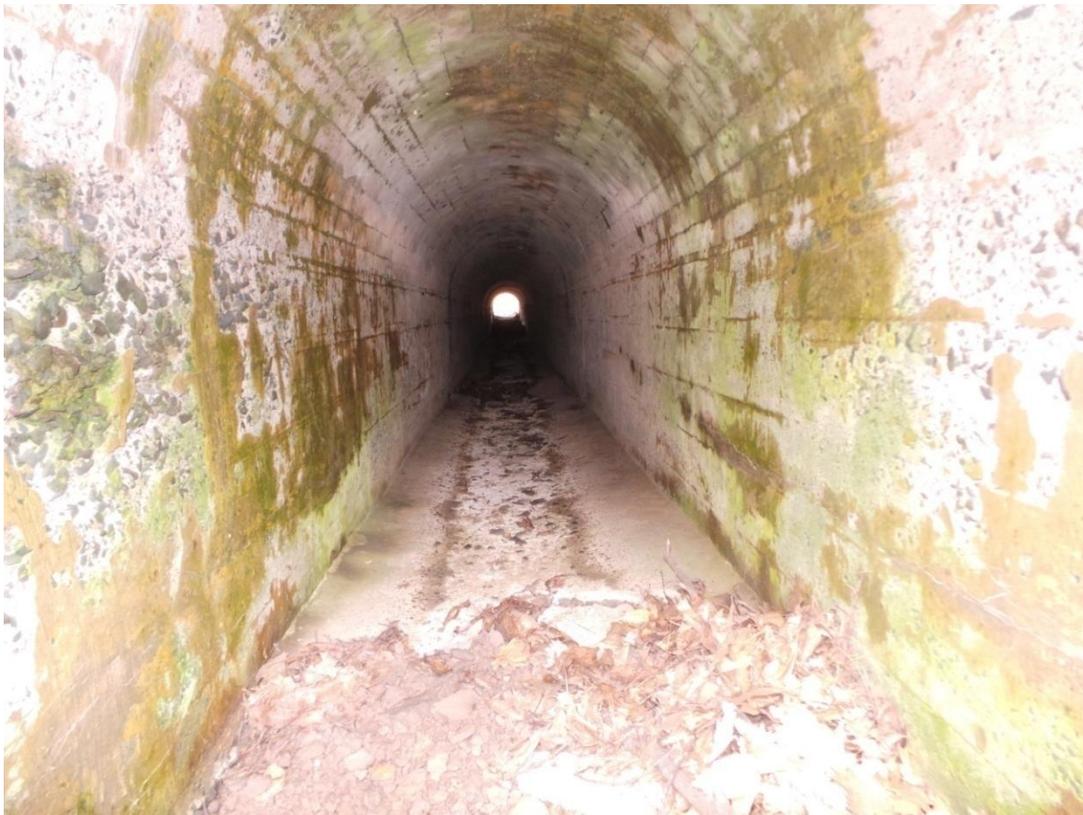
Photo 112 – Acceptable culvert condition, minor scour on bottom slab

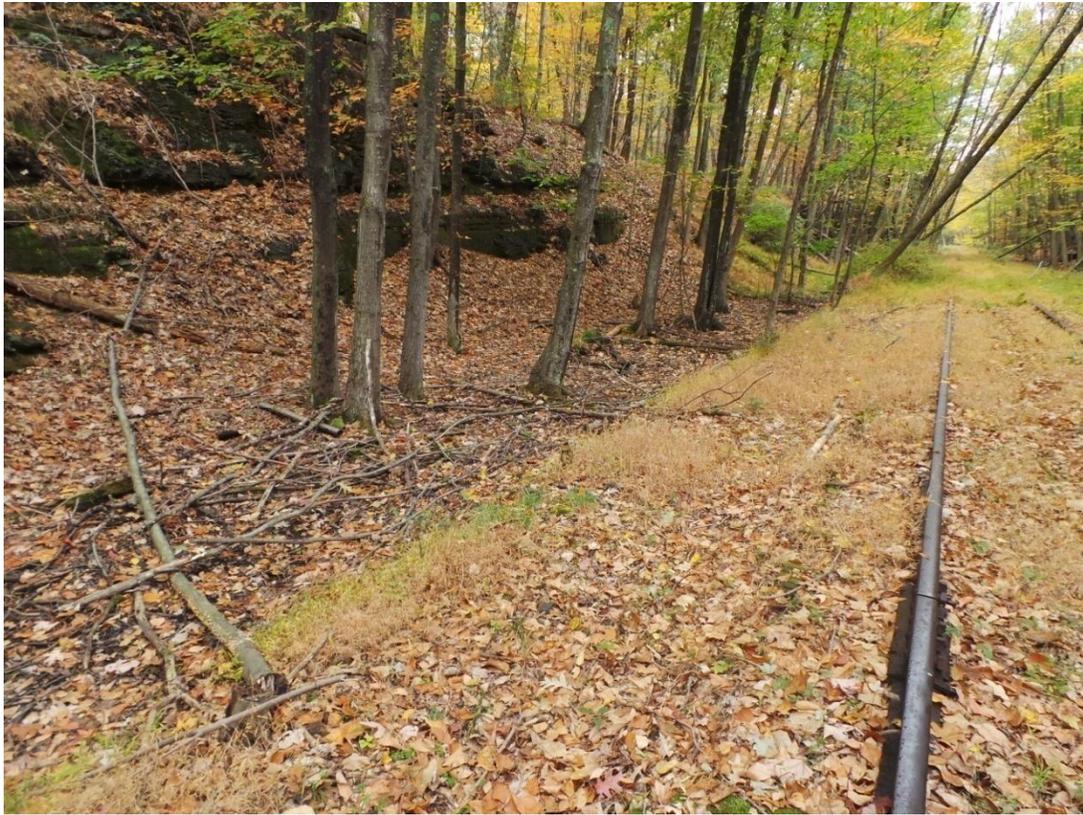
Photo 113 – Drainage Ditch requiring tree/debris removal

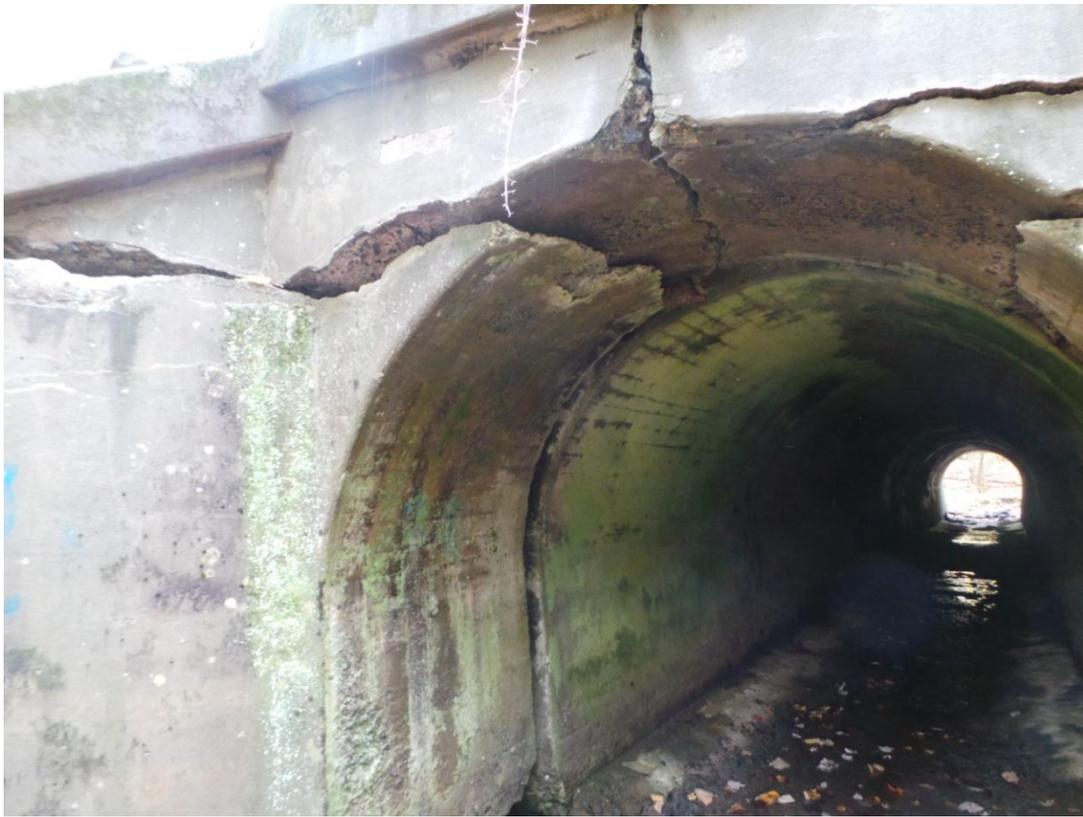
Photo 123 – Large culvert requiring wingwall repair

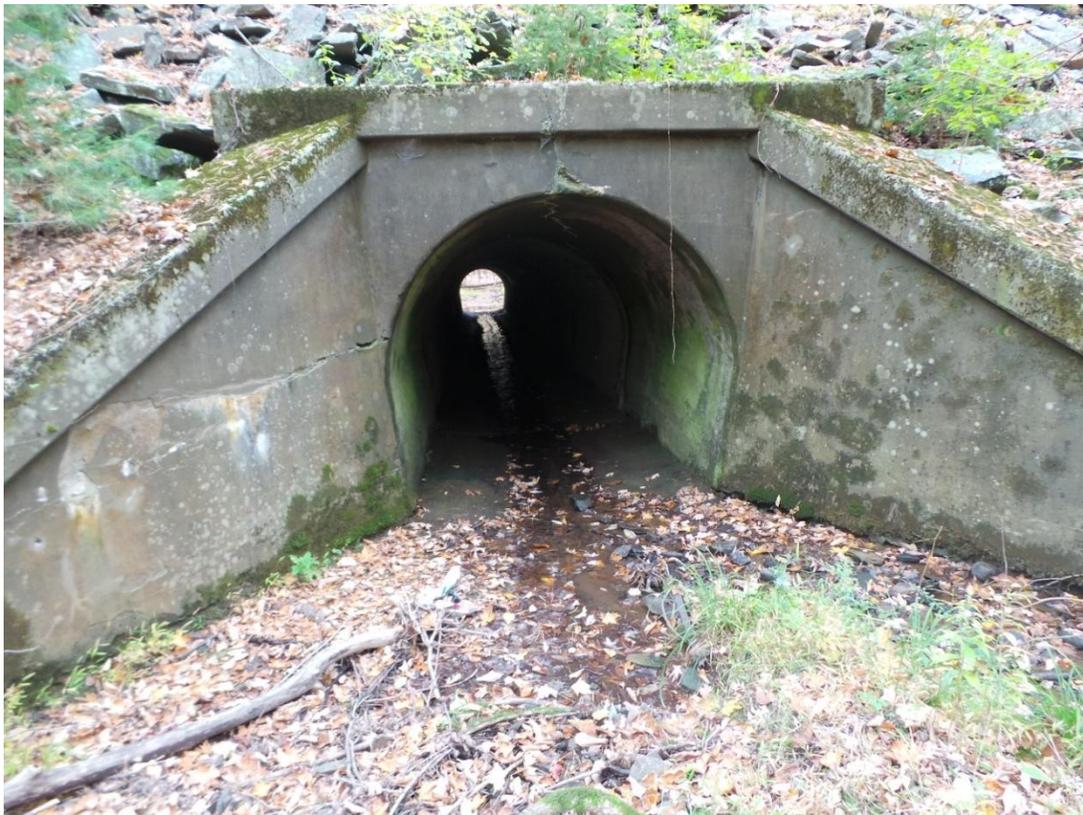
Photo 124 – large culvert requiring minor wingwall repair

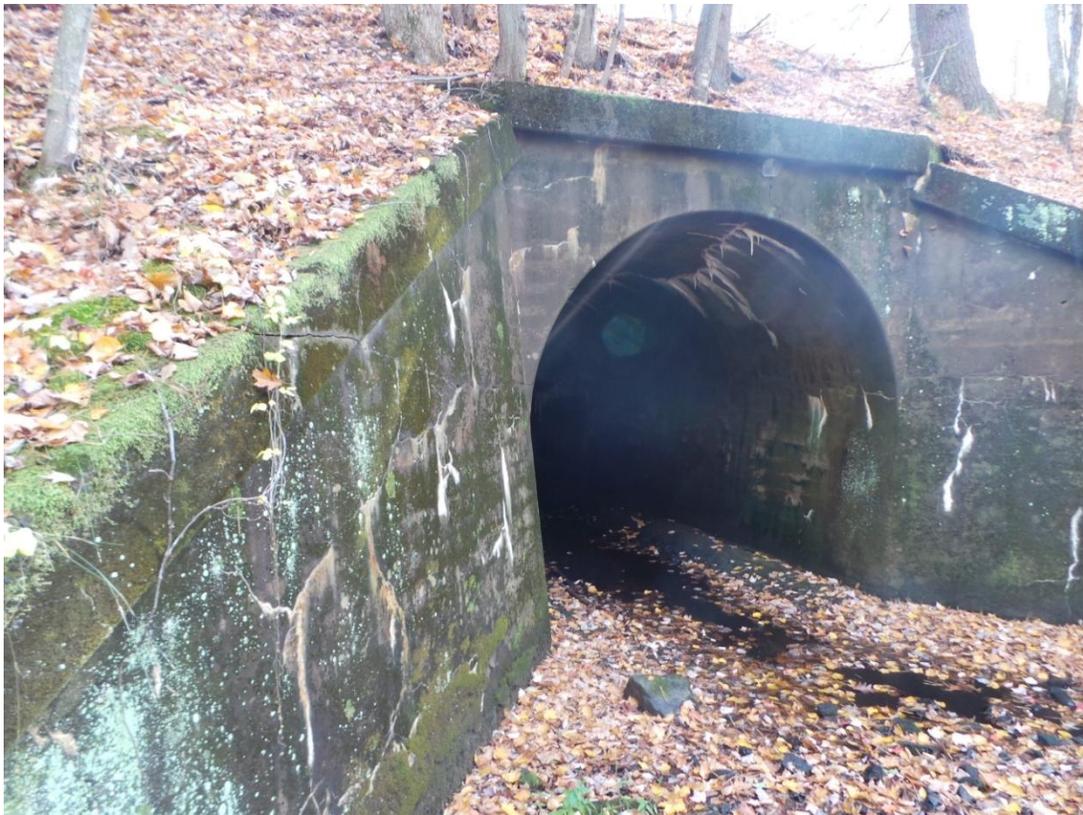
Photo 214 – Large concrete arch culvert good condition

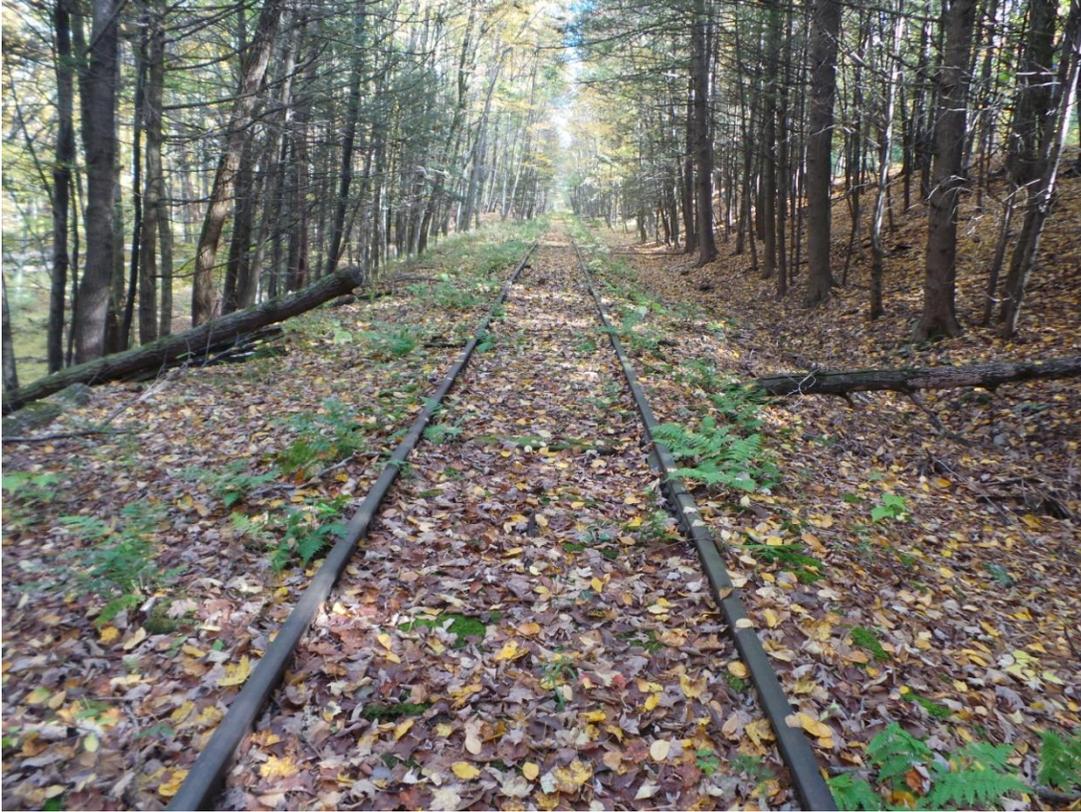
Photo 301 – General rail infrastructure conditions

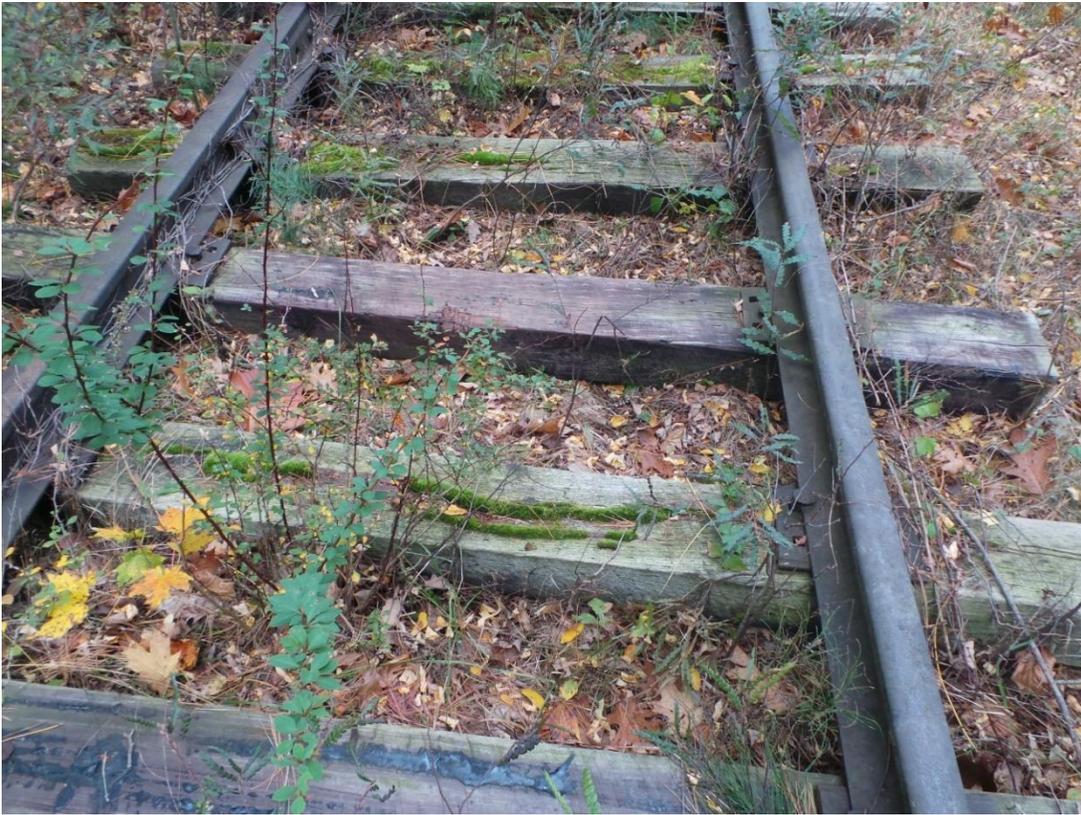
Photo 401 – Steel rails and wooden ties in good condition

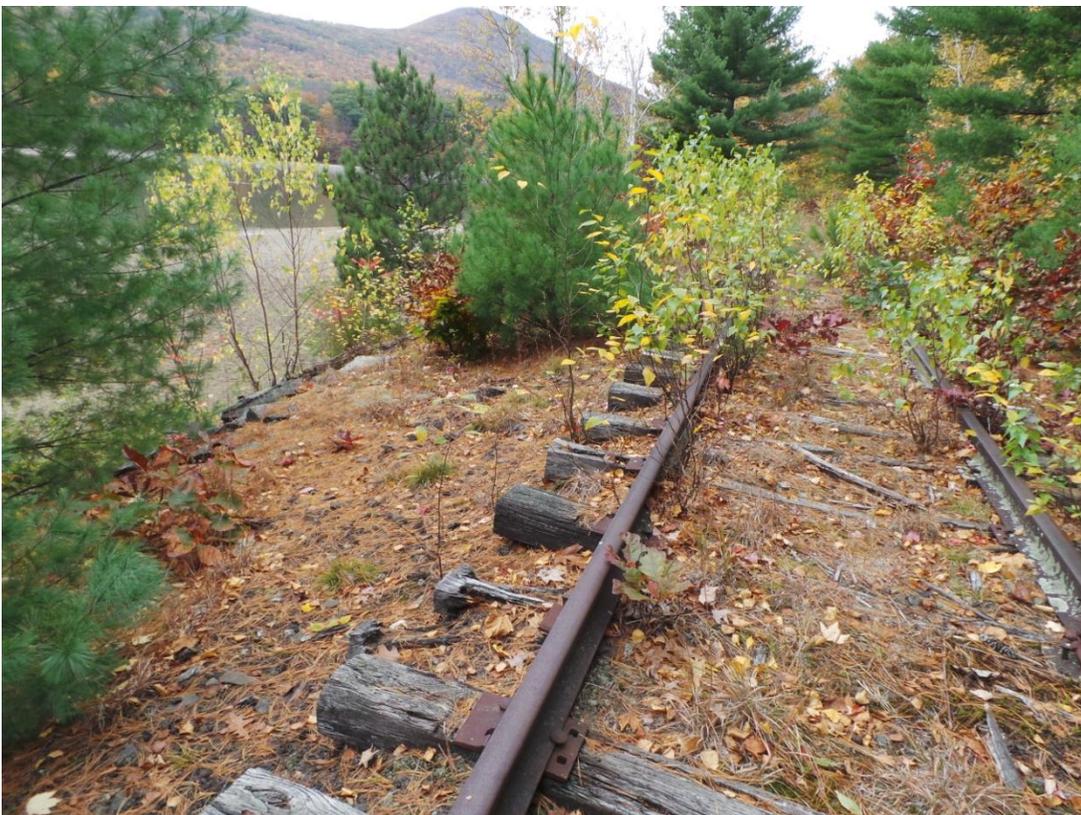
Photo 402 – Split and deteriorated wooden ties

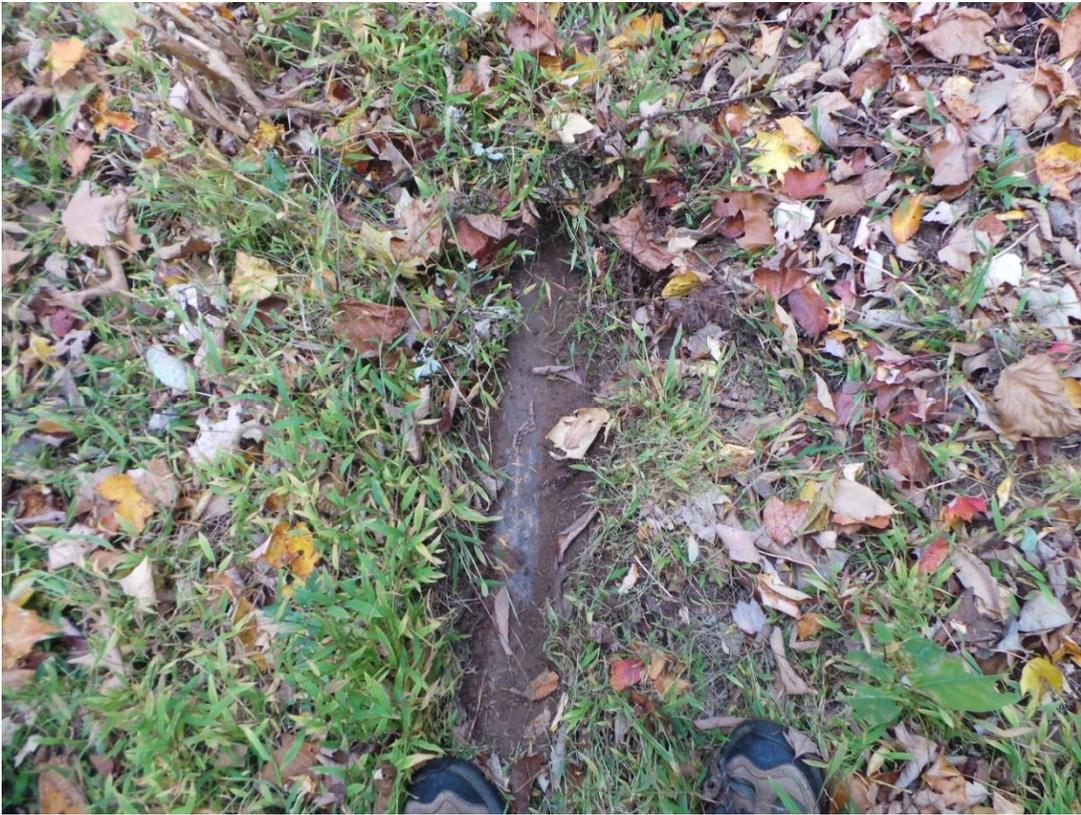
Photo 403 – Tracks completely covered by earth

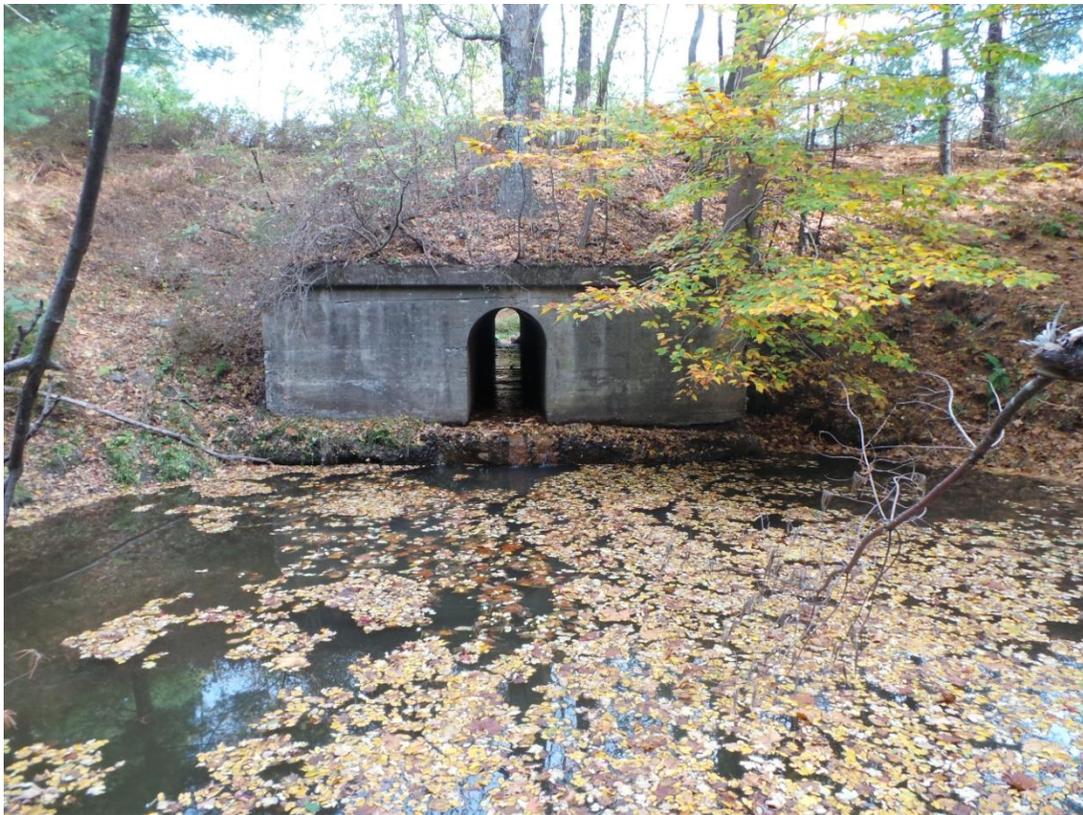
Photo 414 – Concrete drainage culvert in good condition

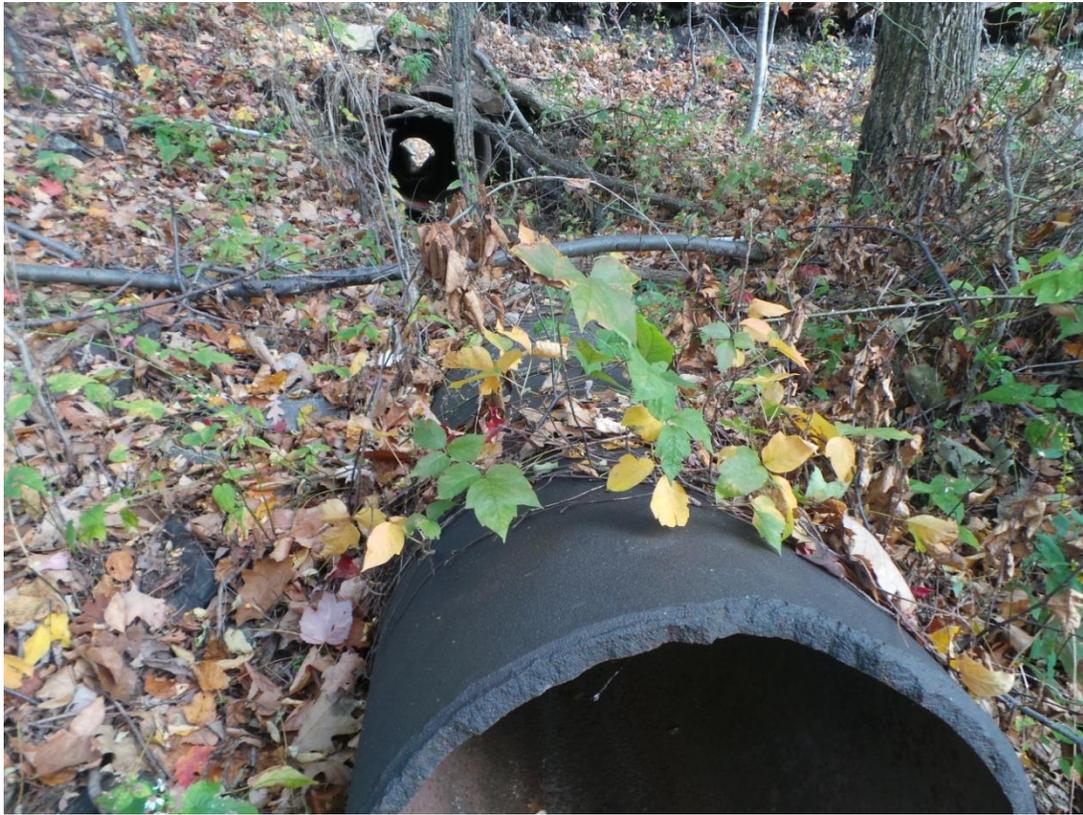
Photo 415 – Complete separation of a section of drainage pipe

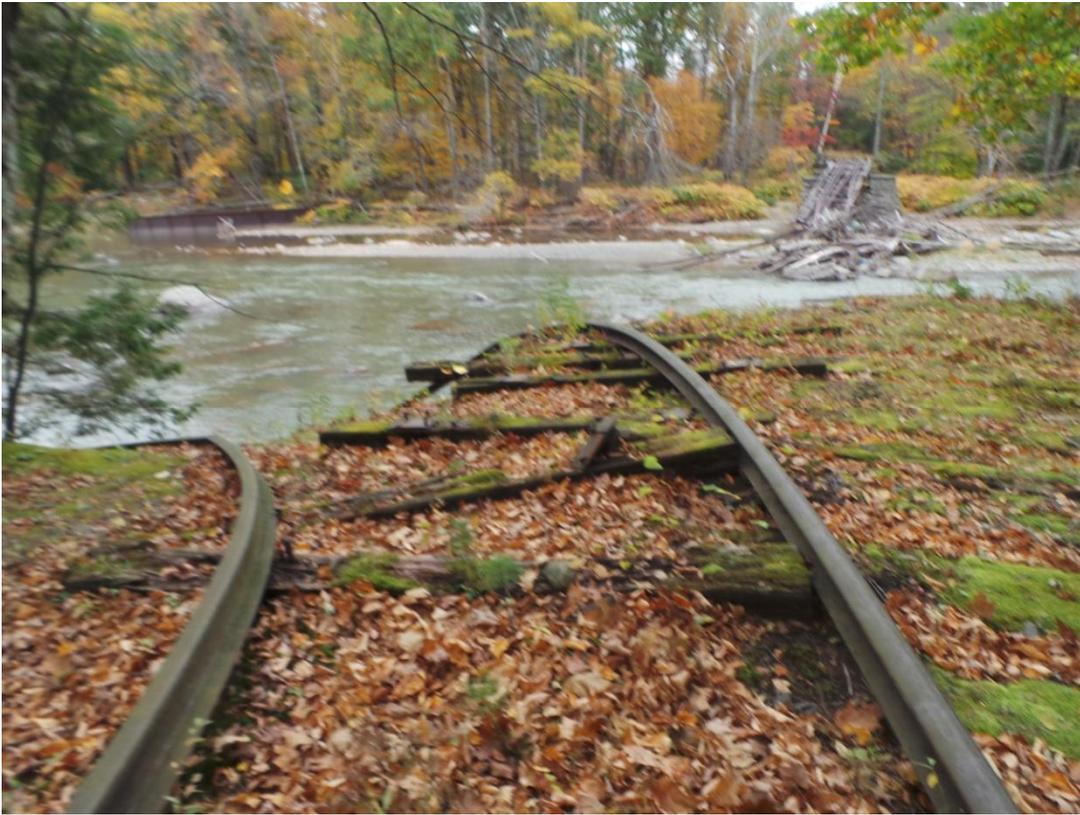
Photo 501 – Bent steel rails caused by the washout

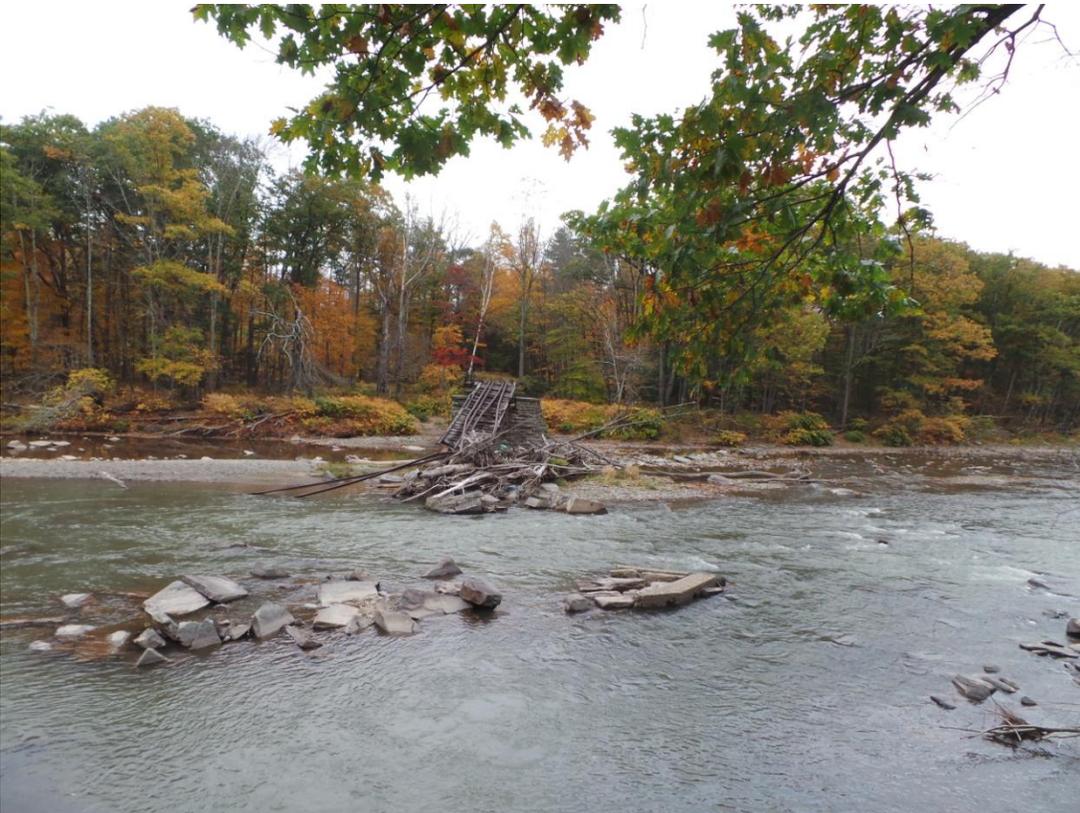
Photo 502 – Former location of the trestle

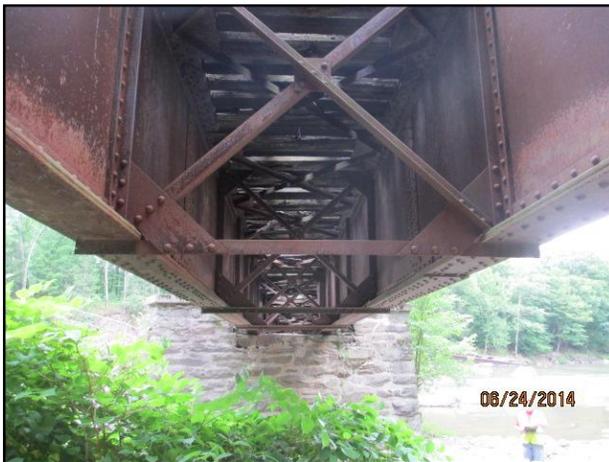
- The superstructure in Span 1 remains generally intact. The structural steel in Span 1 is in fair condition with only minor surface rusting evident. There are large segments of rotted and missing railroad ties throughout Span 1.
- The Span 2 superstructure is dislodged from its support on the south end. The north end of Span 2 rests on Pier 1, while the south end of Span 2 rests on the stream bed of Esopus Creek.
- The Span 3 and Span 4 superstructures have been dislodged from the existing substructures and are currently resting, partially submerged in stream flows, along the banks of the Esopus Creek. One span rests along the north stream bank and the other span rests along the south stream bank.

Span 1 - Condition

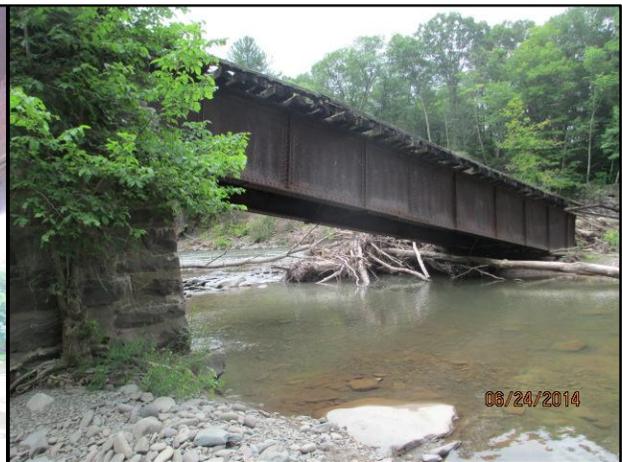
Span 2 - Dislodged From Pier 2

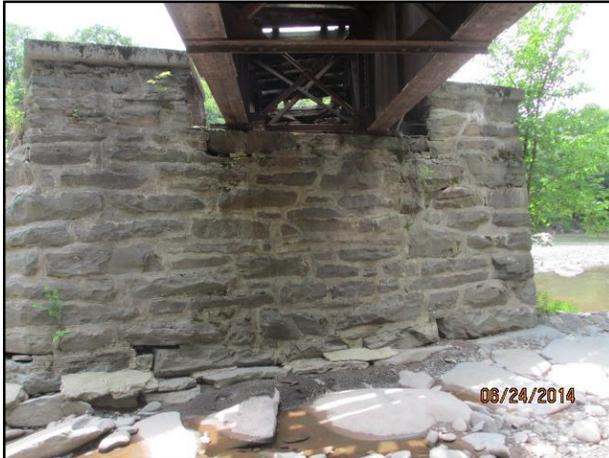
- The North Abutment and Pier 1 remain generally intact and in fair condition. There are areas of dislodged stones with cracks and missing mortar between the stone courses at both substructure units. Pier 1 also exhibits signs of scour and dislodged stones mostly at the upstream pier nose and along the south face at the base of the pier stem.

Pier 1 - General Condition

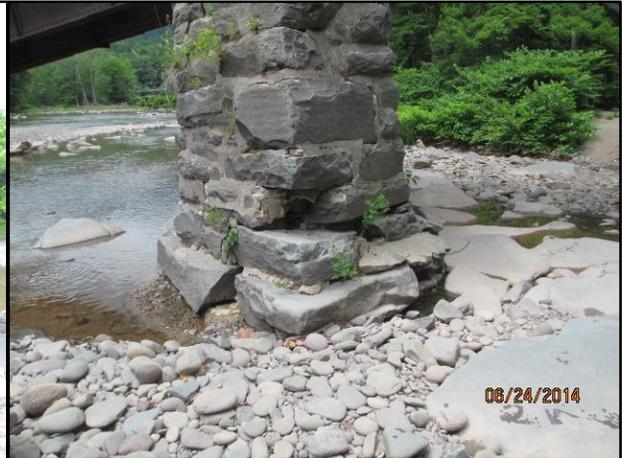
Pier 1 – Scour/Dislodged Stones

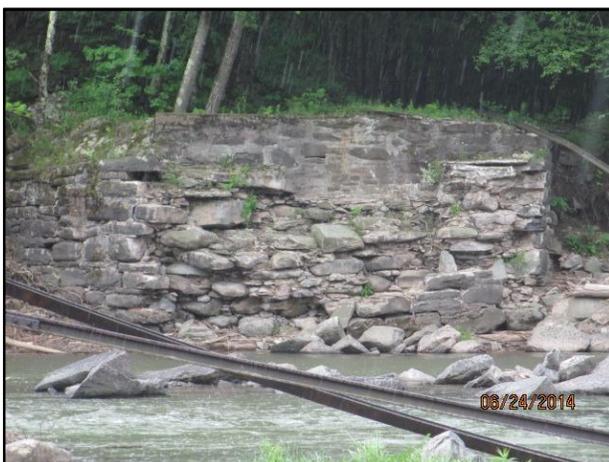
- Pier 2 and Pier 3 were completely destroyed and/or washed away during the storm events and there are only small remnants of these piers that remain intact or partially salvageable at the bridge site.
- The South Abutment exhibits large areas of scour and dislodged stones. The bridge seat has completely failed and is not usable. The South Abutment would require complete re-construction under any of the bridge replacement/rehabilitation alternatives.
- The stream banks of the Esopus Creek exhibit erosion, exposed root systems, and loss of vegetation due to apparent turbulent flow, most notably along the south creek bank.

South Abutment – Dislodged Stones
