**Ulster County Rail Trail Project – Ashokan Reservoir Section
 (“Ashokan Rail Trail”)**

Feasibility Study

July 2015

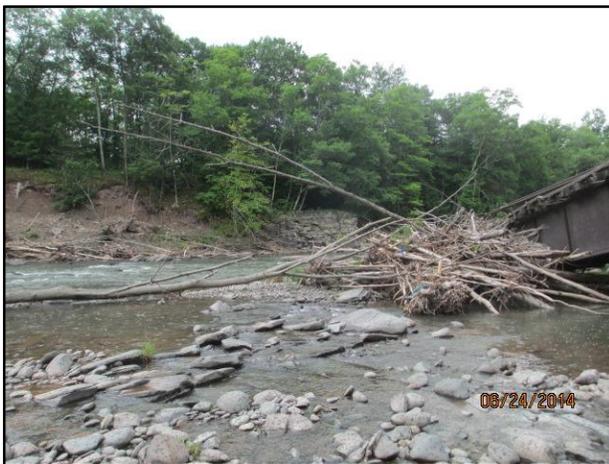
- The existing Span 3 and 4 girders were dislodged from the substructures and have since been washed several hundred feet downstream. The spans have been partially covered in stream flows since the storm events and we do not feel it is prudent to reuse these girder sections given the probability that significant deterioration has likely occurred due to rust and corrosion from wet conditions. In addition, there would likely be significant costs and environmental impacts associated with moving the girder sections from where they rest along the stream banks back in place on the new substructures.

Spans 3 & 4 Dislodged

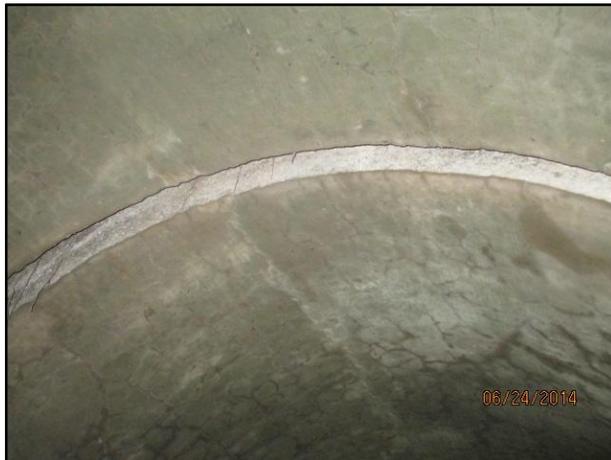
Crack in Culvert Barrel

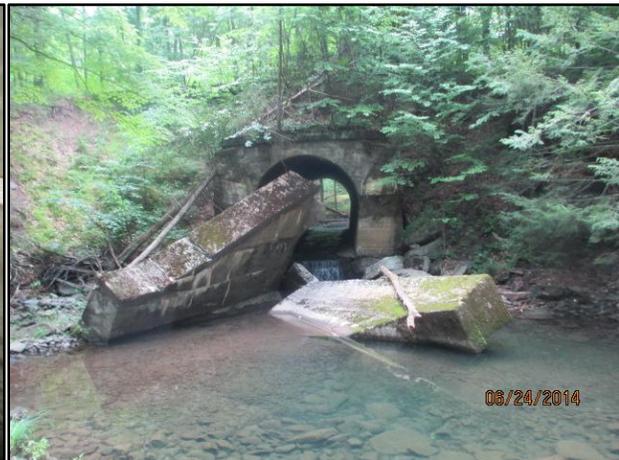
- Both downstream wingwalls have rotated so as to completely separate from the culvert and are currently resting in the middle of the stream. The rotation is indicative of scour or loss of supporting foundation material and is likely caused by high stream flows exiting the structure and scouring away the stream bed below the downstream portion of the culvert and wingwalls.

Downstream Wingwall Failure

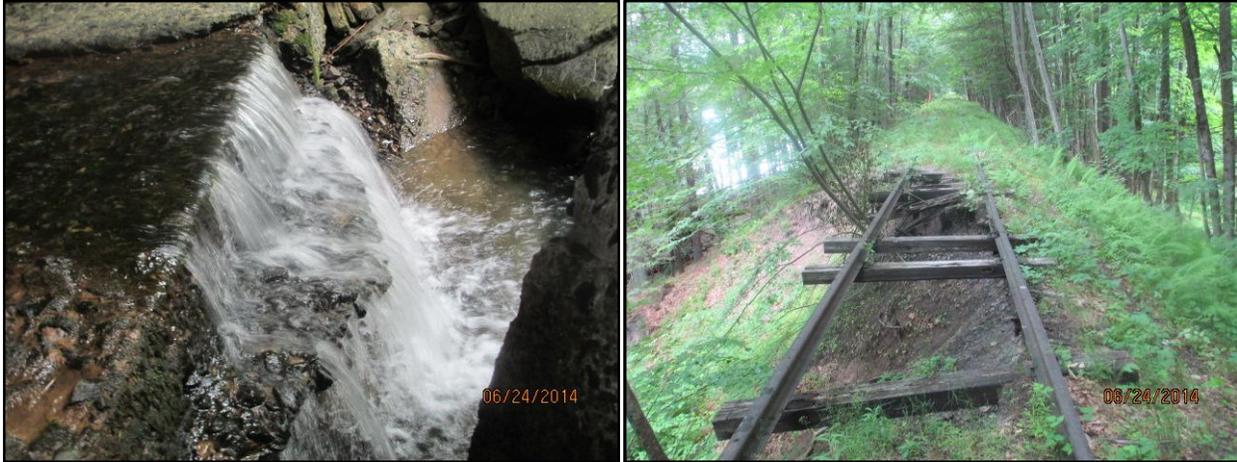
Scour at DS End of Culvert

Erosion/Failure of Rail Embankment
