## 1.0 Existing Conditions Inventory and Assessment

### 1.1 Data Collection Methodology

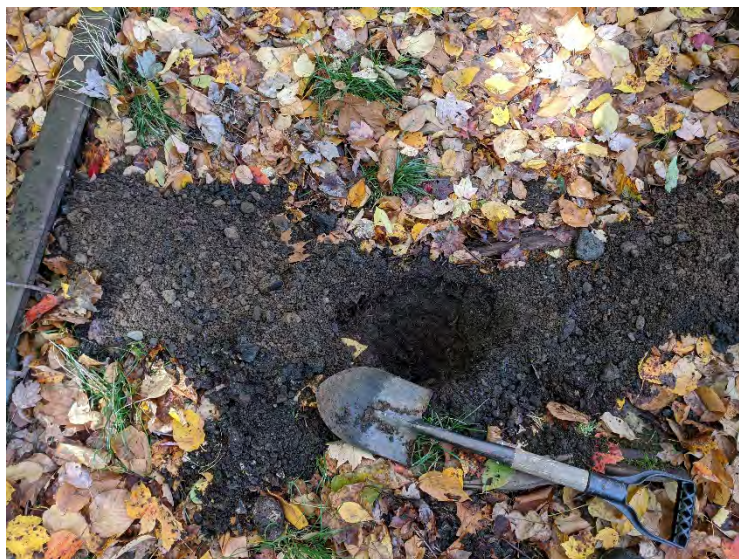
Figure 1-4: Ballast Test Pit performed By B&L Staff

The composition of the ballast was also lacking the high percentage of 1" diameter or larger stone typically found in railroad ballast. The existing stone is also rounded without the sharp angles typically found in crushed granite and limestone. A heavy presence of organic material was also observed to depths greater than 1 ft. with no noticeable transition to a layer of stone free from organics (see Figure 1-4). The depth and composition of the ballast was recorded at three locations throughout the corridor and found to be consistently poor at all three locations. The ballast throughout the corridor should be assumed not suitable for use as a trail base.

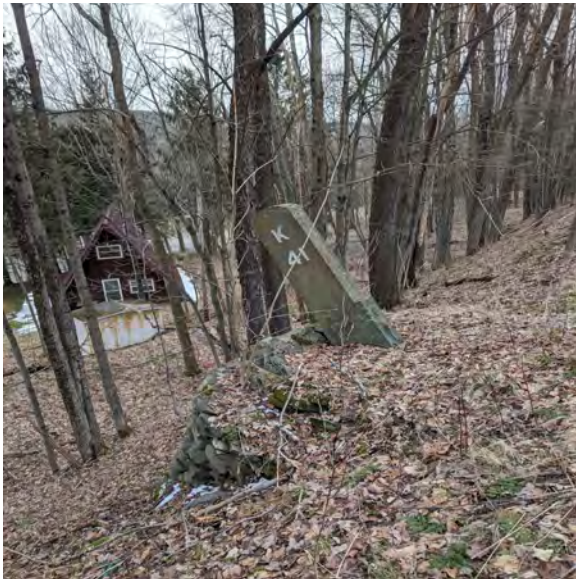
**Figure 1-5: Mile marker K41**

The historic bluestone mile markers, K37 to K41, were all found within the railroad corridor. Markers K40 and K41 are tipped over or leaning on its side and will need to be reset. Other railroad infrastructure includes a "W" post (most likely a whistle post), concrete and stone foundations, and

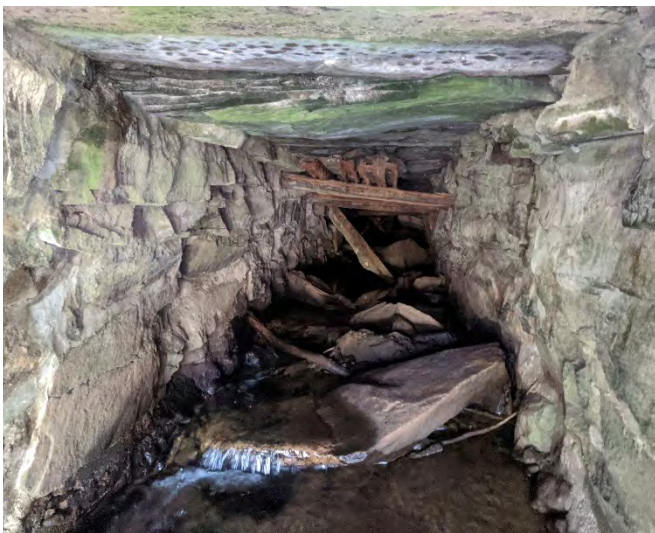
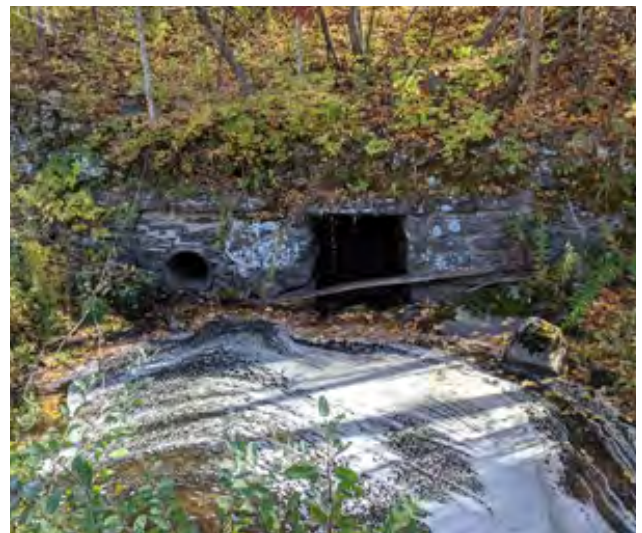
One large culvert located near the Belleayre Mountain snowmaking reservoir and the double horseshoe curve should be replaced. This culvert is a side-by-side (double barrel) system constructed of stacked stone and mortar culverts with both originally measuring 5' x 5' at the outlet. The southern culvert is collapsed halfway through the culvert and repair attempts were made at one point to address the collapsing roof of the culvert by inserting steel railroad rails into the culvert. A large sinkhole has formed within the railroad tracks directly above this collapsed portion of the culvert. Daylight is not visible through the culvert, however, water does flow through the large voids in-between the stone within the culvert. The northern culvert has been repaired by insertion of a steel 24" diameter pipe approximately 75% of the way through the culvert. The original 5'x5' opening of the culvert was walled off with stone and mortar to direct flow into the pipe. The invert of this pipe is above the adjacent southern culvert pipe see Figure 1-3.

The steel sections of pipe have become separated resulting in a wavering flow line from end to end, rather than a straight line. This culvert carries the entire railroad tracks and embankment over the outlet of a snowmaking reservoir for Belleayre Mountain, which has twin 48" steel pipes that control the water elevation of the reservoir and outlet into the culverts under the railroad corridor. Rehabilitation of this culvert is not feasible due to the poor existing condition of the culvert. Therefore, replacement of the failed culverts is the recommended alternative. Options for replacement include a large concrete box culvert or three sided structure with a natural stream bed. The Town of Shandaken indicated that the Belleayre Mountain staff occasionally perform large volume water releases of the reservoir which could further erosion of the embankment if the existing condition of the culverts is not improved to allow water to flow freely below.

**Figure 1-6: Collapsed southern culvert with repair attempts and flowing water visible (left) and inlet of double barrel culverts flowing under railroad (right).**

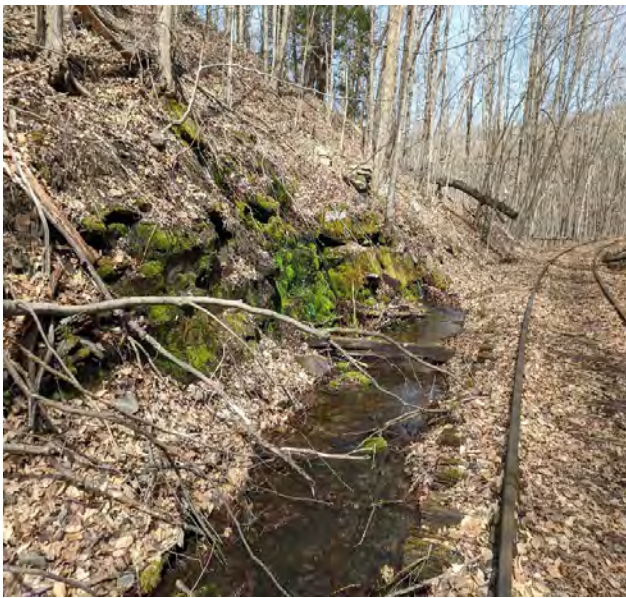
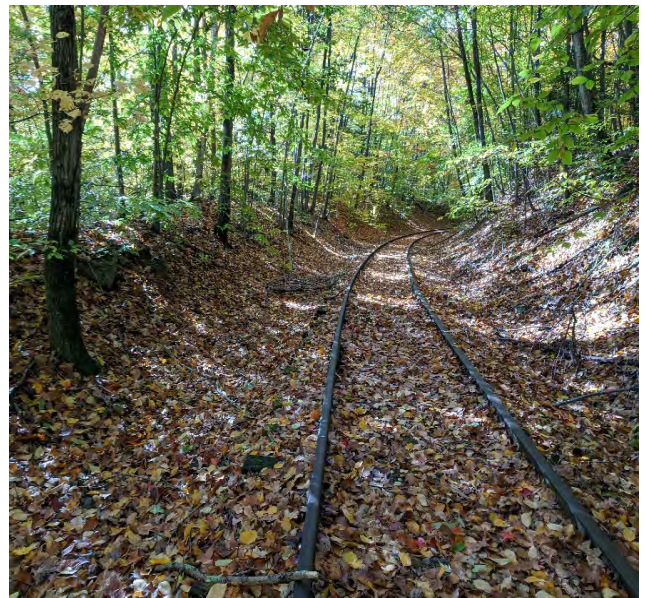
Drainage swales were present throughout the majority of the railroad corridor but were poorly defined. The majority of the southwestern side of the corridor should have a properly functioning swale to convey potential runoff from the mountainside into the culvert pipes and away from the trail. Trees were present within the swales as well as significant debris accumulation. Most swales were dry and did not exhibit signs of flowing water during our field observations. However, active streams were observed within the swales in some locations such as at the double horseshoe curve parallel to the tracks near the Belleayre snowmaking reservoir at milepost K40.36. The stream has caused erosion and sediment transport of the ballast under the ends of the railroad ties. Disturbance to this stream should be limited and the trail potentially shifted or narrowed to avoid this water course. This stream is referenced as delineated stream 3 and is further discussed in section 3.0 along with the other streams that are jurisdictional by USACE or NYSDEC.

**Figure 1-7: Active stream at the double horseshoe curve (left) and dry swales with no apparent flows (right).**

Swale improvements should include the removal of all debris within the swale including sediment and woody materials. However, this work will need to be carefully vetted with the New York City Department of Environmental Protection (“DEP”) staff in preparation of the Stormwater Pollution Prevention Plan (“SWPPP.”) Work that alters an existing drainage feature may be subject to DEP regulation as this project is located within the New York City Watershed. Removal of woody debris within all swales should be performed and should be allowable under DEP Regulations. Ideally, all swales within the corridor would be shaped to provide positive drainage flow toward a culvert. This project has nearly 24,000 ft. of swales that should be cleaned or rehabilitated during the construction of the trail. Locations of existing swales and active streams are included in Appendix A.

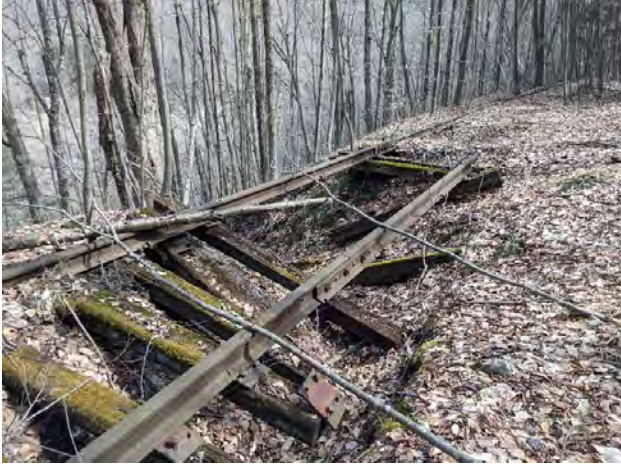
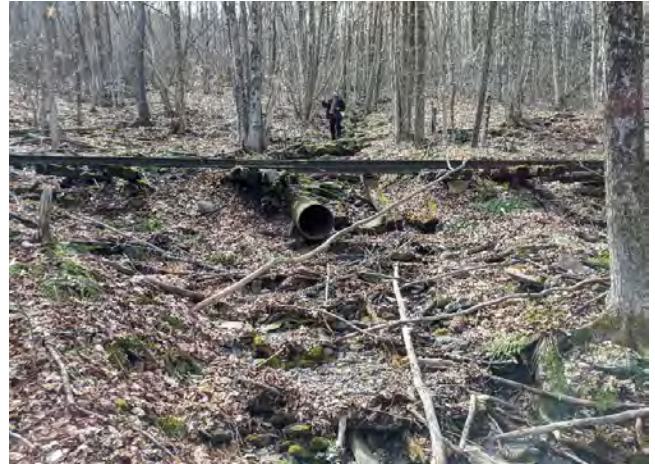
**Figure 1-8: Washout just East of Winding Mountain Road (left) and large washout at milepost K38 (right).**

The above two photos depict the larger washouts found within the corridor. The photo on the left was taken just east of the Winding Mountain Road crossing where it appears that a one-time drainage flow entered the railroad corridor and washed out the ballast below the tracks for about 30 ft. before the flow turned down the side slope. A watershed analysis should be performed during the preliminary design phase to assess the likelihood that drainage flows could re-enter the washed out locations. If the washout is determined to be a one-time event, then washout could be repaired by adding fill to re-establish the desired grade. The photo on the right was taken at Milepost K38 and appears to be an intermittent stream that may only flow during large storm events. There is a defined stream channel both upstream and downstream of the crossing and the existing Pipe and a pipe upstream below a road are evidence that this is, or was at one time, part of an active stream channel. This washout likely occurred over several heavy storm events. Depending on the results of the watershed analysis, a large culvert pipe or a small concrete box culvert should be installed at this washout and a short portion of the stream should be realigned to carry the stream under the new trail.

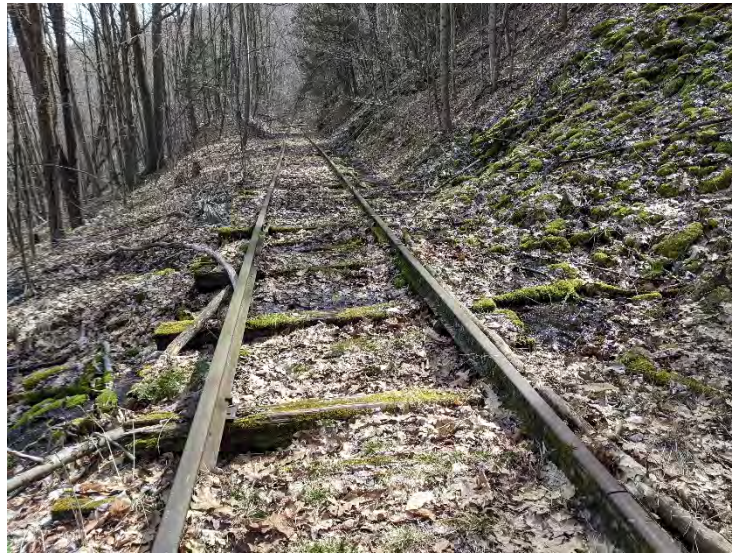
**Figure 1-9: Uncontrolled stream crossing west of milepost K39.**

Figure 1-9 shows an uncontrolled stream crossing approximately 20 ft. in length (measured along the tracks) where a mountain side stream flows between the railroad ties. The stream also collects along the right side of the tracks and flows parallel to the tracks for approximately 100 ft. before entering a culvert pipe below the tracks and outletting down the left side slope. In this location, excavating within the right side drainage swale or installing a culvert pipe where the stream enters the railroad corridor would properly convey the stormwater flows if. Alternatives to reduce impacts within the banks of the stream, if necessary to reduce stream impacts, could be completely spanning the stream and allowing it to maintain its full width below the new trail by installing a concrete culvert or short span low bridge.

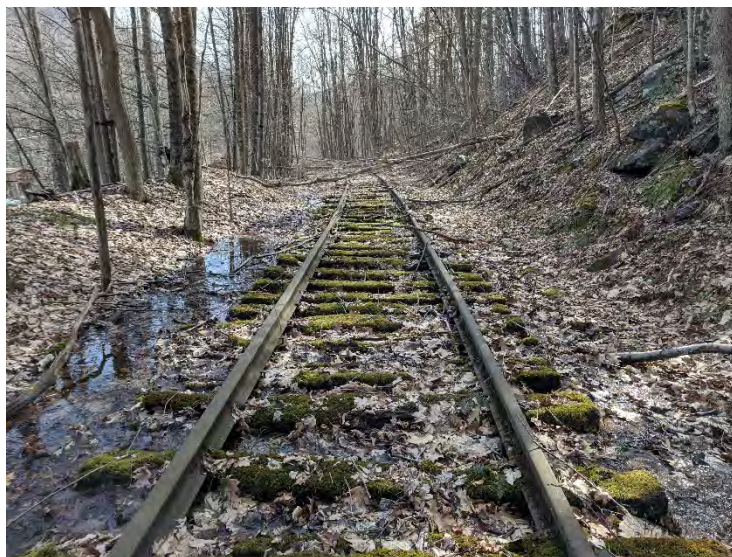
**Figure 1-10: Uncontrolled stream just west of Lasher Road.**

Just west of the Lasher Road overpass, the B&L team observed water flowing between the ties and parallel to the tracks within the rock cut. This water flow appears to be intermittent and was determined not to be a wetland or stream during our site visits. The saturated materials should be removed and replaced with a layer of geotextile fabric and large interlocking stone (1.5” to 3” in diameter) that will provide a solid foundation to accommodate construction and future maintenance or emergency vehicles. The drainage flows should be directed into re-established swales that run parallel to the tracks and away from the railroad corridor. The photo below shows the water in-between the railroad ties.

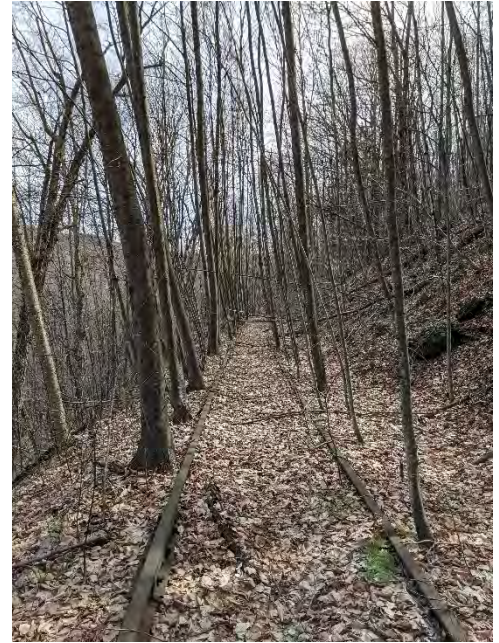
The eastern segment from the Giggle Hollow Bridge to Route 28 in Big Indian exhibits heavy tree and vegetation growth. Trees ranging from 3 to 8 inches diameter at breast height (dbh) have grown within and adjacent to the railroad tracks and within the construction footprint of the trail. Smaller brush growth is also present along this segment. This segment also exhibits numerous large tree blowdowns that will need to be cleared prior to track and tie removal and to construct the trail.

**Figure 1-17: Heavy tree growth adjacent to tracks.**
