Draft Feasibility Report

Ulster & Delaware Corrison Revitalization Study Shandaken Section

Ulster & Delaware Corridor Revitalization Study – Shandaken Section Ulster County, New York

April 2021

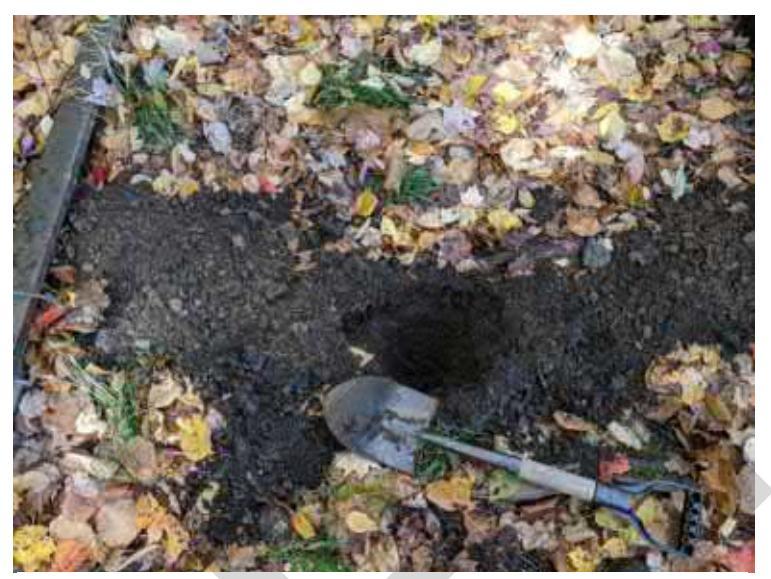
Figure 1-4: Ballast Test Pit performed By B&L Staff

ties. Heavy vegetation growth including grasses, weeds, and even mature trees were found to be growing within and immediately adjacent to the tracks. The composition of the ballast was also lacking the high percentage of 1" diameter or larger stone typically found in railroad ballast. The existing stone is also rounded without the sharp angles typically found in crushed granite and limestone. A heavy presence of organic material was also observed to depths greater than 1 ft. with no noticeable transition to a layer of stone

free from organics (see Figure 1-4). The depth and composition of the ballast was recorded at three locations throughout the corridor and found to be consistently poor at all three locations. The ballast throughout the corridor should be assumed not suitable for use as a trail base.

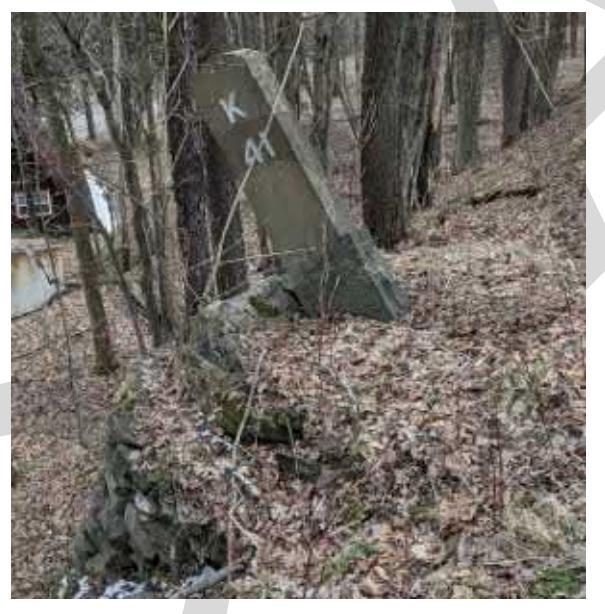
Figure 1-5: Mile marker K41

The historic bluestone mile markers, K37 to K41, were all found within the railroad corridor. Markers K40 and K41 are tipped over or leaning on its side and will need to be reset. Other railroad infrastructure includes a "W" post (most likely a whistle post), concrete and stone foundations, and metal sign remains are located within the corridor and do not inhibit the construction of a trail. Please see the existing condition mapping and documentation in appendix A for the specific locations of the existing railroad infrastructure.

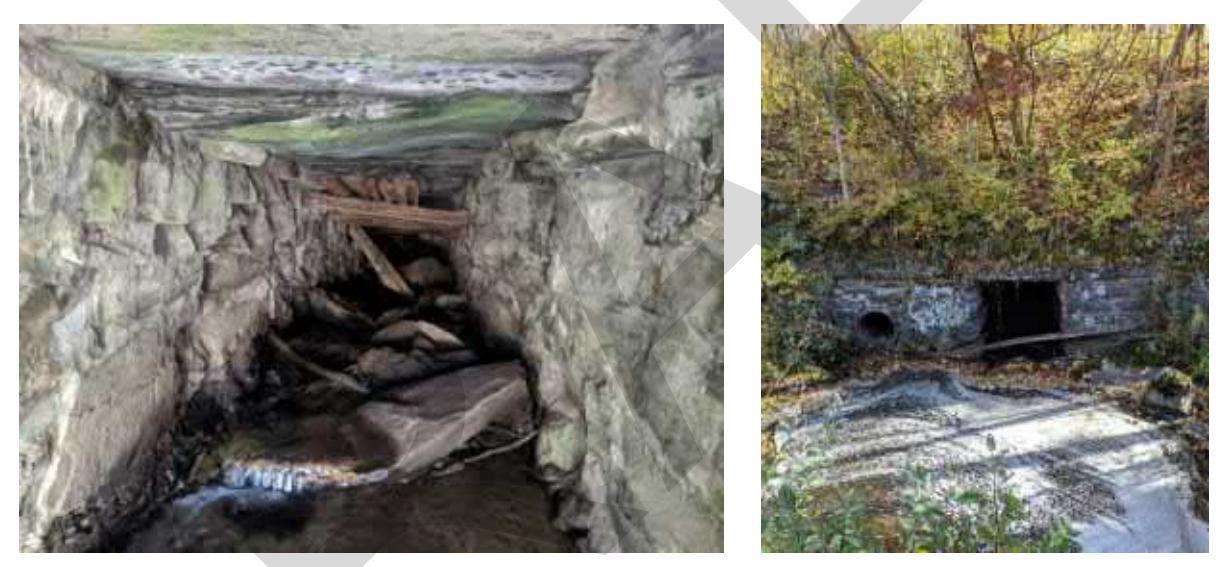
One large culvert located near the Belleayre Mountain snowmaking reservoir and the double horseshoe curve should be replaced. This culvert is a side-by-side (double barrel) system constructed of stacked stone and mortar culverts with both originally measuring 5' x 5' at the outlet. The southern culvert is collapsed halfway through the culvert and repair attempts were made at one point to address the collapsing roof of the culvert by inserting steel railroad rails into the culvert. A large sinkhole has formed within the railroad tracks directly above this collapsed portion of the culvert. Daylight is not visible through the culvert, however, water does flow through the large voids inbetween the stone within the culvert. The northern culvert has been repaired by insertion of a steel 24" diameter pipe approximately 75% of the way through the culvert. The original 5'x5' opening of the culvert was walled off with stone and mortar to direct flow into the pipe. The invert of this pipe is above the adjacent southern culvert pipe see Figure 1-3. The steel sections of pipe have become separated resulting

in a wavering flow line from end to end, rather than a straight line. This culvert carries the entire railroad tracks and embankment over the outlet of a snowmaking reservoir for Belleayre Mountain, which has twin 48" steel pipes that control the water elevation of the reservoir and outlet into the culverts under the railroad corridor. Rehabilitation of this culvert is not feasible due to the poor existing condition of the culvert. Therefore, replacement of the failed culverts is the recommended alternative. Options for replacement include a large concrete box culvert or three sided structure with a natural stream bed. The Town of Shandaken indicated that the Belleayre Mountain staff occasionally perform large volume water realeases of the reservoir which could further erosion of the embankment if the existing condition of the culverts is not improved to allow water to flow freely below.

Figure 1-6: Collapsed southern culvert with repair attempts and flowing water visible (left) and inlet of double barrel culverts flowing under railroad (right).

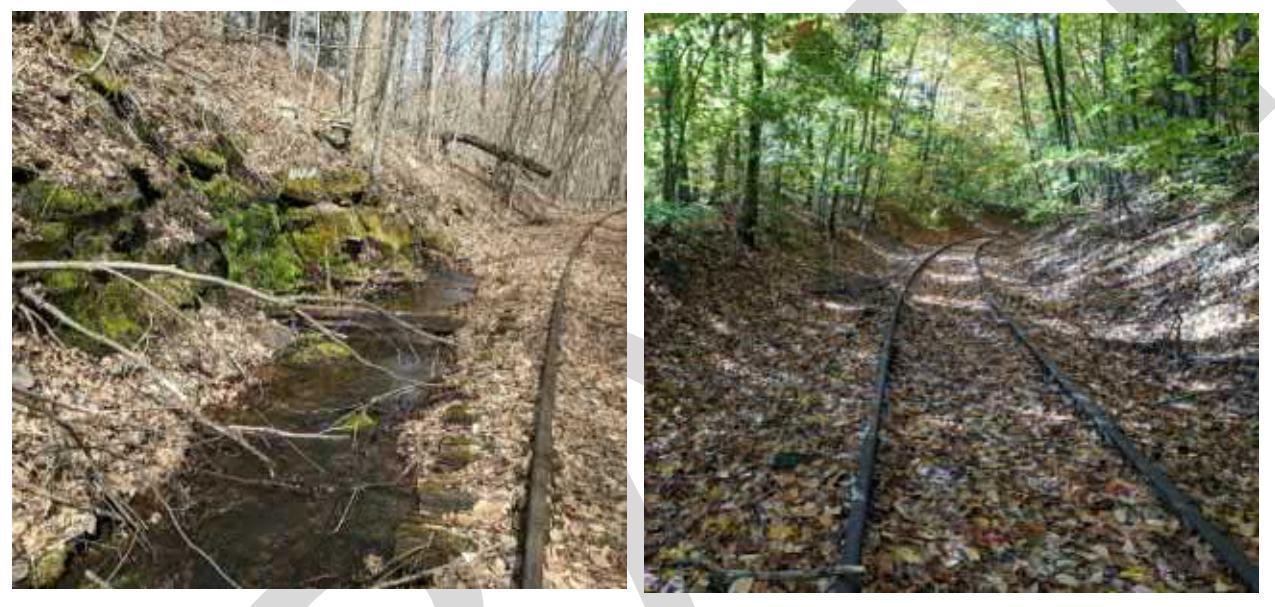
Drainage swales were present throughout the majority of the railroad corridor but were poorly defined. The majority of the southwestern side of the corridor should have a properly functioning swale to convey potential runoff from the mountainside into the culvert pipes and away from the trail. Trees were present within the swales as well as significant debris accumulation. Most swales were dry and did not exhibit signs of flowing water during our field observations. However, active streams were observed within the swales in some locations such as at the double horseshoe curve parallel to the tracks near the Belleayre snowmaking reservoir at milepost K40.36. The stream has caused erosion and sediment transport of the ballast under the ends of the railroad ties.

Figure 1-7: Active stream at the double horseshoe curve (left) and dry swales with no apparent flows (right).

Disturbance to this stream should be limited and the trail potentially shifted or narrowed to avoid this water course. This stream is referenced as delineated stream 3 and is further discussed in section 3.0 along with the other streams that are jurisdictional by USACE or NYSDEC.

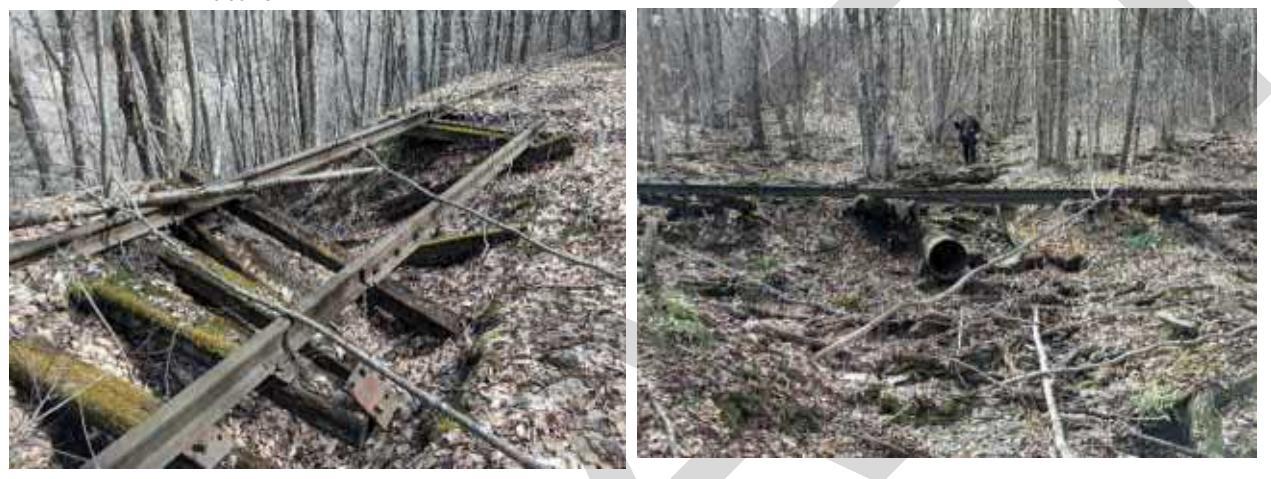
Several washouts were found throughout the corridor and ranged in size from a few feet to nearly 40 feet in width. Repair of the washouts to establish a trail is dependent on the specific washout. If no flow is observed and the washout appears to have stemmed from an isolated storm event, the washout can simply be filled in with earth imported from an off-site location and compacted. The source of the flow that caused the washout will need to be investigated and either mitigated at the source or accommodated in the repair. In areas where the washout occurs in an active drainage channel, or within a clear seasonal drainage channel, a drainage pipe or culvert should be installed to convey any potential drainage flows that may re-enter the corridor in the future.

Figure 1-8: Washout just East of Winding Mountain Road (left) and large washout at milepost K38 (right).

The above two photos depict the larger washouts found within the corridor. The photo on the left was taken just east of the Winding Mountain Road crossing where it appears that a one-time drainage flow entered the railroad corridor and washed out the ballast below the tracks for about 30 ft. before the flow turned down the side slope. A watershed analysis should be performed during the preliminary design phase to assess the likelihood that drainage flows could re-enter the washed out locations. If the washout is determined to be a one-time event, then washout could be repaired by adding fill to re-establish the desired grade. The photo on the right was taken at Milepost K38 and appears to be an intermittent stream that may only flow during large storm events. There is a defined stream channel both upstream and downstream of the crossing and the existing Pipe and a pipe upstream below a road are evidence that this is, or was at one time, part of an active stream channel. This washout likely occurred over several heavy storm events. Depending on the results of the watershed analysis, a large culvert pipe or a small concrete box culvert should be installed at this washout and a short portion of the stream should be realigned to carry the stream under the new trail.

There are other minor washouts found within the corridor that can simply be repaired by filling in the washout and armoring against repeat erosive flow or installing a culvert pipe within the flow channel to carry future flows. These washouts are noted in the existing conditions mapping in Appendix A.

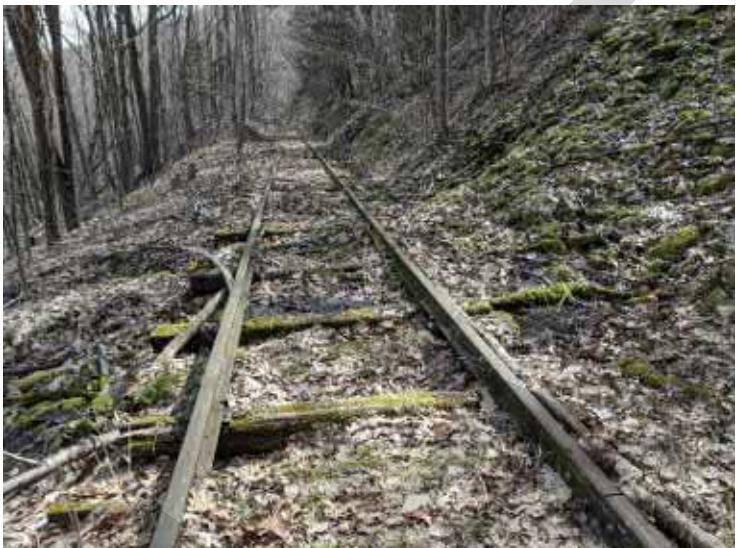
In addition to the washouts and controlled drainage crossings found throughout the corridor, there are also several active uncontrolled drainage crossings of the existing railroad tracks. This is where an active stream was observed to be flowing across the corridor either over the railroad tracks, or through the railroad ties. These drainage crossings are subject to USACE and NYSDEC review through the submission of a Joint Application for Permit submission to the agencies. A complete discussion of the potentially jurisdictional streams is located in Section 3. Culverts or pipes installed to

Figure 1-9: Uncontrolled stream crossing west of milepost K39.

control the stream may need to be 1.25 times the bank full width of the stream, which could lead to a large culvert crossing. In some locations, it may be advisable to install a low short span bridge over the flow rather than a concrete culvert.

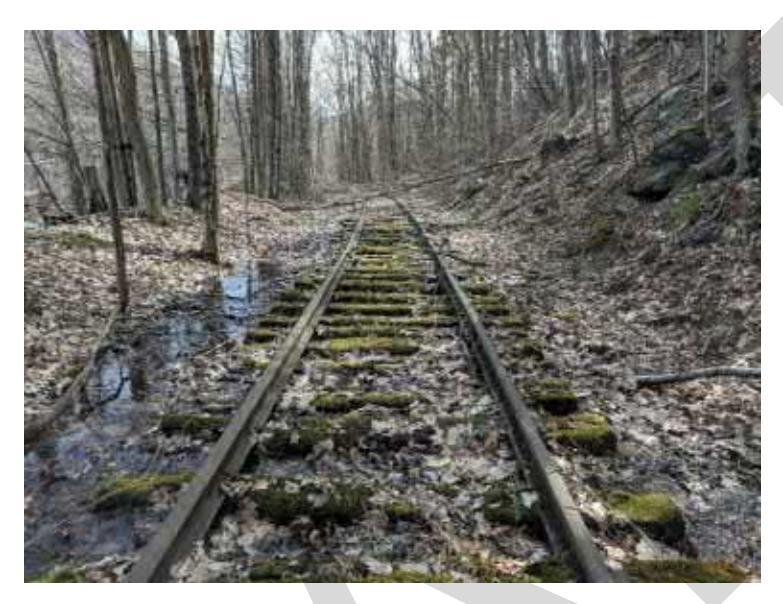
Just west of the Lasher Road overpass, the B&L team observed water flowing between the ties and parallel to the tracks within the rock cut. This water flow appears to be intermittent and was determined not to be a wetland or stream during our site visits. The saturated materials should be removed and replaced with a layer of geotextile fabric and large interlocking stone (1.5" to 3" in diameter) that will provide a solid foundation to accommodate construction and future maintenance or emergency vehicles. The drainage flows should be directed into re-established swales that run parallel to the tracks and away from the railroad corridor. The photo below shows the water in-between the railroad ties.

Figure 1-10: Uncontrolled stream just west of Lasher Road.

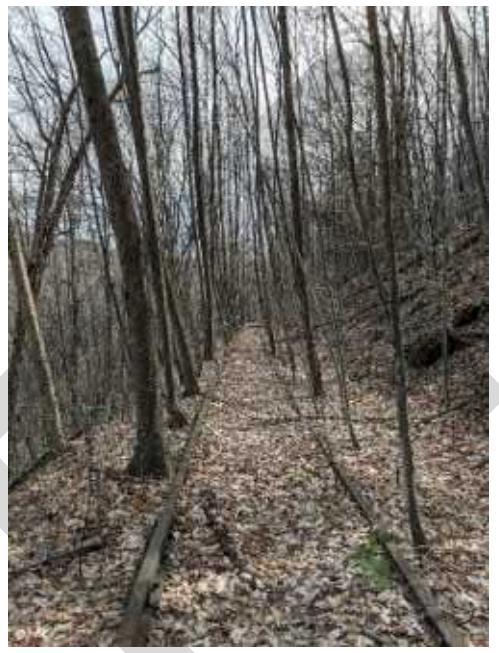
Figure 1-17: Heavy tree growth adjacent to tracks.

The recommended clearing width will vary depending on the final trail width chosen for the trail. Generally, a minimum of 2-3 foot width free of trees and other obstructions is desired adjacent to the trail edge for errant bicyclists. If a 10 foot trail is to be used for the trail, then a minimum 14 foot width should be cleared centered on the tracks.

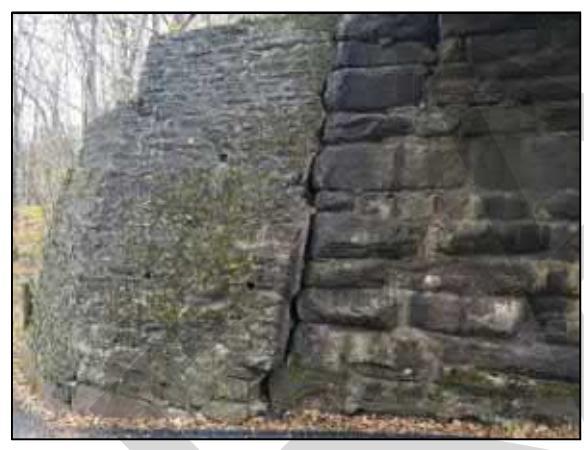
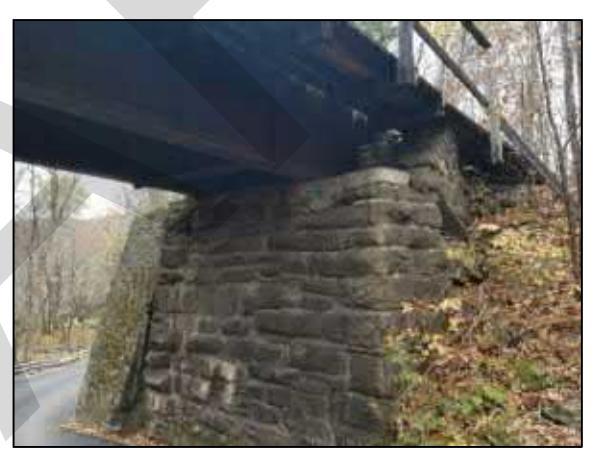
There is a crack at the mortar joint between the begin abutment and begin right wingwall. The northeast wingwall also has deterioration to the stone masonry in the form of two additional full height cracks, up to 1" wide. The southeast wingwall has collapsed behind the abutment and will require reconstruction. Overall, the stone masonry joint mortar is in fair condition. Approximately 30% of the surface areas of all substructures require repointing.

Figure 2-4: Separation between East Abutment and Right Wingwall

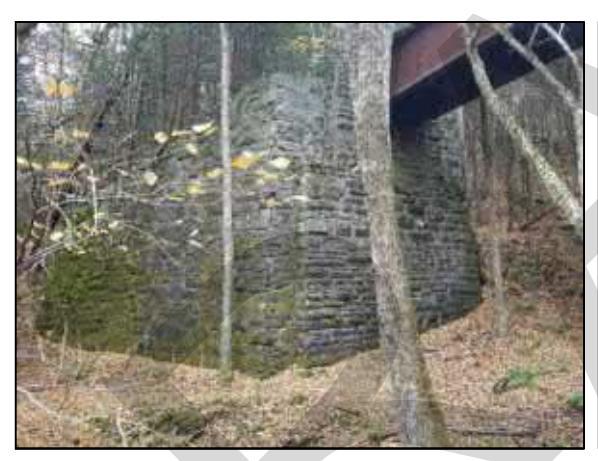
Figure 2-6: Giggle Hollow Bridge East Abutment

The existing bridge at this site carries the railroad corridor over the Giggle Hollow Creek. The structure consists of stone masonry abutments and wingwalls and a 65 foot single span steel girder superstructure. The steel girders consist of two riveted plate girders spaced 8 feet on center and 8 feet in depth. The steel girders appear to be in good condition, with no signs of deterioration or section loss.

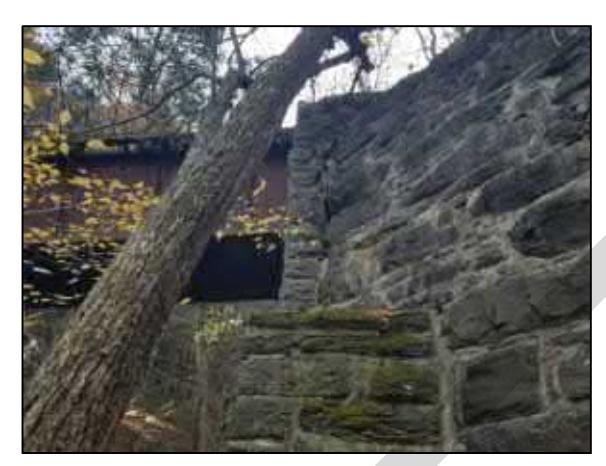
The masonry abutments appear in good condition, with localized areas of deterioration. The most significant areas exist at the west abutment and west wingwalls. There are locations at both west wingwalls where a joint crack exists through multiple layers of grout. The stone masonry in these locations appears to be tipping away from the embankment. There are also signs of joint separation at the northwest cheekwall between the backwall and the wingwall at the west abutment, seen in the photo below. This is causing the stones in this location to tip and rotate away from the backwall. Overall, approximately 20% of the abutment and wingwall surface area has missing mortar between the stones.

Figure 2-8: Separation beginning at the joint between the cheekwall, backwall, and northwest wingwall at the West Abutment

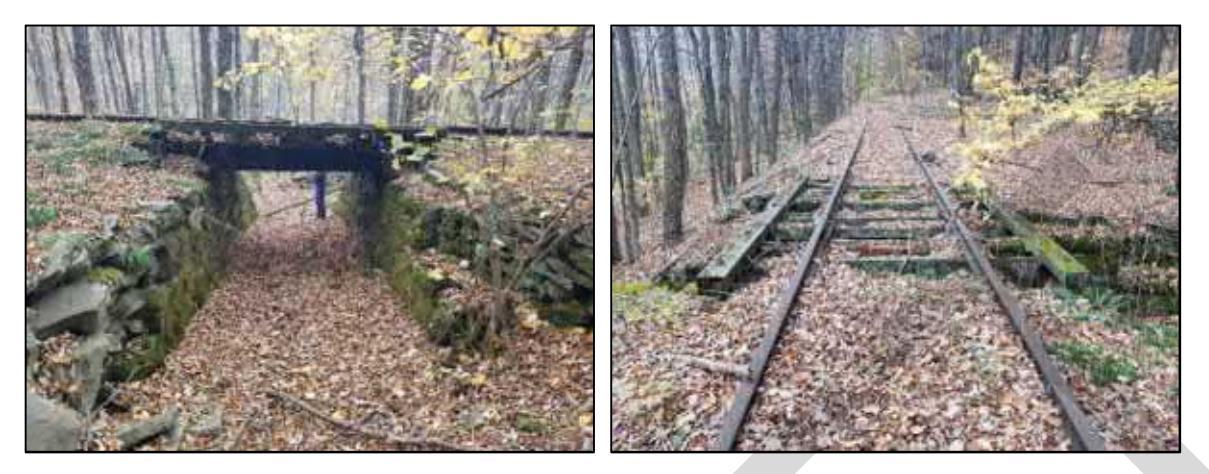
Figure 2-9: View of the rails across the structure, looking south

This structure consists of a timber girder superstructure founded on stone masonry abutments and wingwalls. The two timber girders are spaced approximately 6 feet apart on center, measuring 24 3/4" in depth. Steel rails and timber rail ties exist over the girders. The timber beams and rail ties are heavily rotted and loose in multiples locations.

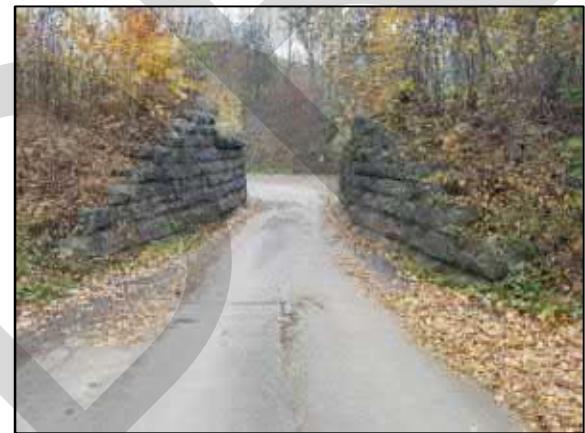
The face-to-face distance between the abutments is 10'-6", allowing only one lane of traffic to pass through. The narrow constriction created by the abutments and the current roadway geometry result in poor sight distances for vehicles travelling in both directions on Lasher Road in the vicinity of this crossing.

Figure 2-12: Elevation view, showing nonstandard horizontal clearance

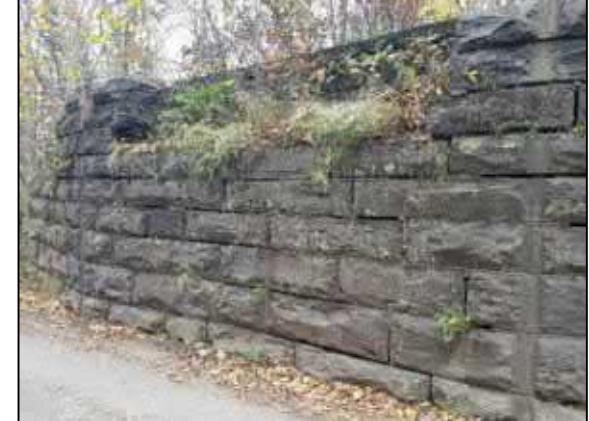
Figure 2-11: Deterioration of the grout between the stone blocks

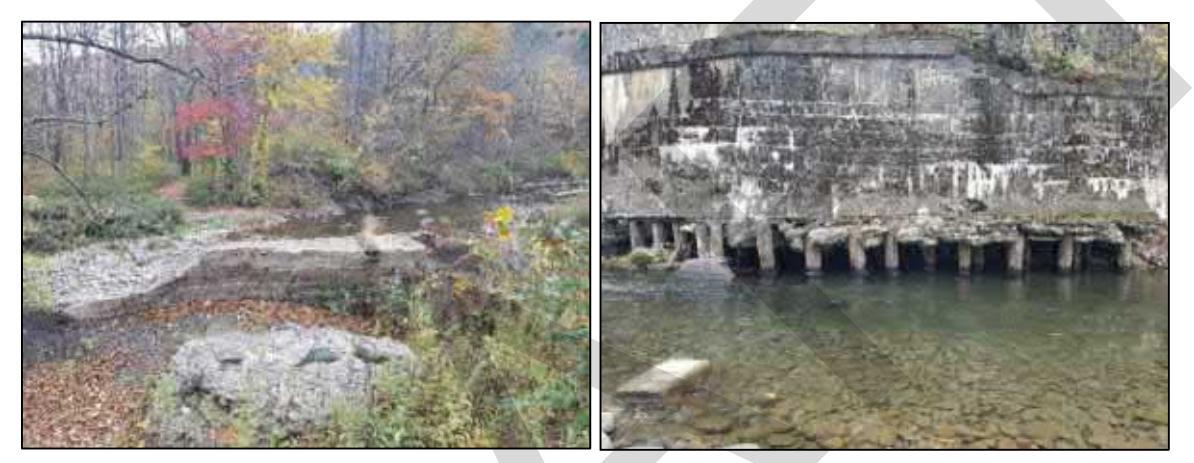
The previous bridge that carried the Ulster and Delaware Railroad over the Esopus Creek sustained substantial damage in 2011 during Hurricane Irene and Tropical Storm Lee, and was later removed by the County. All Desithat remains of the crossing today is the west abutment. The timber piles on which the west abutment was founded are exposed and show signs of severe scour. Based on the vegetation and sediment patterns on the shoreline, it appears that the former abutment locations were constricting stream flows through the bridge opening, resulting in the severe scour which can be seen in following photos. The existing span length of the previous bridge was measured to be approximately 90 feet. This was measured from the face of the west abutment to where the east abutment was assumed to be located.

Figure 2-14: Looking east toward missing east abutment

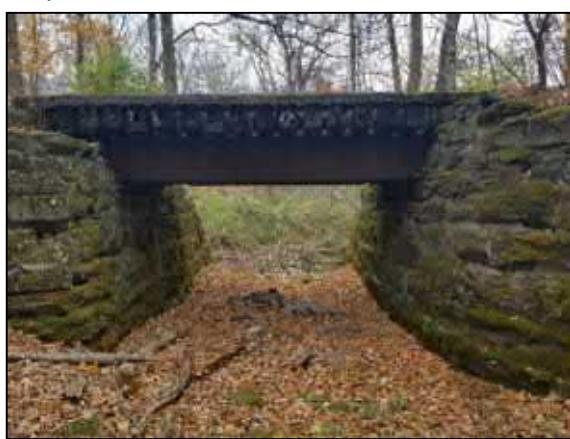
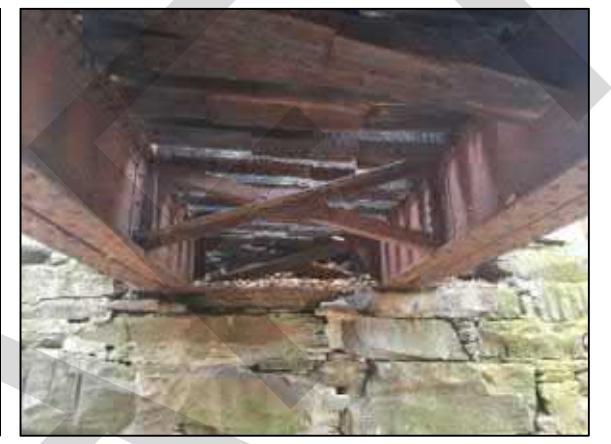
Figure 2-15: Elevation view of Short Span Structure #2

This structure consists of a steel girder superstructure founded on stone masonry abutments and wingwalls. The steel girders consist of two girders spaced approximately 6 feet apart on center. Each girder is composed of two side-by-side riveted I-beams, measuring 22 1/8" in depth. Steel rails and timber rail ties exist over the girders. The rail ties are heavily rotted and
