2.0 Bridge Assessment

2.1 Woodchuck Hollow Bridge (Milepost K39.75)

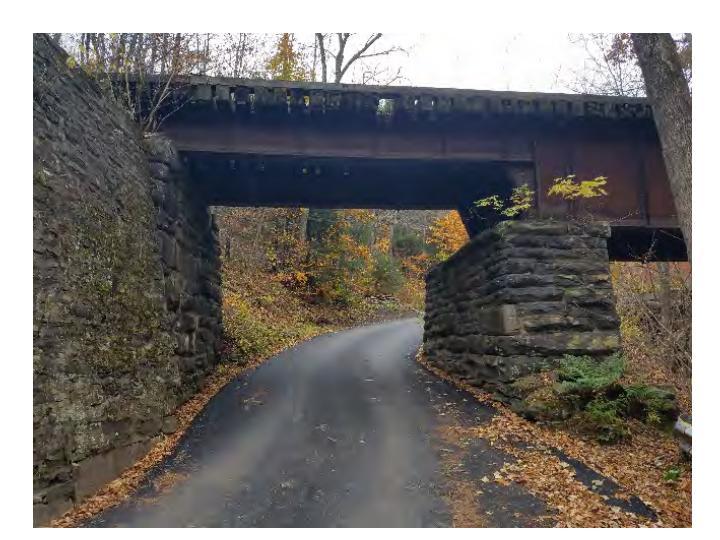
Figure 2-2: Elevation view of Woodchuck Hollow Bridge, Span 1

The existing bridge (BIN 7713410) was originally built in 1896 (as evidenced from the date on the cornerstone) and carries the railroad corridor over Mill Street and an unnamed stream. The structure consists of a two-span continuous steel girder superstructure, supported by stone masonry abutments and one pier. Span 1 is approximately 23 feet in length with two steel girders spaced at 8 feet on center and are 28 inches deep. The Span 1 girders haunch down to a depth of 6 feet at the pier, where 6 feet deep girders are carried over Span 2. The length of Span 2 is approximately 64 feet. The steel girders appear to be in good condition, with no apparent signs of deterioration or section loss.

Of these options, B&L recommends the existing steel girders remain in place and the stone abutments and pier be rehabilitated by repointing the entire surface area of the stone masonry, repairing cracks and joints in and between the stones, and reconstruction of the collapsed wingwall. The timber rail ties will be removed and replaced with a cast-in-place concrete deck. The approximate total construction cost for this alternative is \$430,000.

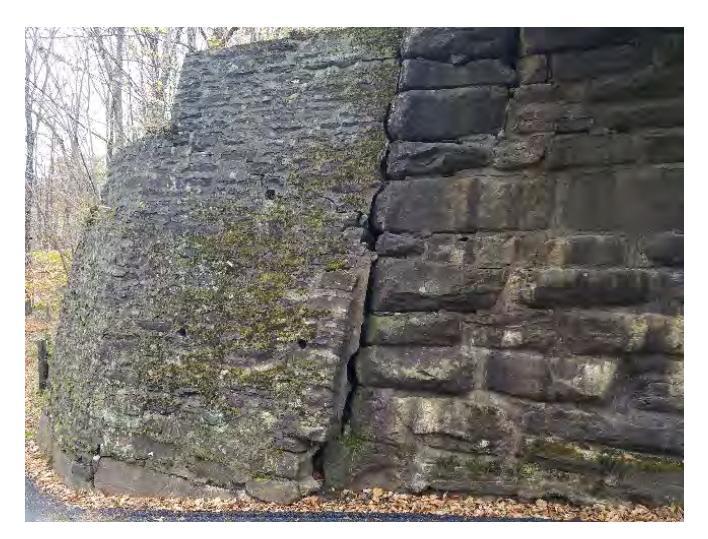
There is a crack at the mortar joint between the begin abutment and begin right wingwall. The northeast wingwall also has deterioration to the stone masonry in the form of two additional full height cracks, up to 1" wide. The southeast wingwall has collapsed behind the abutment and will require reconstruction. Overall, the stone masonry joint mortar is in fair condition. Approximately 30% of the surface areas of all substructures require repointing.

Figure 2-4: Separation between East Abutment and Right Wingwall

At this bridge, B&L recommends the existing substructures and steel girders remain in place, and the existing steel rails and timber rails are removed and replaced with a timber deck, precast concrete bridge deck panels, or a cast-in-place concrete deck. Rehabilitation of the substructures will include repointing the deteriorated areas of the stone masonry, repair to the full height cracks of the northeast wingwall, joint repair between the right wingwall and the begin abutment stem, and reconstruction of the collapsed begin left wingwall.

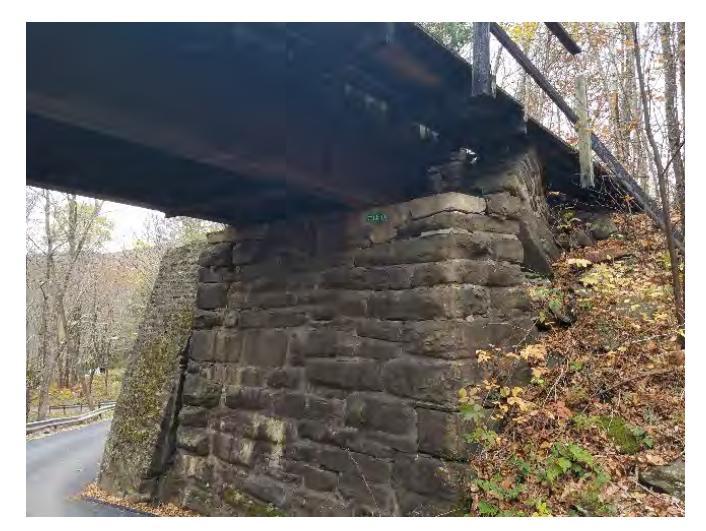
Figure 2-5: Displacement of East Left Wingwall

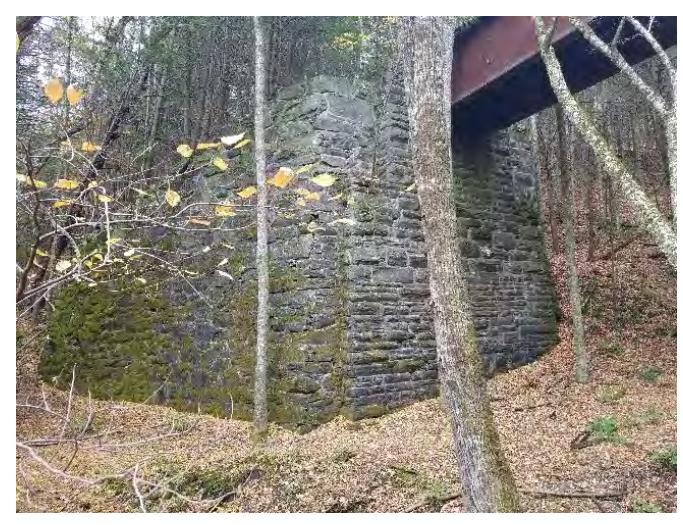
Figure 2-6: Giggle Hollow Bridge East Abutment

The masonry abutments appear in good condition, with localized areas of deterioration. The most significant areas exist at the west abutment and west wingwalls. There are locations at both west wingwalls where a joint crack exists through multiple layers of grout. The stone masonry in these locations appears to be tipping away from the embankment. There are also signs of joint separation at the northwest cheekwall between the

At this bridge, B&L recommends the substructures and steel girders remain in place and be rehabilitated. The existing steel rails and rail ties will be removed and replaced with a new timber deck, concrete deck panels, or a cast-in-place concrete deck. The areas of displaced stone will be removed and reset and all areas requiring mortar repointing will be repaired.

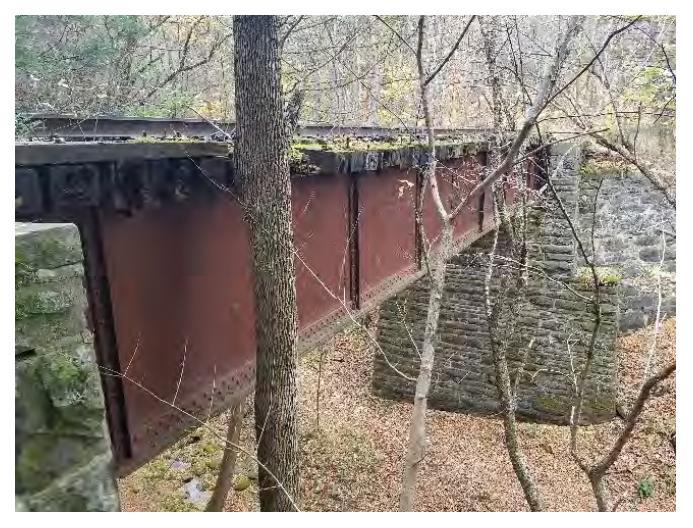
Figure 2-7: Superstructure, looking toward West Abutment

The existing bridge at this site carries the railroad corridor over the Giggle Hollow Creek. The structure consists of stone masonry abutments and wingwalls and a 65 foot single span steel girder superstructure. The steel girders consist of two riveted plate girders spaced 8 feet on center and 8 feet in depth. The steel girders appear to be in good condition, with no signs of deterioration or section loss.

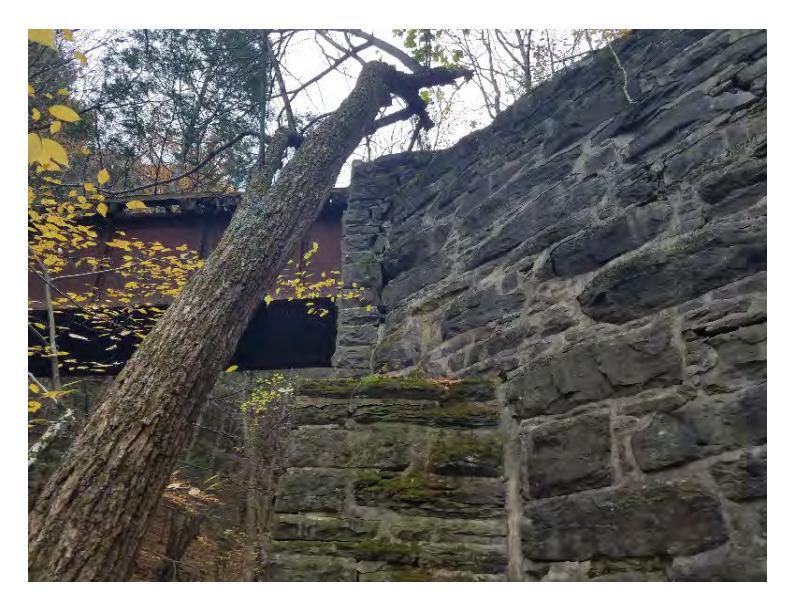
backwall and the wingwall at the west abutment, seen in the photo below. This is causing the stones in this location to tip and rotate away from the backwall. Overall, approximately 20% of the abutment and wingwall surface area has missing mortar between the stones.

Figure 2-8: Separation beginning at the joint between the cheekwall, backwall, and northwest wingwall at the West Abutment

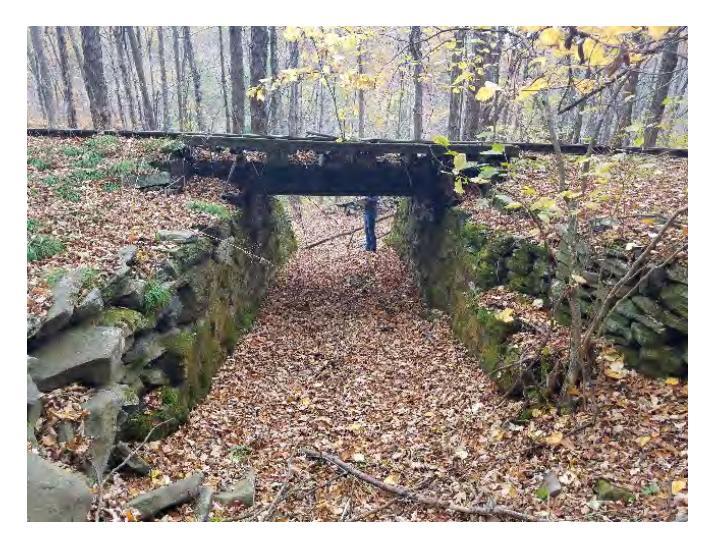
Figure 2-9: View of the rails across the structure, looking south

This structure consists of a timber girder superstructure founded on stone masonry abutments and wingwalls. The two timber girders are spaced approximately 6 feet apart on center, measuring 24 3/4" in depth. Steel rails and timber rail ties exist over the girders. The timber beams and rail ties are heavily rotted and loose in multiples locations.

For this structure, B&L recommends Alternative 1, full removal and replacement with a new steel plate pipe culvert and backfilling the gap to carry the trail over the crossing. The approximate total construction cost of this alternative is \$50,000.

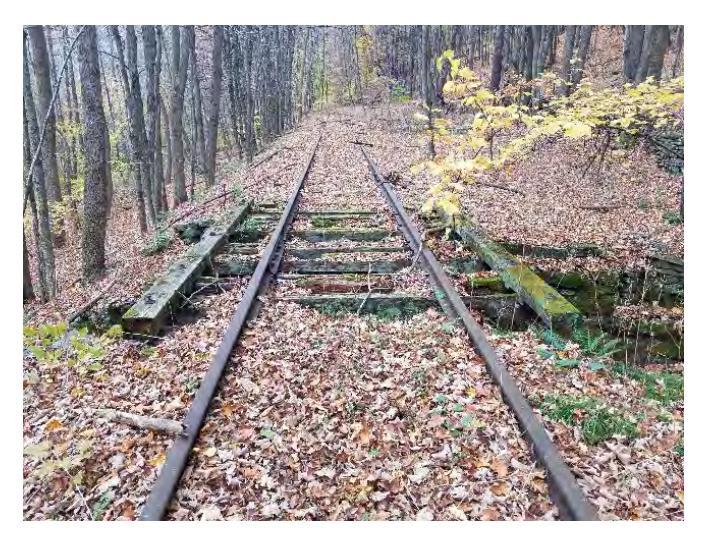
Figure 2-10: Elevation view of Short Span Structure #1

The stone masonry shows signs of deterioration, in the form of loose and missing mortar between adjacent stones, on approximately 50% the total surface area of each abutment and wingwall. The clear span between abutments is 8'-6".

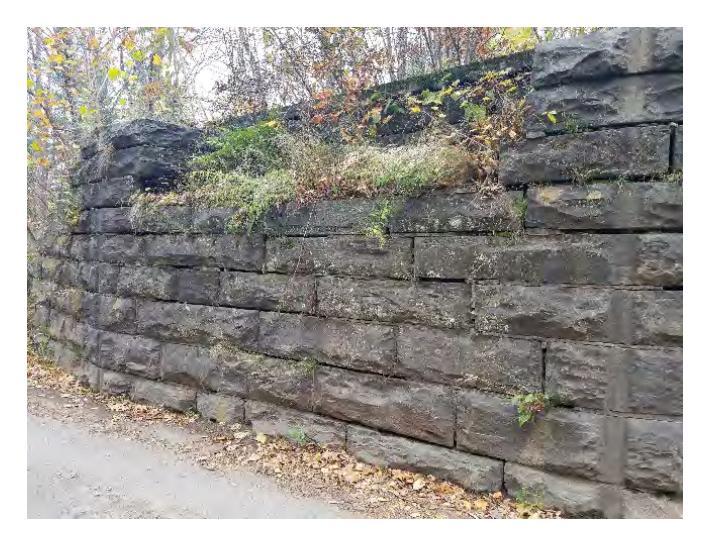
The existing structure at the Lasher Road crossing consists of stone-block masonry abutments with no existing superstructure. The masonry stones at each abutment and wingwall are in fair condition; however, there is missing mortar between the masonry stones across nearly the entire surface area.

Figure 2-11: Deterioration of the grout between the stone blocks

B&L recommends Alternative 3, full removal of the existing abutments and construction of an at-grade crossing between the trail and Lasher Road. The approximate total construction cost of this alternative is \$200,000.

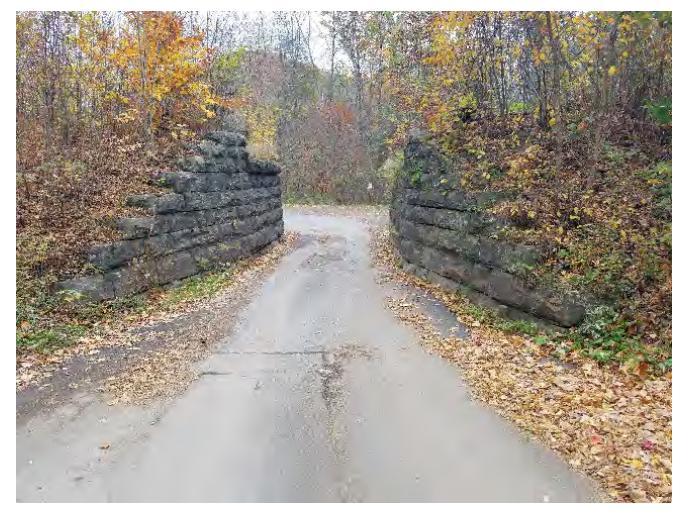
Figure 2 12: Elevation view, showing non-standard horizontal clearance

The face-to-face distance between the abutments is 10'-6", allowing only one lane of traffic to pass through. The narrow constriction created by the abutments and the current roadway geometry result in poor sight distances for vehicles travelling in both directions on Lasher Road in the vicinity of this crossing.

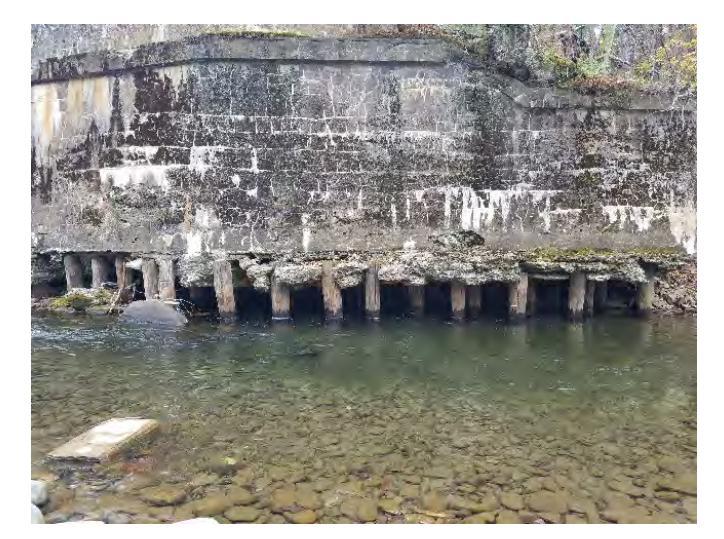
The previous bridge that carried the Ulster and Delaware Railroad over the Esopus Creek sustained substantial damage in 2011 during Hurricane Irene and Tropical Storm Lee, and was later removed by the County. All Desithat remains of the crossing today is the west abutment. The timber piles on which the west abutment was founded are exposed and show signs of severe scour. Based on the vegetation and sediment patterns on the shoreline, it appears that the former abutment locations were constricting stream flows through the bridge opening, resulting in the severe scour which can be seen in following photos. The existing span length of the previous bridge was measured to be approximately 90 feet. This was measured from the face of the west abutment to where the east abutment was assumed to be located.

Figure 2-13: West abutment deterioration due to scour

B&L recommends Alternative 1C, increasing the span length to improve hydraulic capacity, constructing a 150 foot span, steel girder bridge with a cast-in-place concrete deck. The approximate total construction cost of this alternative is \$1,800,000.

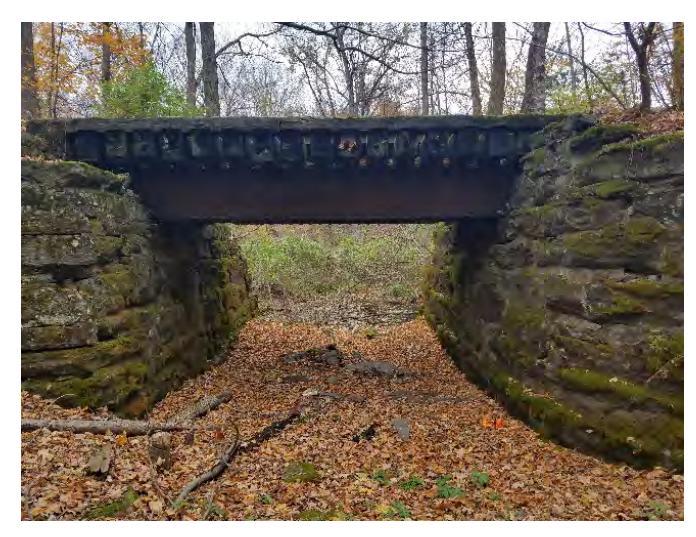
Figure 2-15: Elevation view of Short Span Structure #2

This structure consists of a steel girder superstructure founded on stone masonry abutments and wingwalls. The steel girders consist of two girders spaced approximately 6 feet apart on center. Each girder is composed of two side-by-side riveted I-beams, measuring 22 1/8" in depth. Steel rails and timber rail ties exist over the girders. The rail ties are heavily rotted and loose in multiple locations. The steel girders appear to be in good condition and show no visible signs of section loss or deterioration.

For this structure, B&L recommends Alternative 1, full superstructure removal and installation of a new steel plate pipe culvert to carry the trail over the crossing. The approximate total construction cost of this alternative is \$50,000.

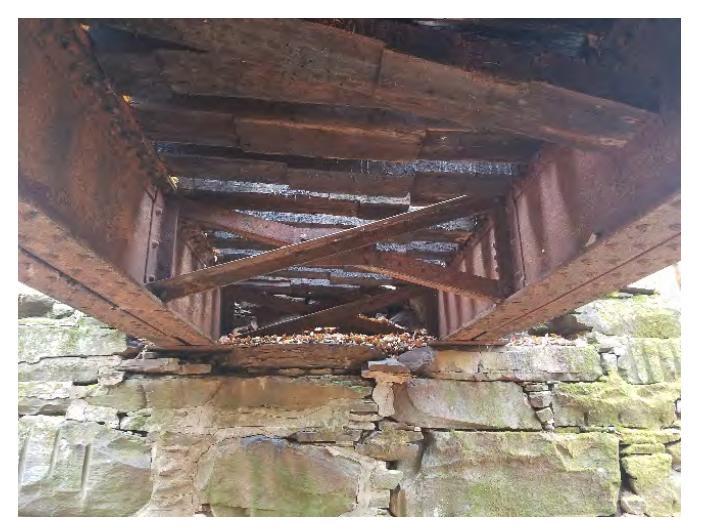
The stone masonry substructures show signs of deterioration in the form of loose and missing mortar between adjacent stones on nearly the total surface area of each abutment and wingwall. Most notably, there is missing mortar between the stones directly below the girders, resulting in a loss of bearing area at three of the four bearing location areas. The clear span between abutments is 12'-8".

Figure 2-16: Deterioration at the bearing area of the east abutment #2
