ULSTER COUNTY COMMUTER PARKING FACILITIES CAPACITY ANALYSIS AND NEEDS ASSESSMENT

2010

Ulster County Transportation Council

April 1, 2011

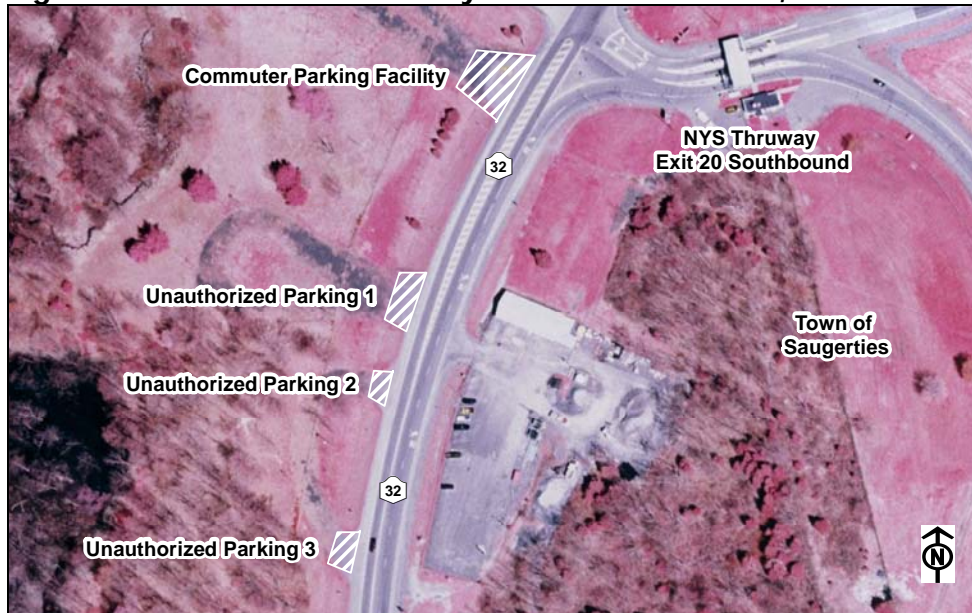
Figure 1: SR 32 at NYS Thruway Exit 20 SB Exit Area, Town of Saugerties

P1: State Route 32 at NYS Thruway Exit 20 Southbound, Town of Saugerties: This commuter parking facility is located on State Route 32 directly opposite the NYS Thruway Southbound Exit 20 in the Town of Saugerties (see Figure 1). The facility has approximately 12 parking spaces that are neither striped nor paved. There has been no improvement in the condition of the facility since 2006. Lack of lighting, pavement, signage and maintenance has raised safety issues at the facility. Due to the poor condition of the facility, commuters prefer to park at the spaces which are not designated for parking. The three unauthorized spaces adjacent to the commuter parking facility are better paved than the authorized facility itself. The capacity analysis adds the cars parked at these spaces to the occupancy numbers of the commuter parking facility.

The average occupancy of the Exit 20 parking facility (P1) including the vehicle count at the three unauthorized lots is 7 cars or 57%. Breaking down the numbers further, more vehicles were observed to be parked at these unauthorized parking spaces than at the actual facility itself. The unauthorized parking 1 (as marked in Figure 1) can accommodate up to 6 cars and the unauthorized parking 2 and 3 can accommodate 3 cars each. The condition of the Thruway Exit 20 parking facility has remained unchanged since 2006 even though the demand has increased. The parking facility is still unpaved and there is no lighting. The potholes in the facility raise safety concerns. Visibility of the lot from the road remains an issue and there is no signage on the road or in the facility indicating its availability. The facility is served by Adirondack/Pine Hill Trailways; however, there is no bus shelter at the lot.

P1 Recommendation: The *Intermodal Opportunities Analysis Final Report* recommends a facility large enough to accommodate 40 to 50 parking spaces with a paved surface. The use of unauthorized parking highlights the need for maintenance at the facility. The current conditions impact both the safety of the commuters and other vehicles on State Route 32. There is a need for immediate improvement of the Thruway Exit 20 commuter parking facility. To accommodate expansion as recommended, a site adjacent to the entrance may be available from the NYS Thruway Authority. With careful location of the driveway it may be possible to provide for a left-hand turning lane into the facility using existing pavement. Transit access should be provided as well as a bus shelter, signage and appropriate lighting. Absent funding for these improvements, the existing facility should be upgraded immediately with new curb cuts and paved area as well as changes in pavement markings to allow for left-turn lanes. A new facility should be a high priority with leadership provided by NYSDOT, NYS Thruway Authority, and UCTC.

P1 - NYS Thruway Saugerties Exit 20 Southbound, Town of Saugerties: The improvement of this parking facility are the second highest priority. The use of the adjoining shoulders along the NYS Rt. 32 is an indication of the urgency for immediate improvement of this facility. The long-term preferred alternative is to construct a new facility to accommodate 40-50 cars. Absent this, the existing facility should be upgraded with pavement, curbing and lighting.

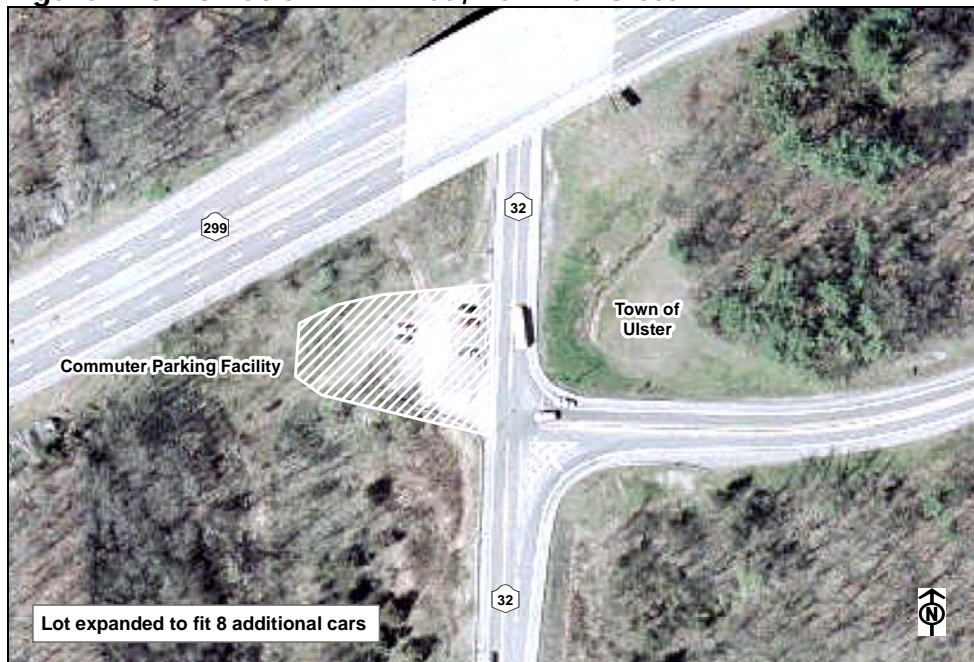
Figure 2: SR 32 at SR 199 Area, Town of Ulster

P2: State Route 32 at State Route 199, Town of Ulster: This unofficial commuter parking facility is located at the eastbound off-ramp intersection of State Route 32 and State Route 199 in the Town of Ulster (see Figure 2). This facility contains approximately 22 parking spaces. The facility was expanded by 8 parking spaces in 2010. The average occupancy of the parking facility was 25% in 2010. There was a 38% decline in the average occupancy of the facility in 2010 compared to 2008. The decline can be attributed to the increase in the capacity of the facility. The lot capacity was increased; however, there has been no improvement in the condition of the facility itself. The parking facility is still unpaved, is not served by public transit, and has no lighting. A traffic signal installed at this location in 2006 for access to State Route 199 improved access to the facility. The facility is owned by NYSDOT and is informally maintained by the Ulster County Department of Public Works. The overall condition of the facility still remains poor.

P2 Recommendation: The *Intermodal Opportunities Analysis Final Report* recommends a commuter parking facility with capacity for 50 cars. The location of the parking facility is ideal for regional carpoolers that use the Kingston/Rhinecliff Bridge. The lot capacity has been increased by 8 cars; however, the condition of the facility is still poor. Transit access is recommended as is a bus shelter, necessary signage and lighting. Security cameras may be needed to address illegal dumping issues if dumping continues to occur. These improvements are of moderate priority. Lead agencies are NYSDOT, Town of Ulster and UCTC.

P2 - NYS Route 32 at Route 199, Town of Ulster: The facility has been expanded; however, the condition of the facility is still poor. The facility is in need of improvement such as paving and lighting consistent with the *Intermodal Opportunities Analysis Final Report*.

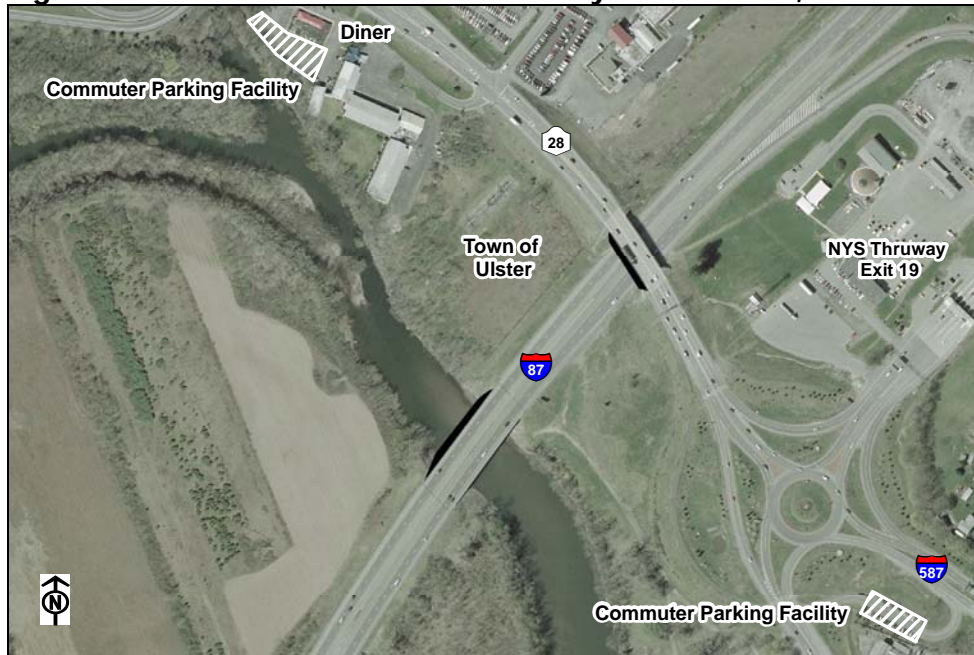
Figure 3: SR 28 at I-587 at NYS Thruway Exit 19 Area, Town of Ulster

P3 (NYS Thruway Exit 19) and P3A (Diner/Super Lodge Parking Lot), Town of Ulster: The NYS Thruway Exit 19 commuter facility contains 38 parking spaces and is located adjacent to I-587 near the roundabout (see Figure 3). The site is owned by NYSDOT and maintained by Ulster County. Access is one way from I-587 with a right-turn only exit onto Washington Avenue. The facility is highly visible and directional signage exits on I-587. The facility is well-lit. The site is not served by public transit. The site is located within a designated flood plain and was flooded at least once since its construction in 2003. The issue of congestion has intensified at the facility over the years. To ease congestion at the facility, NYSDOT through Metropool has leased 35 parking spaces at the parking lot of the Diner/Super Lodge in the Town of Ulster. The parking facility at the Diner/Super Lodge is in good condition with good paving, striping and lighting. This facility is underutilized and has not eased congestion at the Exit 19 facility which remained overcapacity with cars parked on the ramps. Commuters continue to park on the entrance and the exit ramps of the facility. One reason may be the lack of proper signages or directions to the available parking facility at the Diner/Super Lodge Parking Lot. The location of the commuter parking facility by the Diner/Super Lodge is also an issue. Located well away from the Thruway and behind the facility the facility is ill-suited to its park and ride purpose.

P3 Recommendation: Expansion of the P3 commuter parking facility was recommended as a top priority by the studies conducted in the previous years. The capacity of this lot should be increased utilizing adjoining lands of the NYS Thruway and private land owners if needed to accommodate and additional 80-100 parking spaces. The Diner/Super Lodge lot should be abandoned as it as failed to ease congestion at P3. In the short term, consideration should be given to providing a satellite facility by renting private property adjoining P3 or along the Washington Avenue Corridor. Failing that parking spaces should be considered within the City of Kingston such as it Kingston Plaza.

The Intermodal Opportunities Analysis Final Report identifies a parking “annex” south and east of the Thruway Exit 19 interchange near the Esopus Creek behind the Kingston Tourist Information Center Caboose on Washington Avenue. This area is mostly owned by Ulster County. Access would be by right-of-way through a private parcel. The site is not without problems as it is highly susceptible to flooding and access is difficult. Provisions for short term parking at this location should be explored with the scheduled improvement of Washington Avenue. This improvement could provide safe access to the proposed parking annex site. Lead agencies are NYSDOT, Town of Ulster, and the UCTC.

P3 - NYS Thruway Exit 19, Town of Ulster: The expansion of this parking facility is the top priority. It is well overcapacity and commuters continue to park on the entrance and exit ramps, raising safety concerns. The parking facility at the Diner/Super Lodge in the Town of Ulster has not helped ease congestion at the facility and this adjunct facility should be abandoned with consideration given to locate additional parking in the Washington Avenue corridor or the City of Kingston.

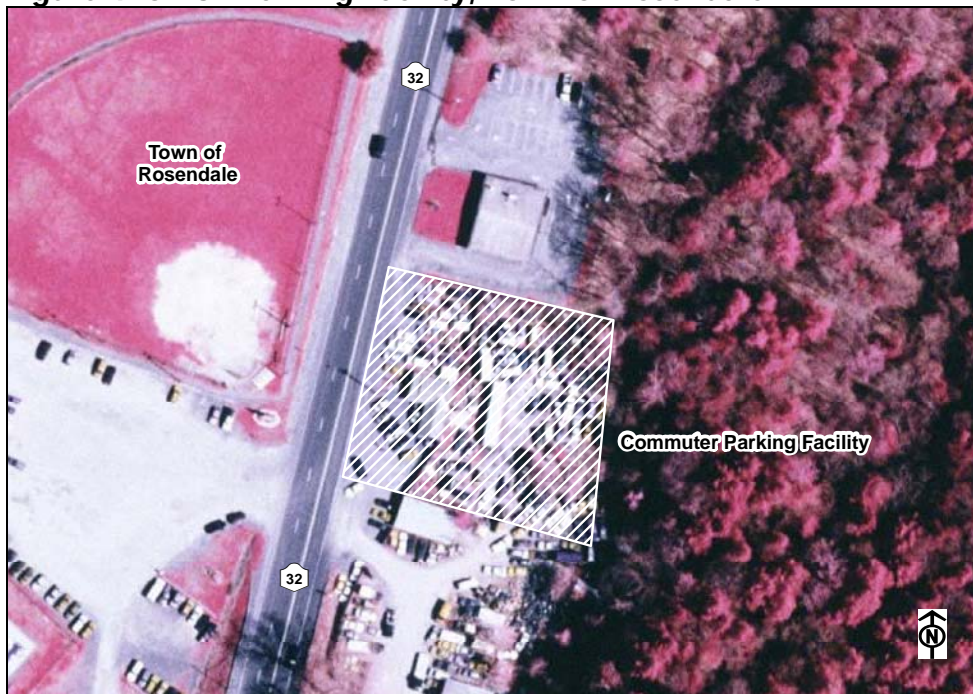
Figure 4: SR 32 Parking Facility, Town of Rosendale

P4: State Route 32 Parking Facility, Town of Rosendale: This official commuter parking facility comprising of 58 parking spaces is located opposite the Town of Rosendale Recreation Center (see Figure 4). This facility which was constructed in 2006 is in excellent condition. It is paved and has signage, lighting, landscaping and a bus stop shelter. The lot is visible from State Route 32 and way-finding signage is posted. UCAT and Trailways access the site. Ulster-Poughkeepsie Link operated by Ulster County Area Transit (UCAT) connects to the Poughkeepsie Train Station. Trailways has ticket counter as well as a waiting area. The location of the facility is ideal for regional carpoolers and Trailways users. The site is owned and maintained by a private land owner who has a lease arrangement with the Town of Rosendale. NYSDOT reimburses the Town for the lease using federal and state funds. In 2006, the UCTC approved a five-year commitment of funds under this

arrangement. The average occupancy of the parking facility in 2010 was 83% which was a 5% decrease from 2008. Overall, the facility is well used and maintained.

P4 Recommendation: Despite the decline in the average occupancy of the parking facility in 2010, the facility still has a high occupancy rate. The study recommends expansion of the facility by 40-50 cars, although, it is not an immediate priority.

P4 - State Route 32 Parking Facility, Town of Rosendale: Expansion of the parking facility on adjoining lands to accommodate additional 40-50 cars is recommended.

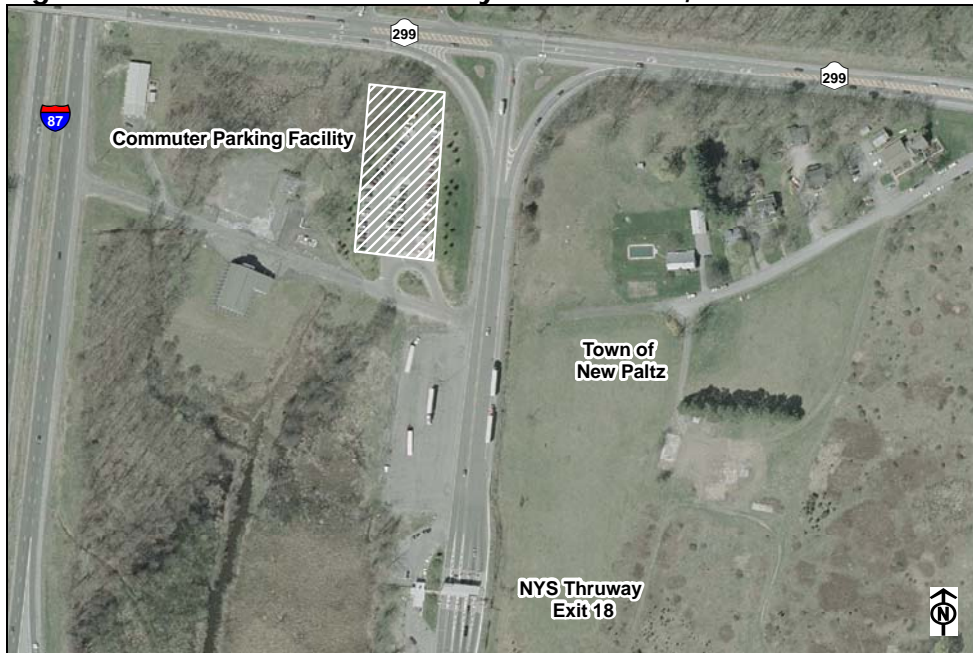
Figure 5: SR 299 at NYS Thruway Exit 18 Area, Town of New Paltz

The facility is located on the west side of the Thruway entrance near the toll booths in the Town of New Paltz (see Figure 5). This official commuter parking facility is comprised of 151 parking spaces. Due to the increased demand, 71 additional parking spaces were added to the facility in 2008. The expansion of the lot, funded by NYSDOT, has significantly eased congestion at the facility. The average occupancy of the commuter parking facility was 85% in 2010, which is an increase of 14% from 2008. The facility is in excellent condition with good paving, lighting, bus shelter, dedicated bus stop area, and is served by Trailways as well as the Ulster-Poughkeepsie Link. The New York State Thruway Authority (NYSTA) owns and maintains this facility. The location of the facility is ideal for regional carpoolers and Trailways customers.

P5 Recommendation: The latest expansion of the parking facility follows the recommendations from the *Intermodal Opportunities Analysis Final Report* and *New Paltz Transportation and Land Use Plan*. Expansion or improvement of the facility is not required at this time. The newly built commuter parking facility on State Route 32 Southbound in the Village of New Paltz should help ease congestion at this commuter parking facility.

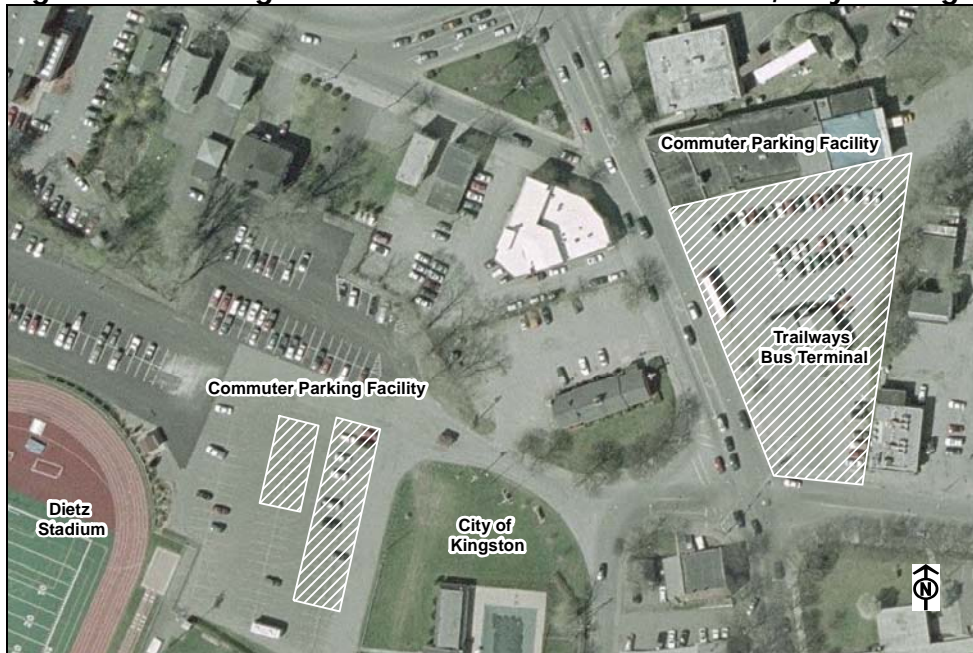
Figure 7: Washington Avenue at Dietz Stadium Area, City of Kingston

P7A: Trailways Bus Terminal, Washington Avenue, City of Kingston: The Trailways Bus Terminal offers its customers the opportunity to park on-site at the intersection of Washington Avenue and North Front Street in the City of Kingston (see Figure 7). The parking facility has a capacity of approximately 48 cars. The average occupancy of the commuter parking facility was 95% in 2010, an increase of 12% from 2008. The parking facility is privately owned and reserved for Trailways customers only. The Trailways customers can obtain a parking permit for the facility while purchasing the bus ticket. It was observed that 95% of the cars parked at the facility had parking permits issued by Trailways. The bus terminal is equipped with restrooms, vending machines and a waiting area.

P7B: Trailways Parking Annex, Dietz Stadium Parking Lot, City of Kingston: The Dietz Stadium Parking Facility serves as an overflow parking annex for the Trailways Bus Terminal and is located a block west of the Terminal (see Figure 7). Adirondack Trailways negotiated with the Dietz Stadium Commission in 2007 for the rights to reserve 32 parking spaces at the stadium parking lot for its customers. In 2008, the number of reserved parking spaces was increased to 50. Despite the increase in the reserved parking spaces, there was a significant rise in the average occupancy of the facility in 2008 and 2010. There was a 14% increase in the average occupancy of the commuter parking facility in 2010. Customers of Trailways receive parking permits when purchasing the bus tickets. Parking restrictions posted on-site delineate the parking boundary for Trailways customers and others. UCTC approved federal funding to support a portion of commuter parking expense for Trailways at this facility.

P7A and P7B Recommendation:

The congestion at the parking facilities for the Adirondack Trailways was observed to have increased in 2010. Increased parking capacity is needed for Trailways customers because the designated commuter parking facilities at the Trailways Bus Terminal as well as the Dietz Stadium are at capacity. The surface condition of the parking facility at the Adirondack Trailways bus terminal calls for need to improve paving and striping. Trailways should be encouraged to explore additional parking on lands adjoining its facility to provide a more permanent solution for transit oriented parking.

P7A and P7B: Adirondack/Pine Hill Trailways Parking, City of Kingston: The two commuter parking facilities for Trailways customers are at capacity. There is a need to provide additional parking spaces for Trailways passengers as well as improve the paving condition of the commuter parking facility at the Terminal. Trailways should be encouraged to find additional parking on properties that adjoin its facility as a longer term solution to meeting its parking needs.

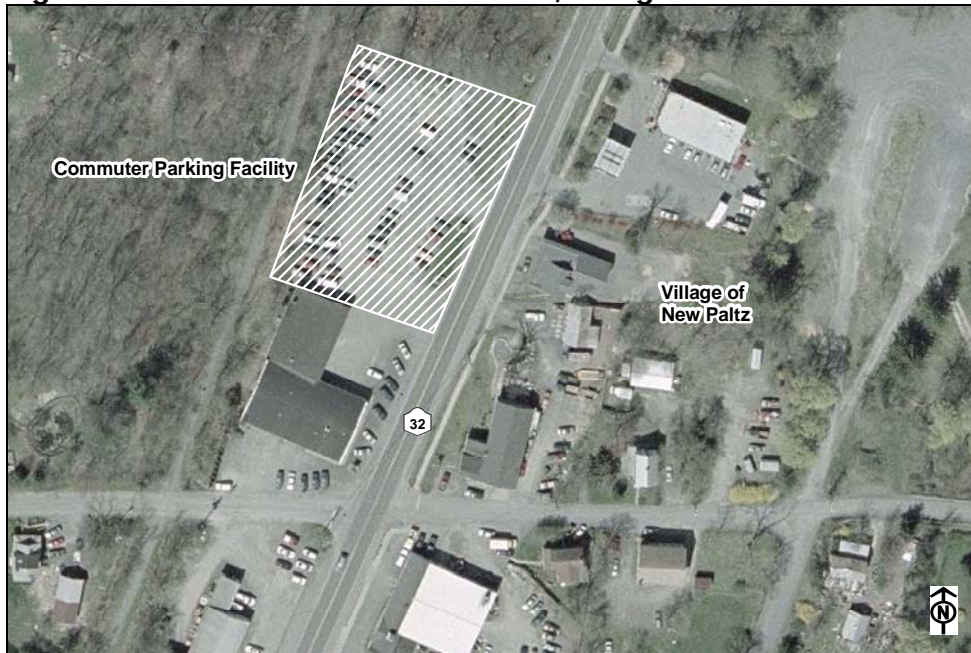
Figure 8: State Route 32 Southbound, Village of New Paltz

P8: State Route 32 Southbound, Village of New Paltz: The commuter parking facility is located on State Route 32 Southbound in the Village of New Paltz (see Figure 8). This is a new facility with capacity for 63 cars. The facility is well built with good parking, striping, lighting, landscaping and a bus shelter. The facility is served by the Ulster-Poughkeepsie Link to the Poughkeepsie Train Station. The facility is leased by the Village of New Paltz from a private landowner who provides maintenance. UCTC has provides funding for the facility. The average occupancy for the commuter parking facility in 2010 was only 25%. The average occupancy of the facility should grow in future due to its location, good condition and recent arrangements with Trailways to include it as a stop.

P8 Recommendation: Since this is a newly constructed commuter parking facility, the condition is excellent and has all the amenities needed.

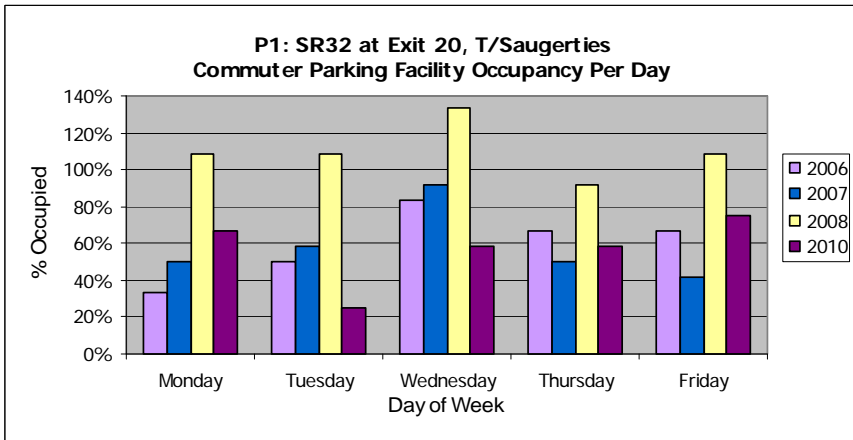
Graphic A1

P1: SR32 at Exit 20, T/Saugerties									
Days	Lot Capacity	2006		2007		2008		2010	
		No. of Cars	% Occupied	No. of Cars	% Occupied	No. of Cars	% Occupied	No. of Cars	% Occupied
Monday	12	4	33%	6	50%	13	108%	8	67%
Tuesday	12	6	50%	7	58%	13	108%	3	25%
Wednesday	12	10	83%	11	92%	16	133%	7	58%
Thursday	12	8	67%	6	50%	11	92%	7	58%
Friday	12	8	67%	5	42%	13	108%	9	75%
Average Occupancy		7	60%	7	60%	13	110%	7	57%

Note: Occupancy includes the vehicles parked in the unauthorized adjacent properties along State Route 32.

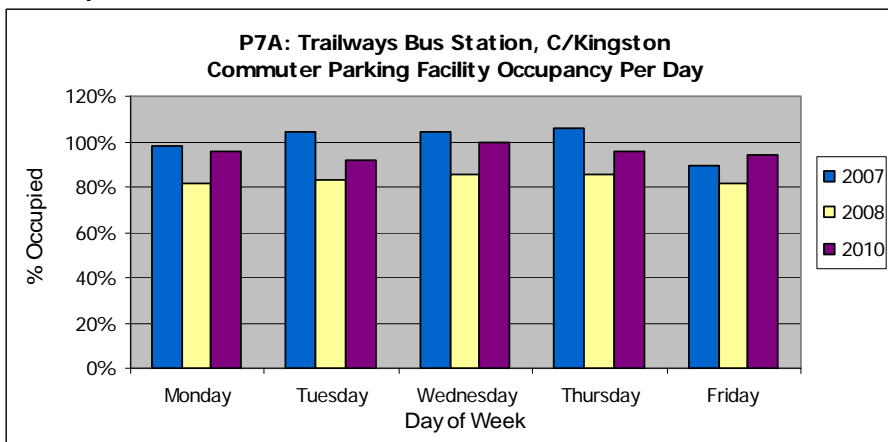
Graphic A7A

P7A: Trailways Bus Station, C/Kingston									
Days	Lot Capacity	2006		2007		2008		2010	
		No. of Cars	% Occupied	No. of Cars	% Occupied	No. of Cars	% Occupied	No. of Cars	% Occupied
Monday	48	-	-	47	98%	39	81%	46	96%
Tuesday	48	-	-	50	104%	40	83%	44	92%
Wednesday	48	-	-	50	104%	41	85%	48	100%
Thursday	48	-	-	51	106%	41	85%	46	96%
Friday	48	-	-	43	90%	39	81%	45	94%
Average Occupancy		-	-	48	100%	40	83%	46	95%

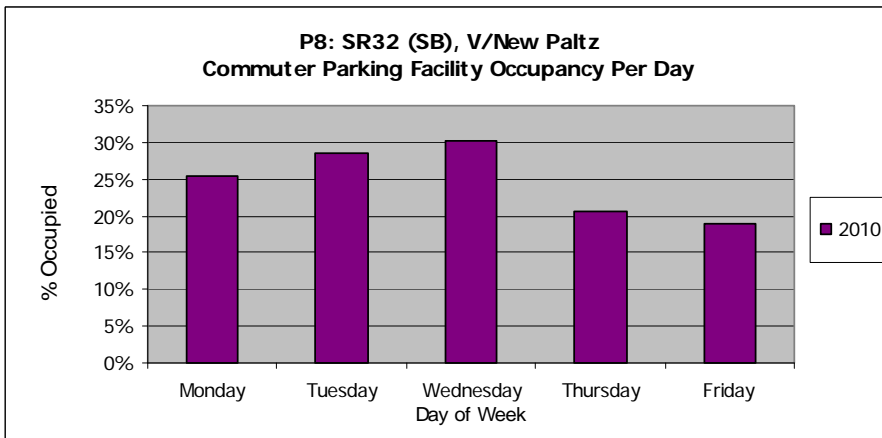
Graphic 8

P8: SR32 (SB), V/New Paltz									
Days	Lot Capacity	2006		2007		2008		2010	
		No. of Cars	% Occupied	No. of Cars	% Occupied	No. of Cars	% Occupied	No. of Cars	% Occupied
Monday	63	-	-	-	-	-	-	16	25%
Tuesday	63	-	-	-	-	-	-	18	29%
Wednesday	63	-	-	-	-	-	-	19	30%
Thursday	63	-	-	-	-	-	-	13	21%
Friday	63	-	-	-	-	-	-	12	19%
Average Occupancy								16	25%
