# 1

## EXISTING CONDITIONS

# Building a Better Broadway

## Broadway Corridor Conceptual Design Plan, Kingston, NY

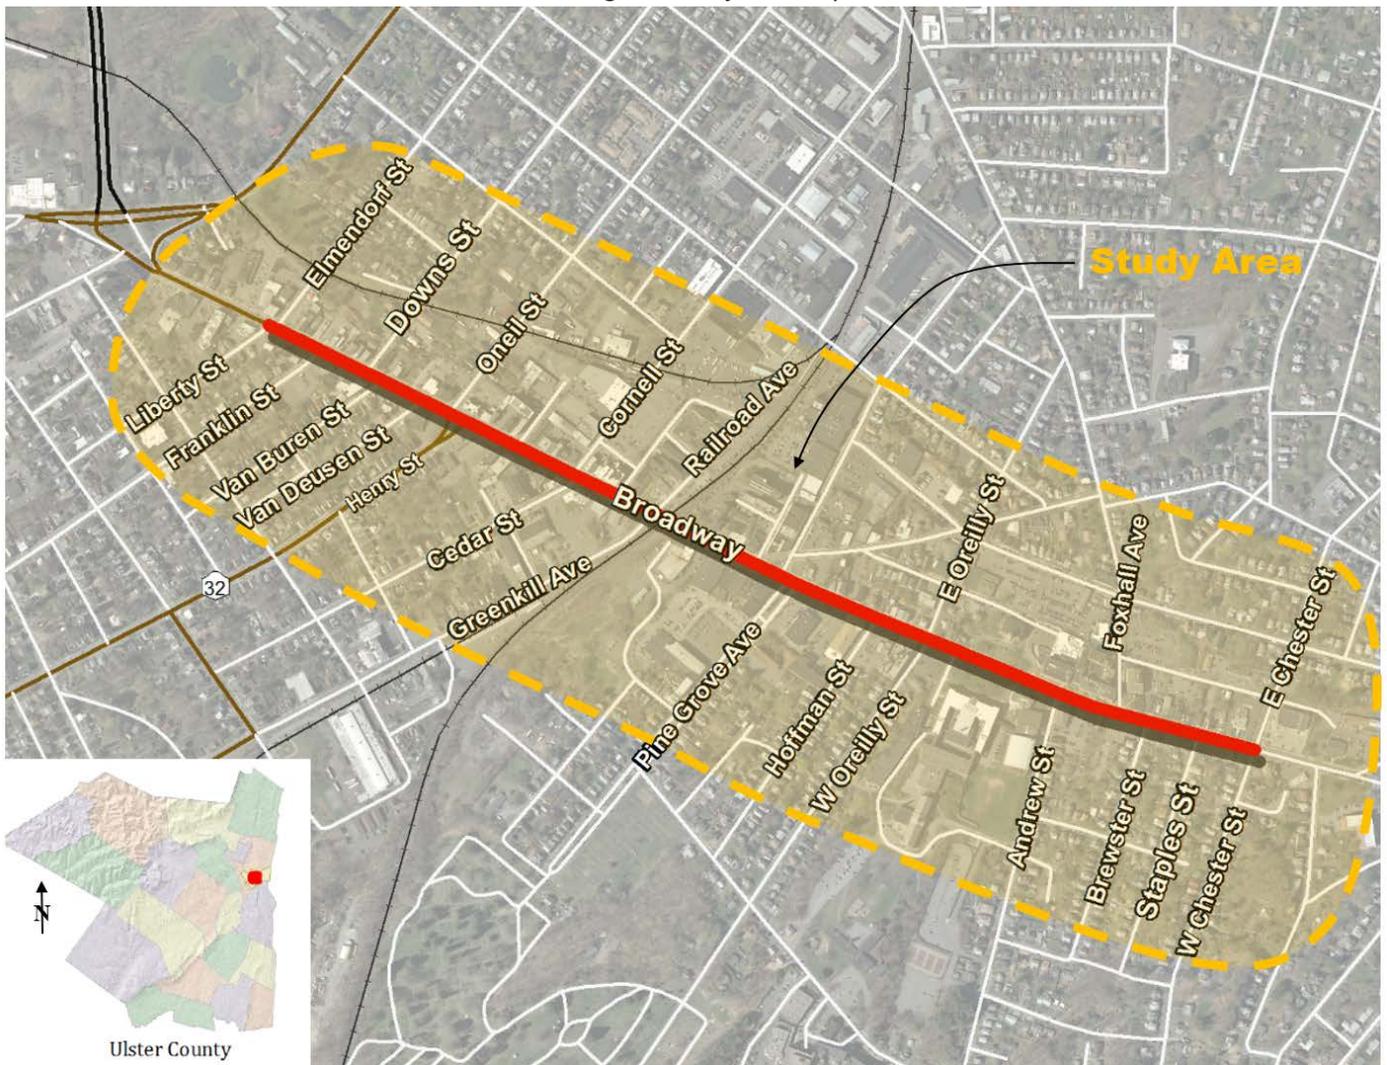
Figure 1 Project Study Area

This existing conditions technical memorandum summarizes the VHB's review of previous studies, analysis of existing conditions and assessments for traffic, safety, parking, transit, complete streets, streetscaping, and land use for the Kingston Broadway Corridor Plan. The study limits are from Liberty Street/Elmendorf Street to Chester Street, as shown in Figure 1.

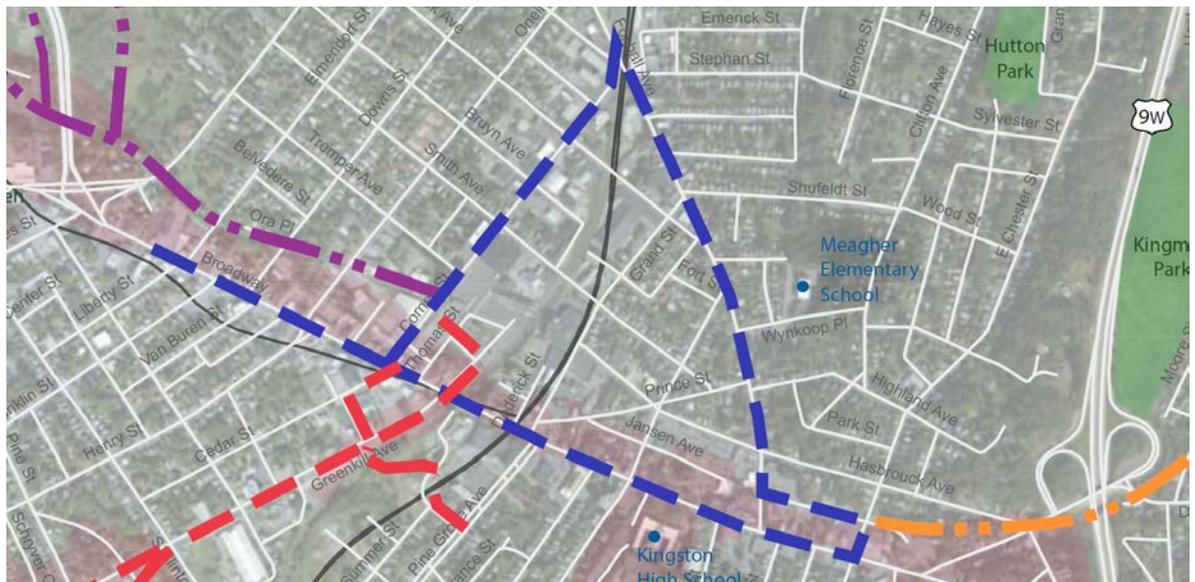
Figure 2: Kingston Greenline Complete System Map Excerpt

This draft plan has valuable trail planning information which will need to be considered and incorporated into the study. As shown on Figure 2, the “Complete System Map” shows the Midtown Hub running along Broadway from Liberty Street to Chester Street, then one block north on Chester Street followed by one block west on Jansen Avenue, thence northwest on Foxhall Avenue to Cornell Street before turning back south along Cornell Street to Broadway. Connections from the Uptown area trail system, the Rondout trail system and the Walkill Valley rail trail system are proposed at Cornell Street, E. Chester Street and Cedar Street, respectively.

Greenline conceptual Midtown Hub (in blue) with connections (clockwise from top left) to the Uptown Area, the Rondout Area and the Walkill Valley Rail Trail system

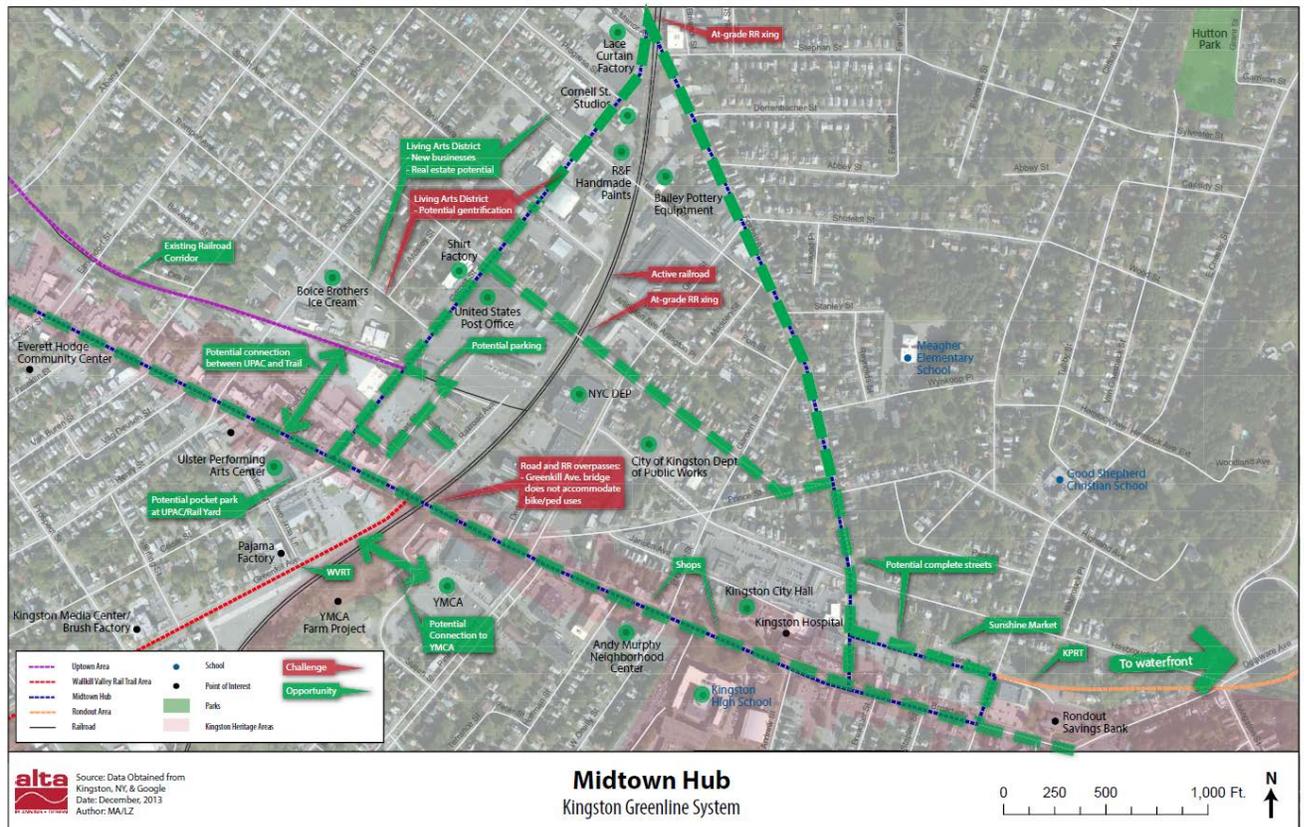
Figure 3: Kingston Greenline Midtown Hub Information Map

The Greenline Concept Plan also includes more detailed information for the Midtown Hub (included herein as Figure 3) showing existing railroad corridors, challenges and opportunities, potential bicycle circulation routes, points of interest, parking, etc.

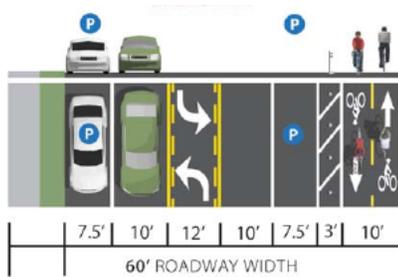
Figure 4: Kingston Greenline Plan Cross-Section Concepts

Finally, the Greenline Concept Plan presents a number of cross sections illustrating concepts (shown below in Figure 4) for roadway configurations to accommodate cycle tracks, bike lanes or shared routes with shared lane markings, depending on the street. These concepts, which are presented below, will need to be evaluated as part of this study.

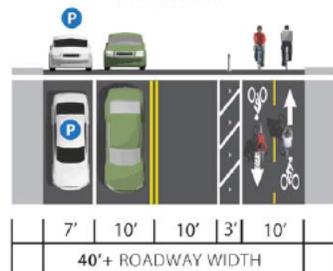
#### CYCLE TRACK & SIDEWALKS

West of the railroad, Broadway has a 60 foot curb to curb width. A road diet, from four travel lanes to three, is proposed. A 10 foot wide cycle track is proposed on the north side of Broadway. A 3 foot separation is recommended between the cycle track and the westbound parking lane.

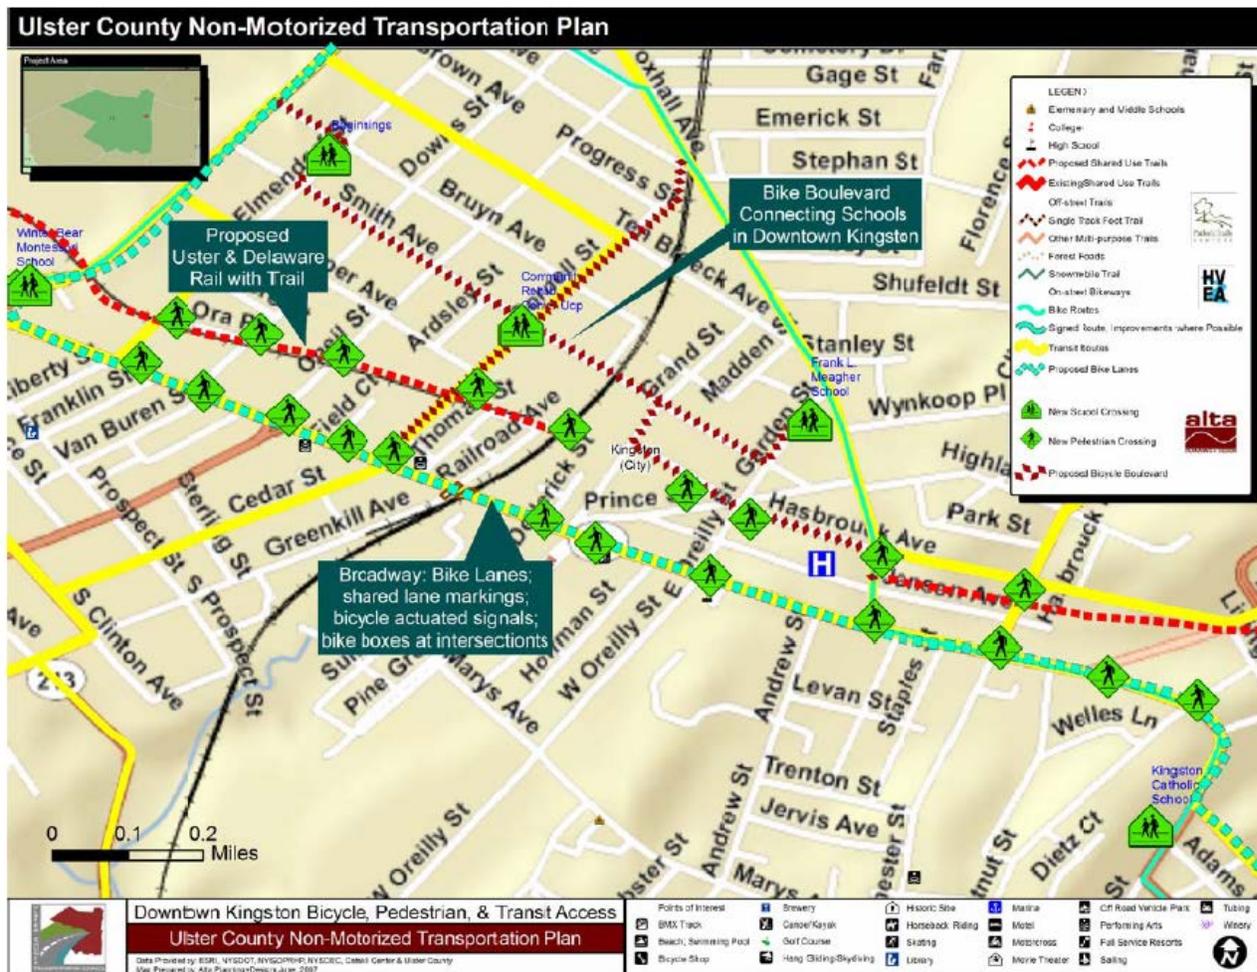
Figure 5: Ulster County Non-Motorized Transportation Plan: Downtown Kingston Access

This plan includes the Kingston Broadway Non-Motorized Access project. The plan recommendations relevant to the Kingston Broadway Corridor study area are options to provide four to five-foot bike lanes by restriping Broadway, pedestrian safety improvements, traffic calming treatments, consideration of a road diet, and shared lane markings, depending on the cross section. A map from that study is included in Figure 5.

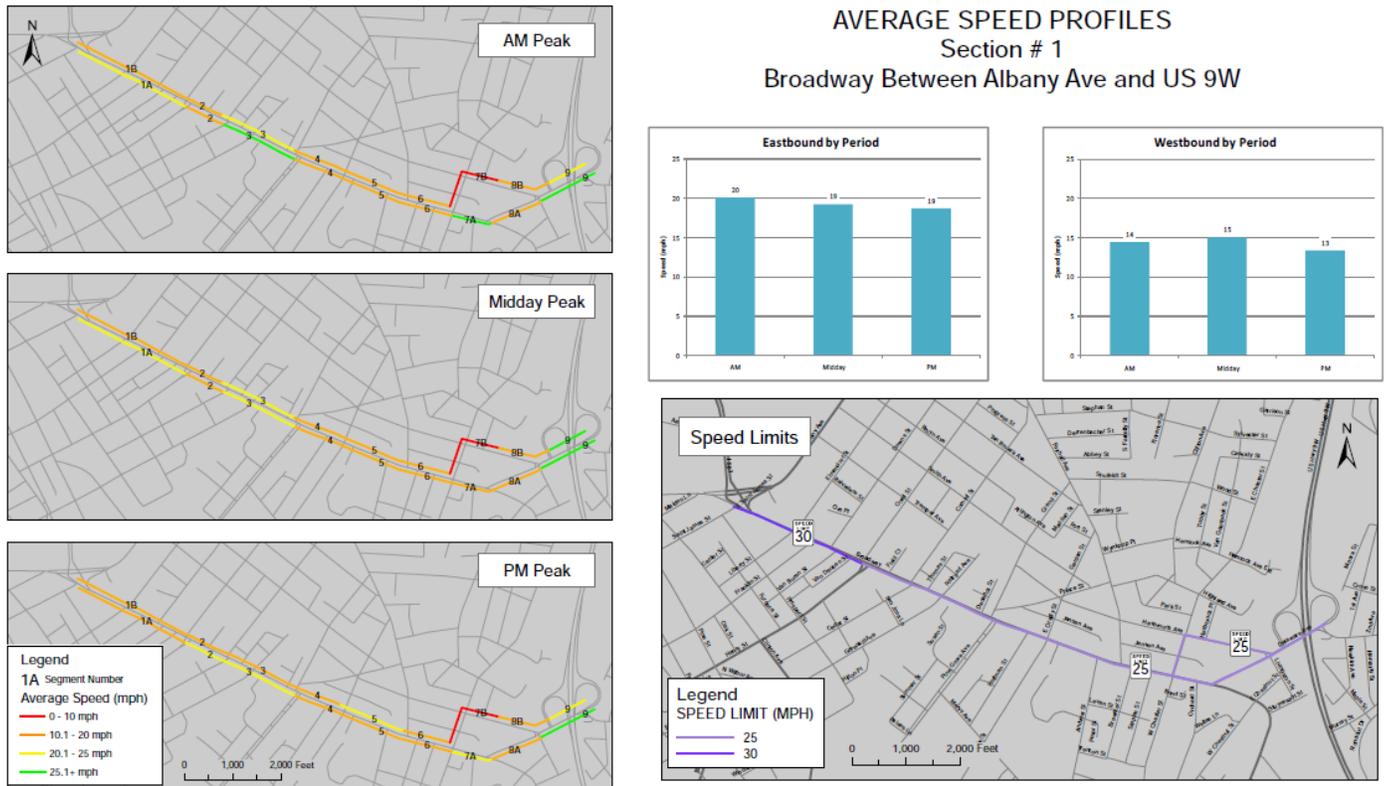
Figure 6 – Average Peak-hour Speeds Along Broadway

As indicated in Figure 6, eastbound peak-hour speeds along the corridor averaged between 18 and 20 miles per hour while westbound peak-hour speeds averaged between 13 and 14 miles per hour.

This study included Broadway between Albany Ave and US 9W. The study found that average speed in the corridor was acceptable although travel times could use some improvement, as evidenced by the directional imbalance along the corridor. The average travel time for Broadway was approximately 4 minutes and 10 seconds for eastbound travelers and 6 minutes and 40 seconds for west bound travelers. Most of the delay in the westbound direction was in segment 1B at the intersection of Broadway and Albany Ave within the project limits of the NYSDOT intersection improvement project scheduled to begin in 2015.

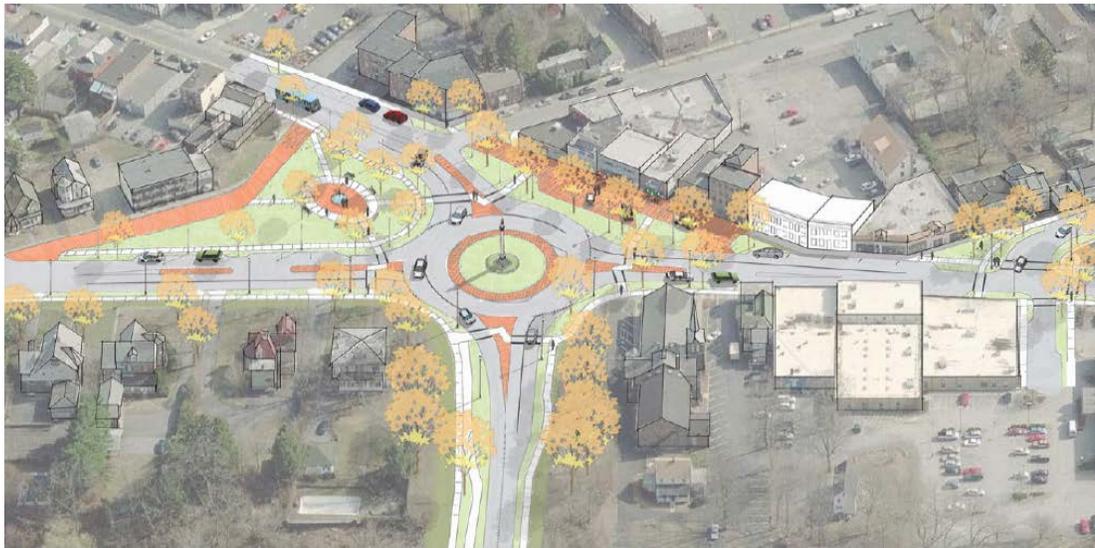
Figure 7: Rendering of the Proposed I-587 Roundabout Looking South

**The I-587 at Albany Avenue/Broadway report** provided information regarding the benefits of traffic improvements at and in the vicinity of that intersection (see Figure 7). Benefits on the Kingston Broadway Corridor study area were not quantified, however, it is assumed that the improvements would have a positive effect on the Broadway Corridor by reducing delays in the westbound direction. It is not clear whether there would be a noticeable effect on traffic delays in the eastbound direction although, with capacity improvements at the Albany Avenue/Broadway intersection the volume of traffic entering the corridor in the eastbound direction could increase during peak periods.

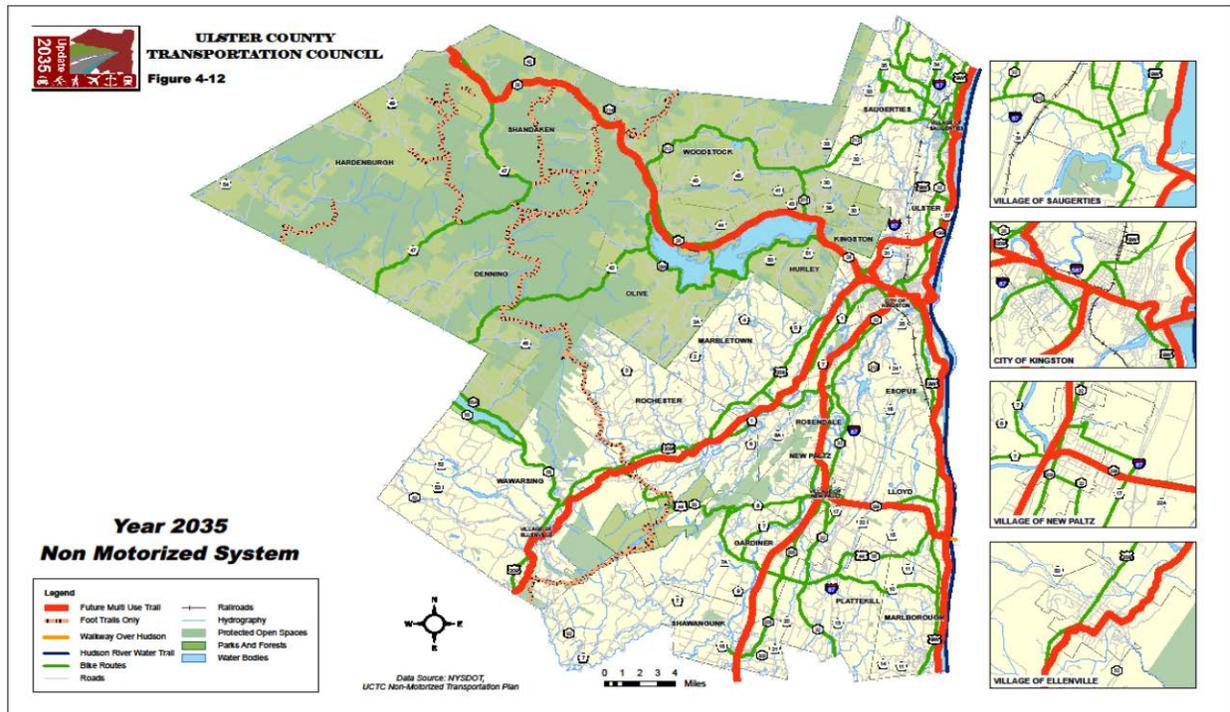
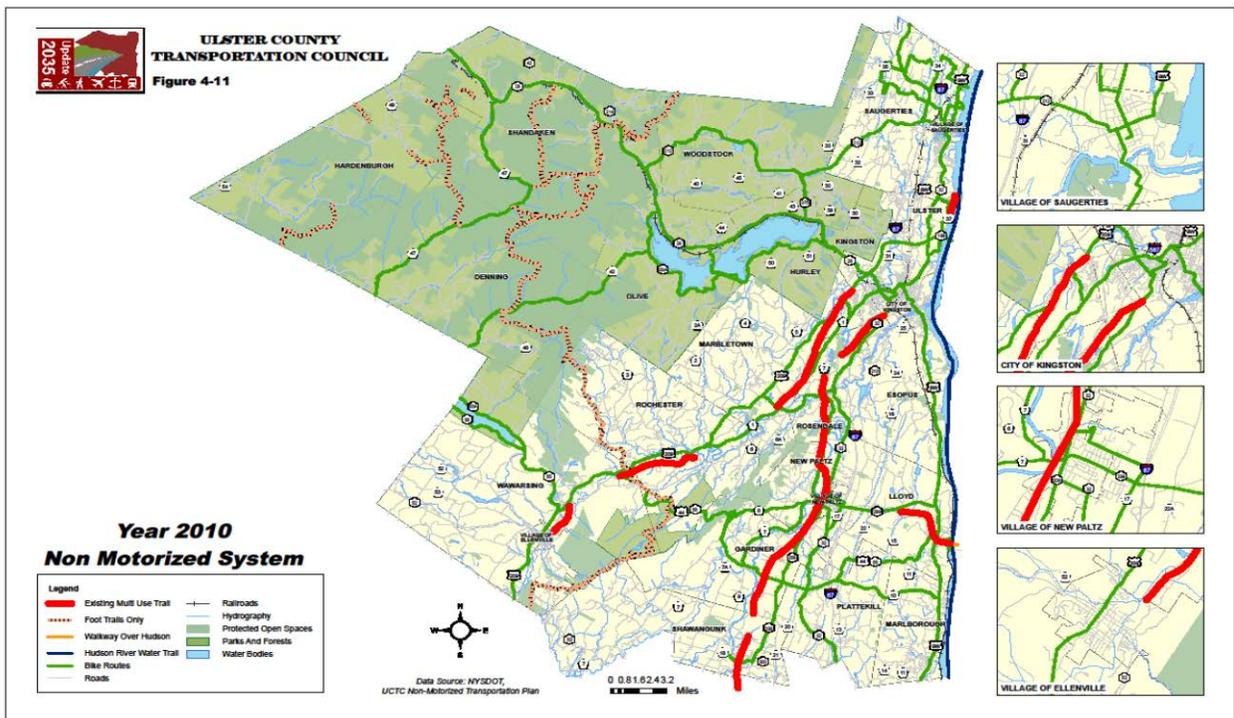
Figure 8: Maps from Ulster County Transportation Council Year 2035 Long Range Transportation Plan

**The Ulster County Transportation Council Year 2035 Long Range Transportation Plan** programs and prioritizes several projects within or adjacent to the study area, such as the Greenkill Avenue Bridge Replacement over Broadway, and the improvements at I-587/ Albany Avenue/Broadway. The Long Range Plan also includes relevant 2010 Existing Non-Motorized and 2035 Projected Non-Motorized Maps. These two maps, which are presented in Figure 8, show existing and proposed (2035) bike routes and multi-use trails in the study area. As can be discerned from the Kingston inserts in the figure, there is currently no multi-use trail in the study area, while bike routes run along Broadway from St James Street to Henry Street, from Andrew Street east, and along Foxhall Avenue. In the future, Broadway is envisioned as a multi-use trail with Foxhall Avenue remaining as a connector bike route.

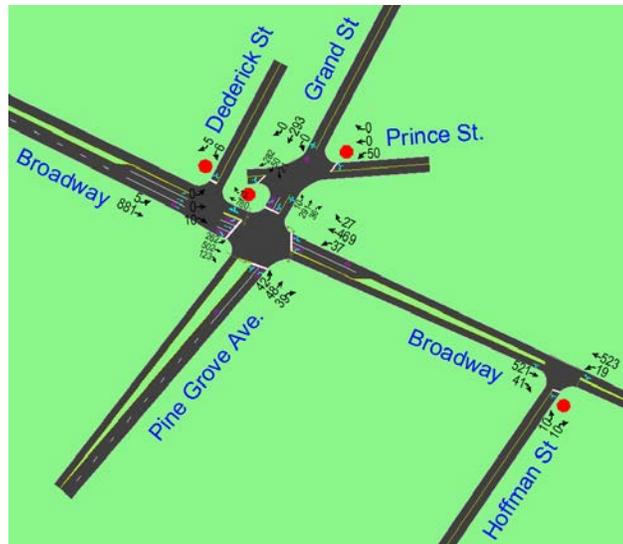
Figure 10: Estimated Peak PM Hour Traffic Volume from Dederick Street to Hoffman Street

The weekday PM peak-hour volumes from Dederick Street to Hoffman Street are shown on Figure 10.

As can be seen from Figure 10, the volume of peak-hour traffic on Broadway in the 3-lane transitional section of the corridor from Dederick Street Hoffman Street peaks under the

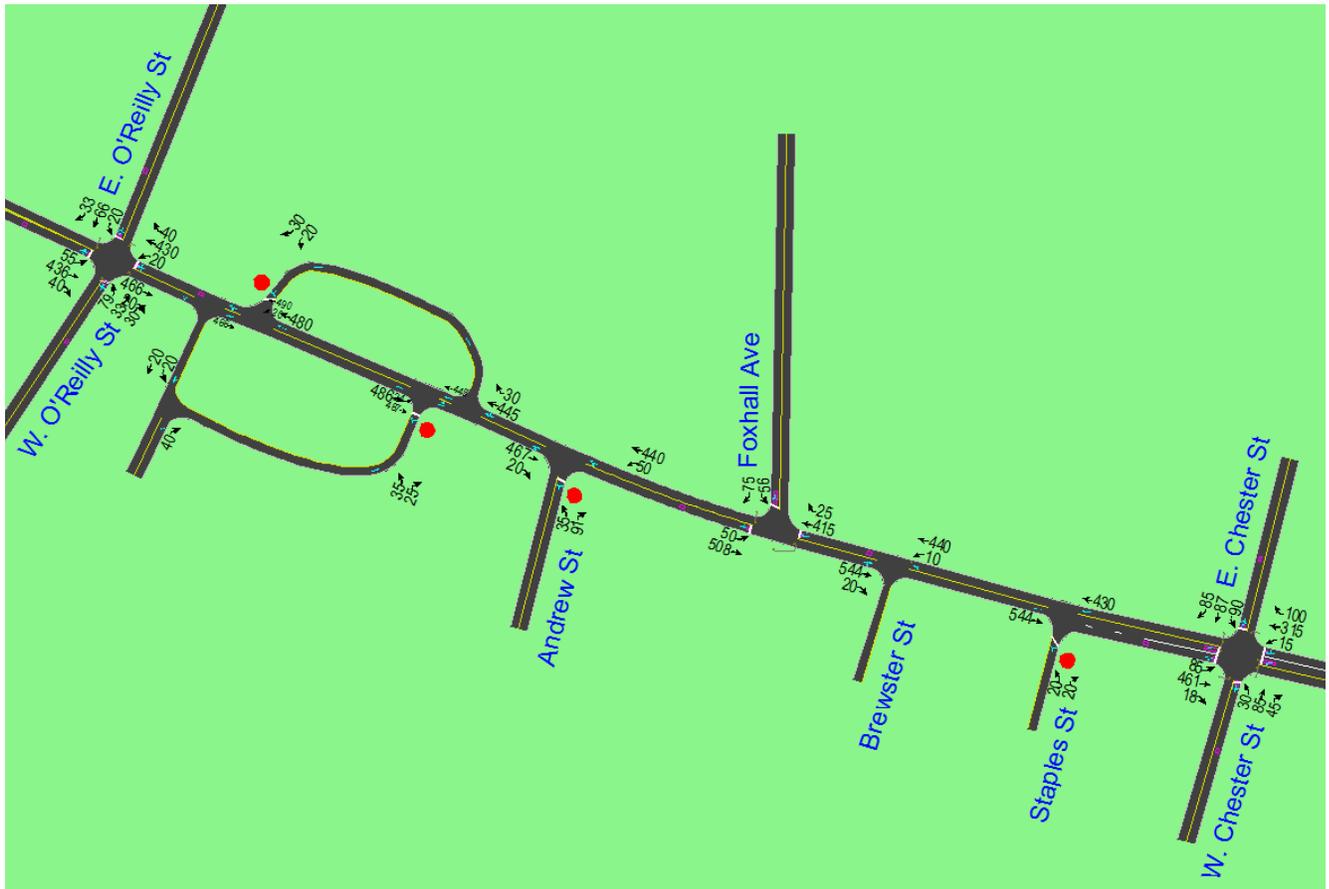
Figure 11: Estimated Peak PM Hour Traffic Volume from O'Reilly Street to Chester Street

The weekday PM peak-hour volumes from E/W O'Reilly Street to E/W Chester Avenue are shown on Figure 11.

As can be seen from Figure 11, the volume of peak-hour traffic on Broadway in the 2-lane section of the corridor from O'Reilly Street east peaks just west of O'Reilly Street with 531 vehicles traveling in the eastbound direction and 542 vehicles traveling in the westbound direction. Traffic volumes on the side street approaches range from 40 vehicles on the Staples Street approach to 262 vehicles on the East Chester Street approach.

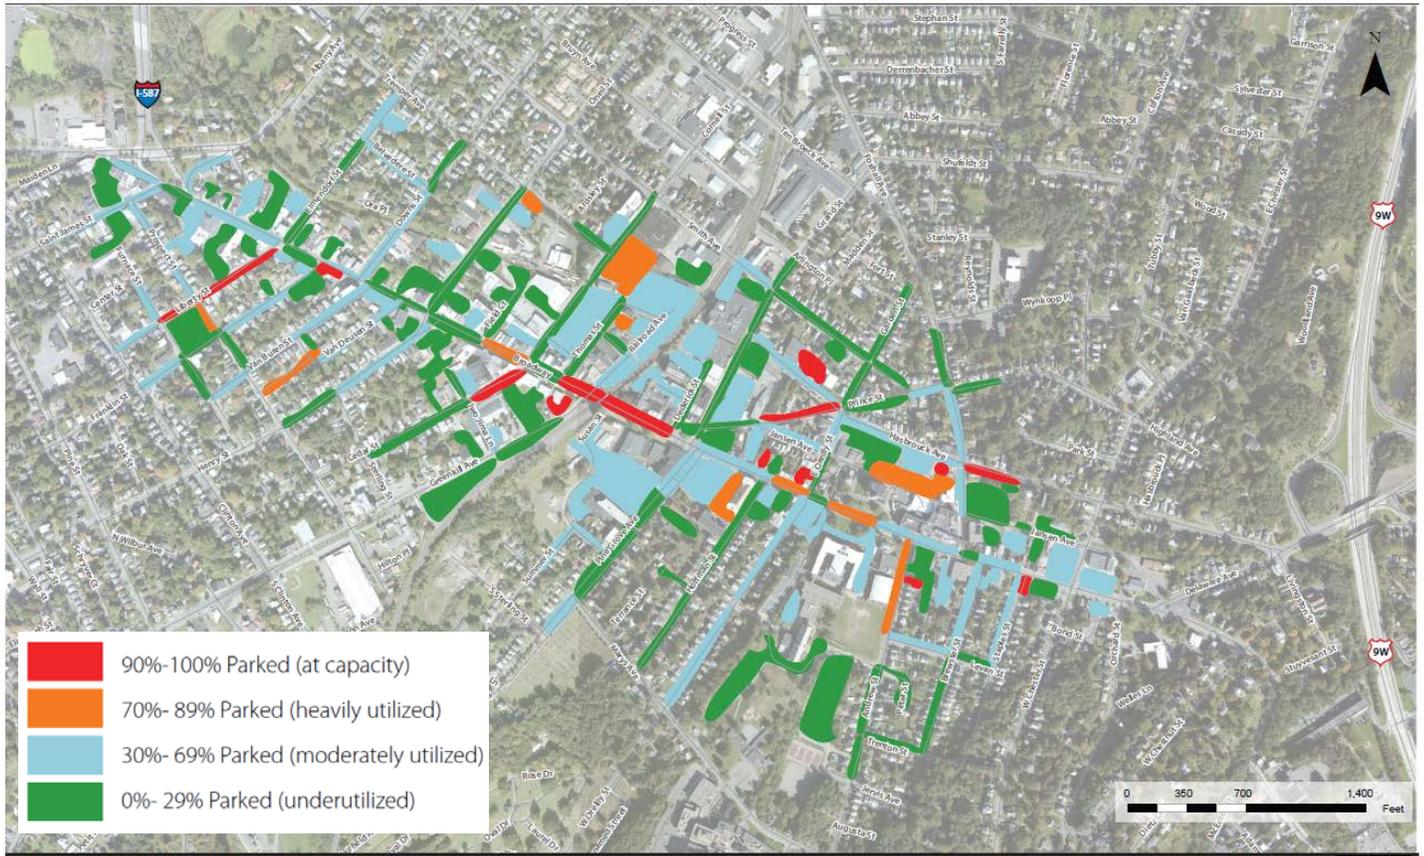
Figure 12 – Parking Use on Broadway Corridor

According to the data, most streets and lots are not used to more than 70 percent of capacity, indicated by blue and green on Figure 12. It is noted that parking is restricted during certain hours on Broadway between O’Reilly Street and Andrew Street to allow for the drop-off and pick up of high school students, as this activity was recently prohibited from the circle in front of the school.

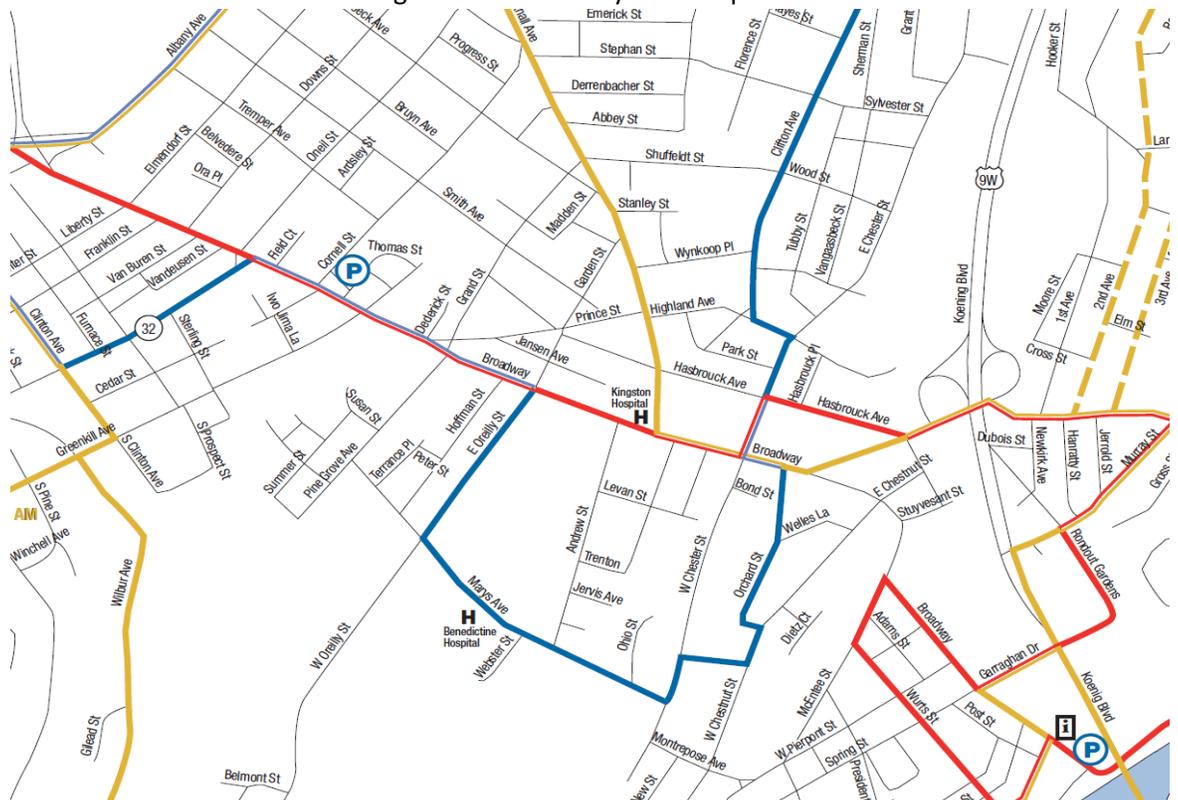
Figure 13 – Citibus System Map

Citibus operates three routes which provide service to Broadway in what has been referred to as a deviated-fixed-route system: A (red), B (blue) and C (yellow). Service on the routes is infrequent with 1 hour headways and only operating from about 6:30 AM to 7:00 PM. Improvements to the transit service, as documented/referenced in the UCTC 2012 transit study, would benefit users and businesses along the Broadway Corridor.

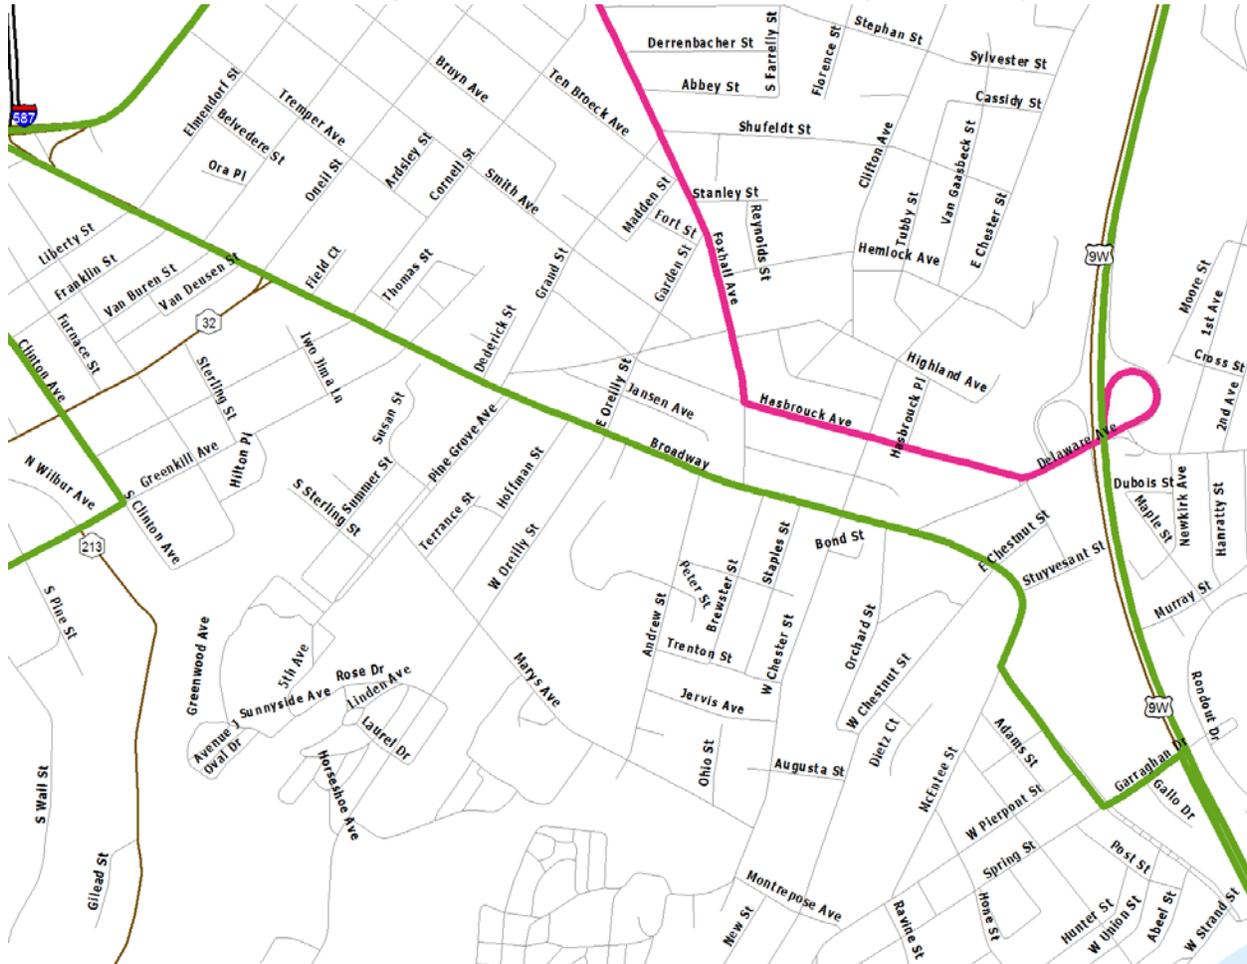
Figure 14 – UCAT Bus Routes in the vicinity of Broadway

UCAT currently operates as a “flag-stop” fixed-route system, meaning passengers may board at any location that is safe for the bus to stop along a bus route by flagging down an approaching bus. Similarly, passengers may request to exit the bus anywhere along the route. In the City of Kingston UCAT buses will drop passengers off upon request, but will only pick up passengers at Kingston Plaza and along Albany Avenue (for trips to Hudson Valley Mall).

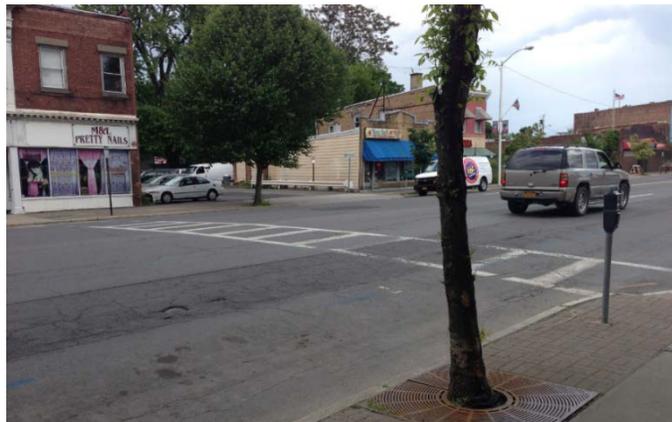
- Pedestrian warning signs – either crossing signs approaching uncontrolled, marked crosswalks or turning vehicles yield to pedestrian signs – are largely absent from the corridor; there are a few “state law yield to pedestrians in crosswalks” signs; more pedestrian warning signage is needed

Crosswalk without signs advising motorists

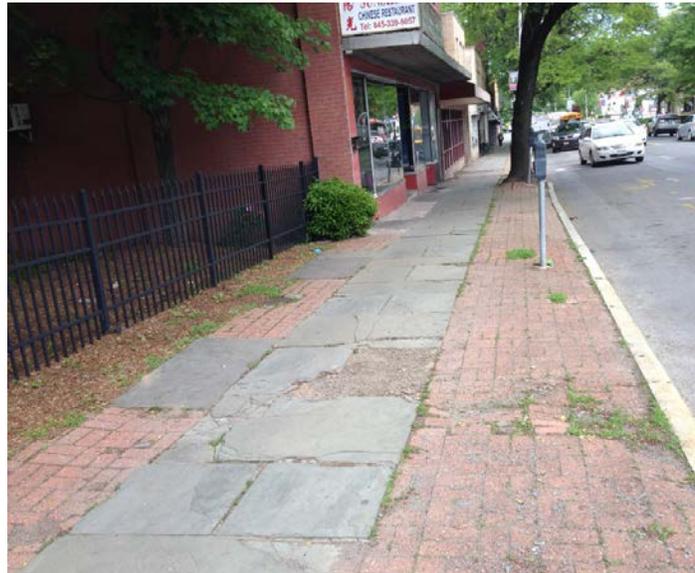
Traditional Bluestone Sidewalk
