COUNTY OF ULSTER

Track and Corridor Inspection

November 10, 2015

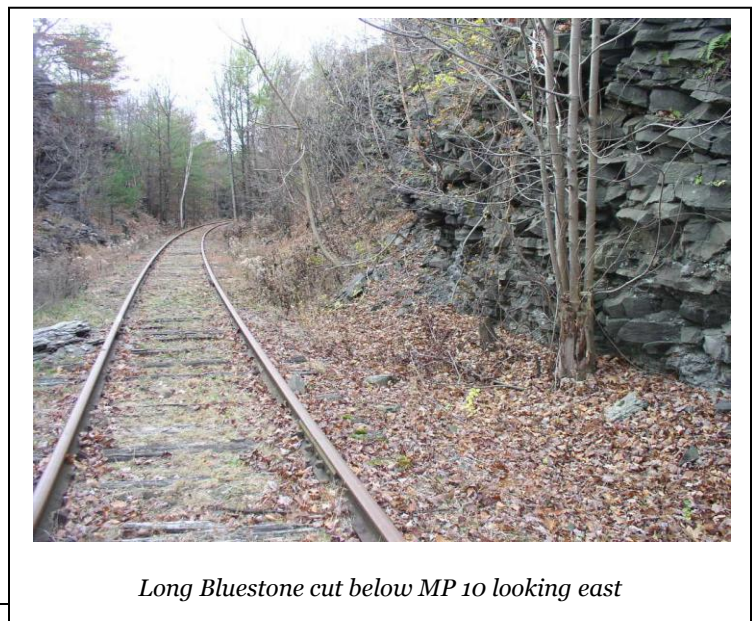
MP 10 – immediately below Basin Road – the track enters into a long curve within a deep Bluestone cut. This cut is opened wide to 33-35 feet, and appears to verify some historic information that cut areas were deliberately widened in order to provide more fill material in other adjacent areas. This is a very wide cut profile and the rock faces appear very stable. Rock faces are steep, and were likely blasted.

Rail in this area on the curve was 105# Dudley, comped down to 90#AS (33-foot sections) rolled in 1913, verifying the original reconstruction. Lackawanna 1912 90# rail was also identified.

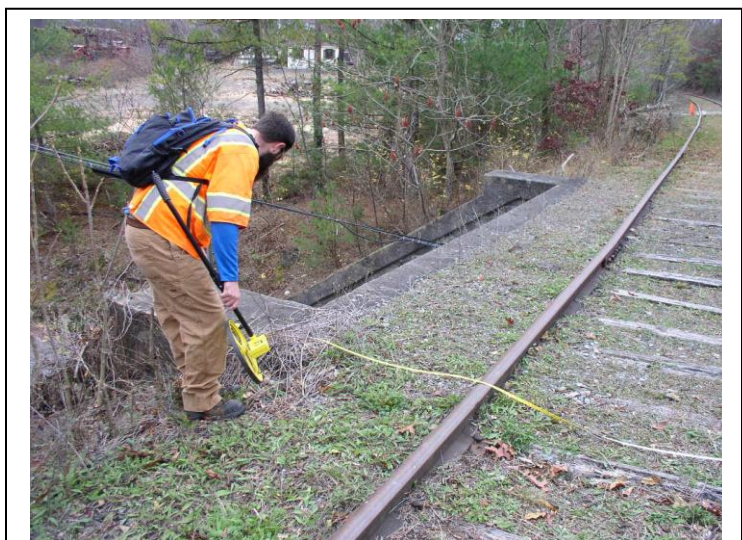
Beesmer Road Bridge

MP9 (Beesmer Road). Bridge is relatively short at 25 feet, ballasted deck, and measures 13' wide at concrete edge. It is assumed this would be allowed in the narrower trail profile for a short section. While

standard trail design would assume a second parallel bridge, the alternative would be for a cross-over at this location. Short distance would allow for a parallel trail bridge as an alternative.

CMRR plan shows crossover at this location to the south side.

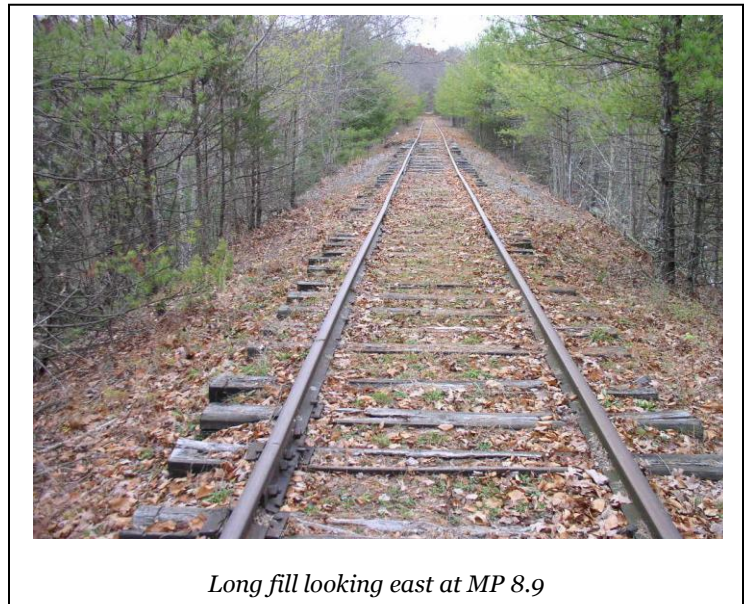
Below MP 9 the track traverses roughly 2700 feet of fill; with a 30' drop closer to MP9 and deepening to as much as 90 feet (or more) to the deepest portion. Side slopes are steep; likely not completely 1:1 but steeper than 2:1 standard evident on top. Wetlands are evident to both sides of the track and were verified by DEC mapping² as "State Regulated Freshwater Wetlands".

Between the relocation at 8.79 and the end of fill roughly at MP8.55, another observation is that the Valuation maps do not show a drainage structure through the fill itself; this indicates that the water flow is essentially stagnant and goes through subsoils for aquifer purposes. This may be the underlying reason for any ongoing settlement issues in the fill; while certainly not severe, the likelihood of further settling remains particularly if the fill structure is disturbed.

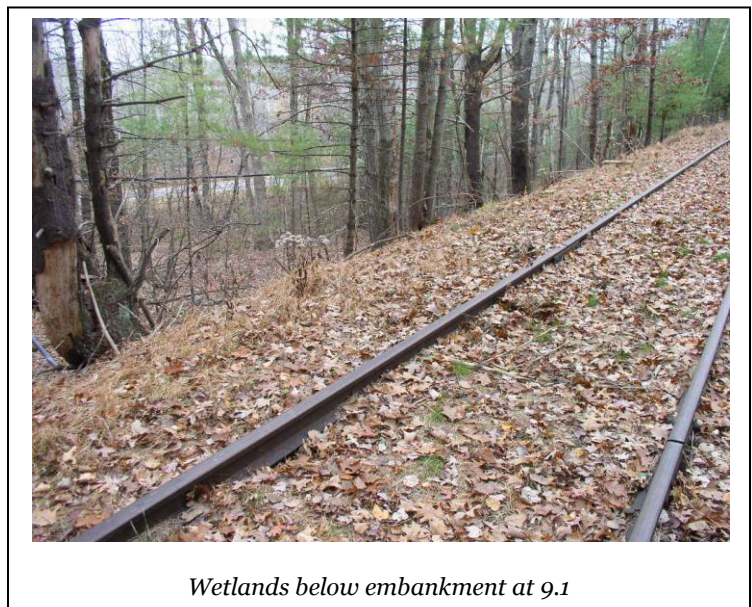
MP 9 also marks where the 'real grade' begins in earnest – the relatively consistent 2% grade down into Kingston is visually evident. The track does not flatten out in any location. As track charts are not available (although historic resources were checked) and the line has not been surveyed as the top portion has, exact grades are not available so there may be shallower or steeper localized spots. Historic records indicate the line was built to 2% and the "Ulster and Delaware" book shows an unofficial profile between MP10 and MP 6

of 2%.³ The vertical distance is more evident visually on Rt. 28A; the general vertical rise is slightly over 400 feet. In contrast, the section through the Ashokan Reservoir shows maximum grades of .5% (half a percent) over roughly 12 miles – essentially flat and relatively ideal multi-use trail characteristics for all users including those that are mobility restricted.

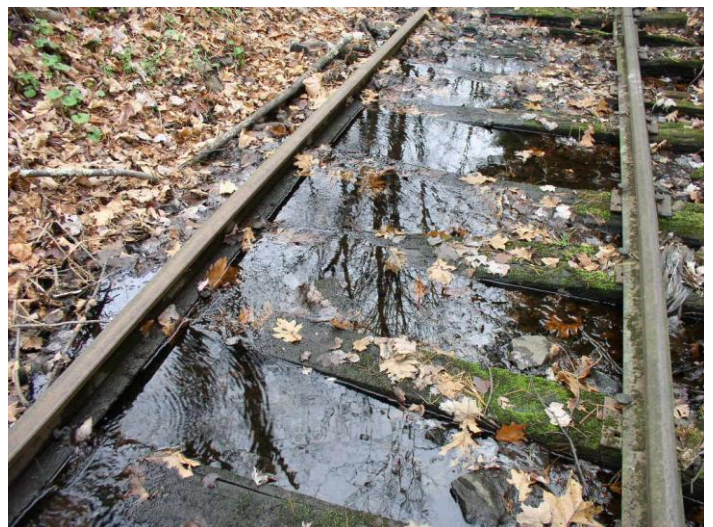
Immediately east of the 28A crossing is a very narrow, wet, and misaligned track section that is barely passable even by track car. Drainage in this area is now flowing directly through the track structure leaving ties submerged, hanging, grown with moss, and also within a shallow cut area that measures only 14’ 6” to 15 feet wide from ditchline to ditchline. This situation is nearly unusable for either rail or trail, and the entire

East of Rt. 28A crossing

drainage system in this area must be re-engineered. Even for trail usage, the cut must likely be widened and new drainage cut into a wider profile. This zone is basically 300' long with a cut as deep as 10 feet on both sides, and appears to be Bluestone. This is by far the worst drainage situation on the corridor between West Hurley and Kingston, and thankfully, is an isolated and unusual section. CMRR shows a parallel trail profile on the south side; this is only the recommended location due to the proximity of a private residence on the north side of the alignment. Any alignment here will require excavation, and a trail placement will require virtually the same level of remedial work.

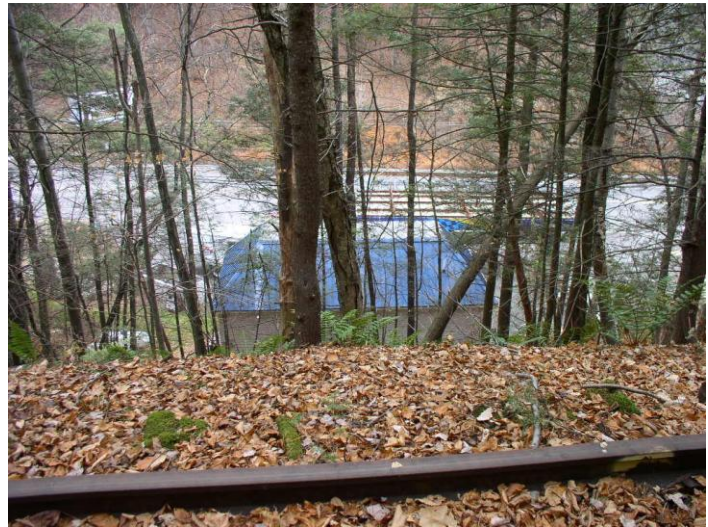
MP 7.75 has one of the very highest fill areas on the entire lower line, a 433' fill that extends approximately 110' down on the south side and even further on the north side nearly to the highway level, and an additional parcel off of the ROW was shown on valuation to allow for the fill footprint. This area was shown for retaining wall placement north on the CMRR plan (fill top was measured to a nominal 18' width). The drainage box at the bottom of the valley is shown as 3x4 foot in size, and it already appears

7.75 looking toward Honda dealer

extended approximately ten feet uphill without any fill on it – allowing some fill widening without extension. This presents at least some opportunity for fill expansion on the north side to gain space rather than the south side placement assuming extensive new wall construction. This area is directly behind the Honda dealership on Rt. 28.

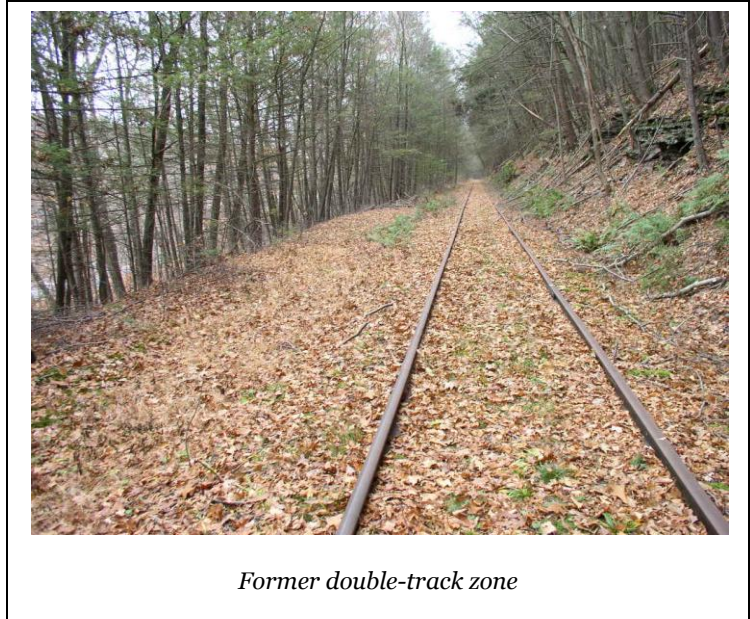
The ‘very best’ rail with trail location on the entire railroad begins approximately at MP 7.28 and continues south to MP 6.74; this was an excavated and widened passing siding area with the second track placed to the north side and then removed. CMRR plan shows the trail to this north side; this assumed continuation of this alignment north of this point on retaining wall. At this point there could either be a crossover of the trail to the north side of the ROW, or any heavy track rebuilding could relocate the track

over to the north side to allow easy location of the trail continued on the south side without a crossover. This is one location on the entire alignment that allows relatively easy, full-width trail profile with little excavation or filling necessary. For comparison, this amounts to half a mile of relatively easy parallel (and full-12’ width) construction that at minimum extends any work to 6.74 to easily be continued to 7.28. For any ‘rail with trail’ alternative, this should be emphasized as it allows the railroad the track/time distance to MP 7.28 with any further issues only from 6.74 to MP 6 – ¾ of a mile of more difficult co-location issues with a ‘free’ half-mile at the end with minimal conflict. As in other locations, when the track needs a virtual rebuild from scratch due to tie conditions, relocating the track is a viable alternative to reducing crossovers or gaining additional clearance.

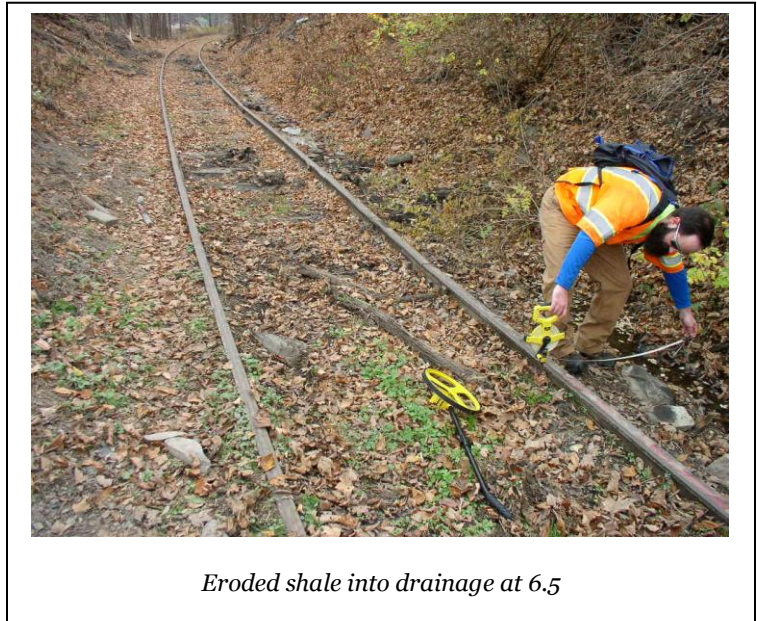
The railroad comes nearly out to the Rt. 28 right-of-way at this point, on a steep-shelf with a narrow alignment and generally inadequate width with some portions of only 50' ROW. Two private residences in this area have issues with right-of-way occupancy; the first at MP 6.54 (current north end of trackwork); the rock cut just below this residence is generally shale; the trail could not go to the uphill side due to the proximity of the residence, although drainage in this area is constrained even for a trail.

It should be noted at this location that the embankment to the north side was being dug out and partially removed simply to attempt to do normal tie replacement, and the characteristics of the embankment were soil with loose shale rock. While the zone was over 250 feet, it did appear to be gently sloped, not over 10 feet high at the worst point, and possible to widen to put the trail to the north side at this location.

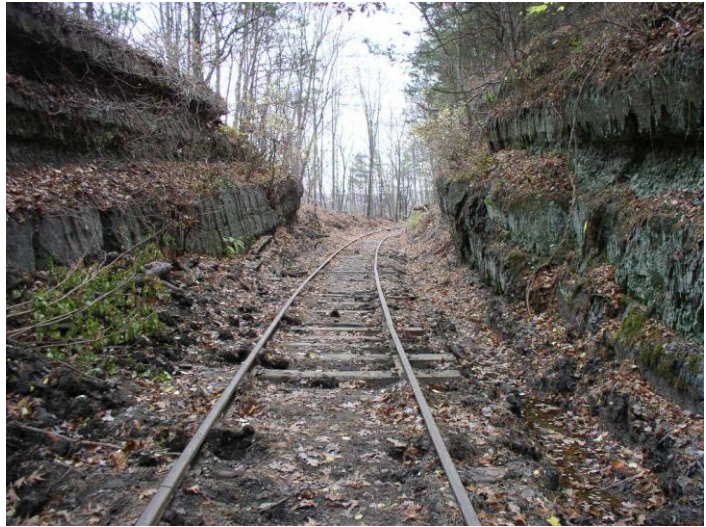
The final 'cut zone' before Hurley Mt. Road was between MP 6.2 and MP 6; this consisted of a massive excavated rock wall to the south side, compared to a relatively low mound on the north side; while the south side was virtually impossible to open, the north side was limited to a 200' zone of relatively low and shale-based rock that had relatively few obstacles to reduce to a parallel level grade.

Bluestone cut near Hurley Mt. Road

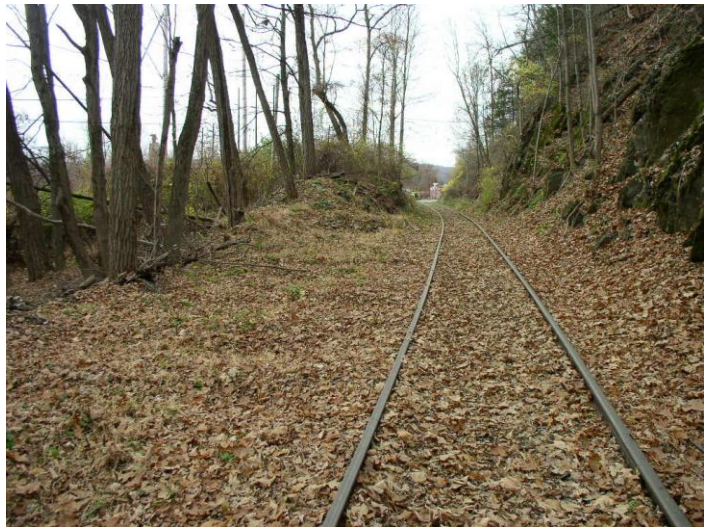
The final note of issue was that the Hurley Mt. Road crossing is assumed to be hand-flagged during rail operations, and has exceedingly poor visibility and is even lacking required crossbucks by NYDOT/FRA regulation as an active rail crossing. This visibility problem will remain for the trail, as any downhill bike traffic has at least the potential to run directly into the path of a vehicle at Hurley Mt. Road without significant advance warning and perhaps Bollard fencing to slow downhill bike traffic.

Approaching Hurley Mt. Road in distance
