# Kingston Intersection Study

## I-587 AT ALBANY AVENUE/BROADWAY INTERSECTION

**City of Kingston I-587/Albany/Broadway Intersection Study  
Project Discovery Technical Memorandum**

**August 2010**

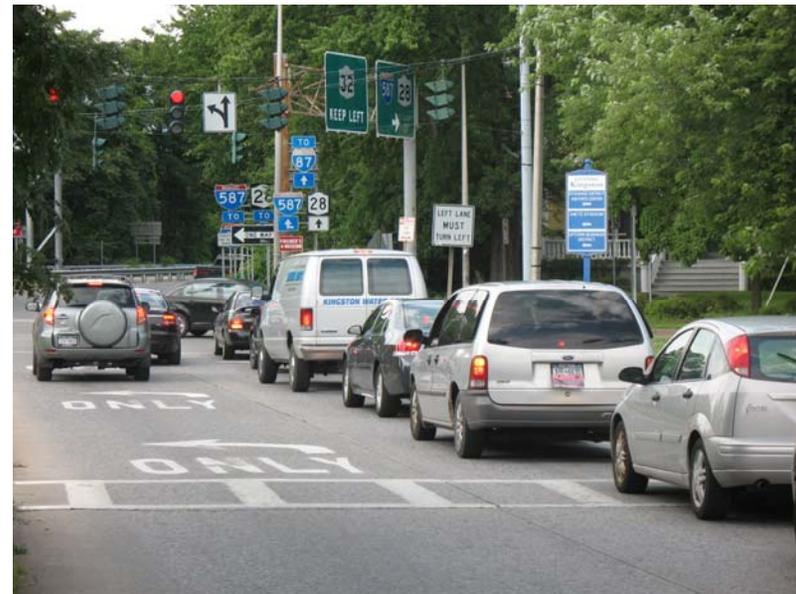
*Multiple signs on Broadway approaching Albany Avenue*

When signs are improperly located, obscured or damaged, or clustered in groups, their effectiveness is minimized. In general, there is a proliferation of signage in the study area that contributes to driver confusion. A detailed signing plan prepared by NYSDOT for the study area can be found in the Technical Appendix.

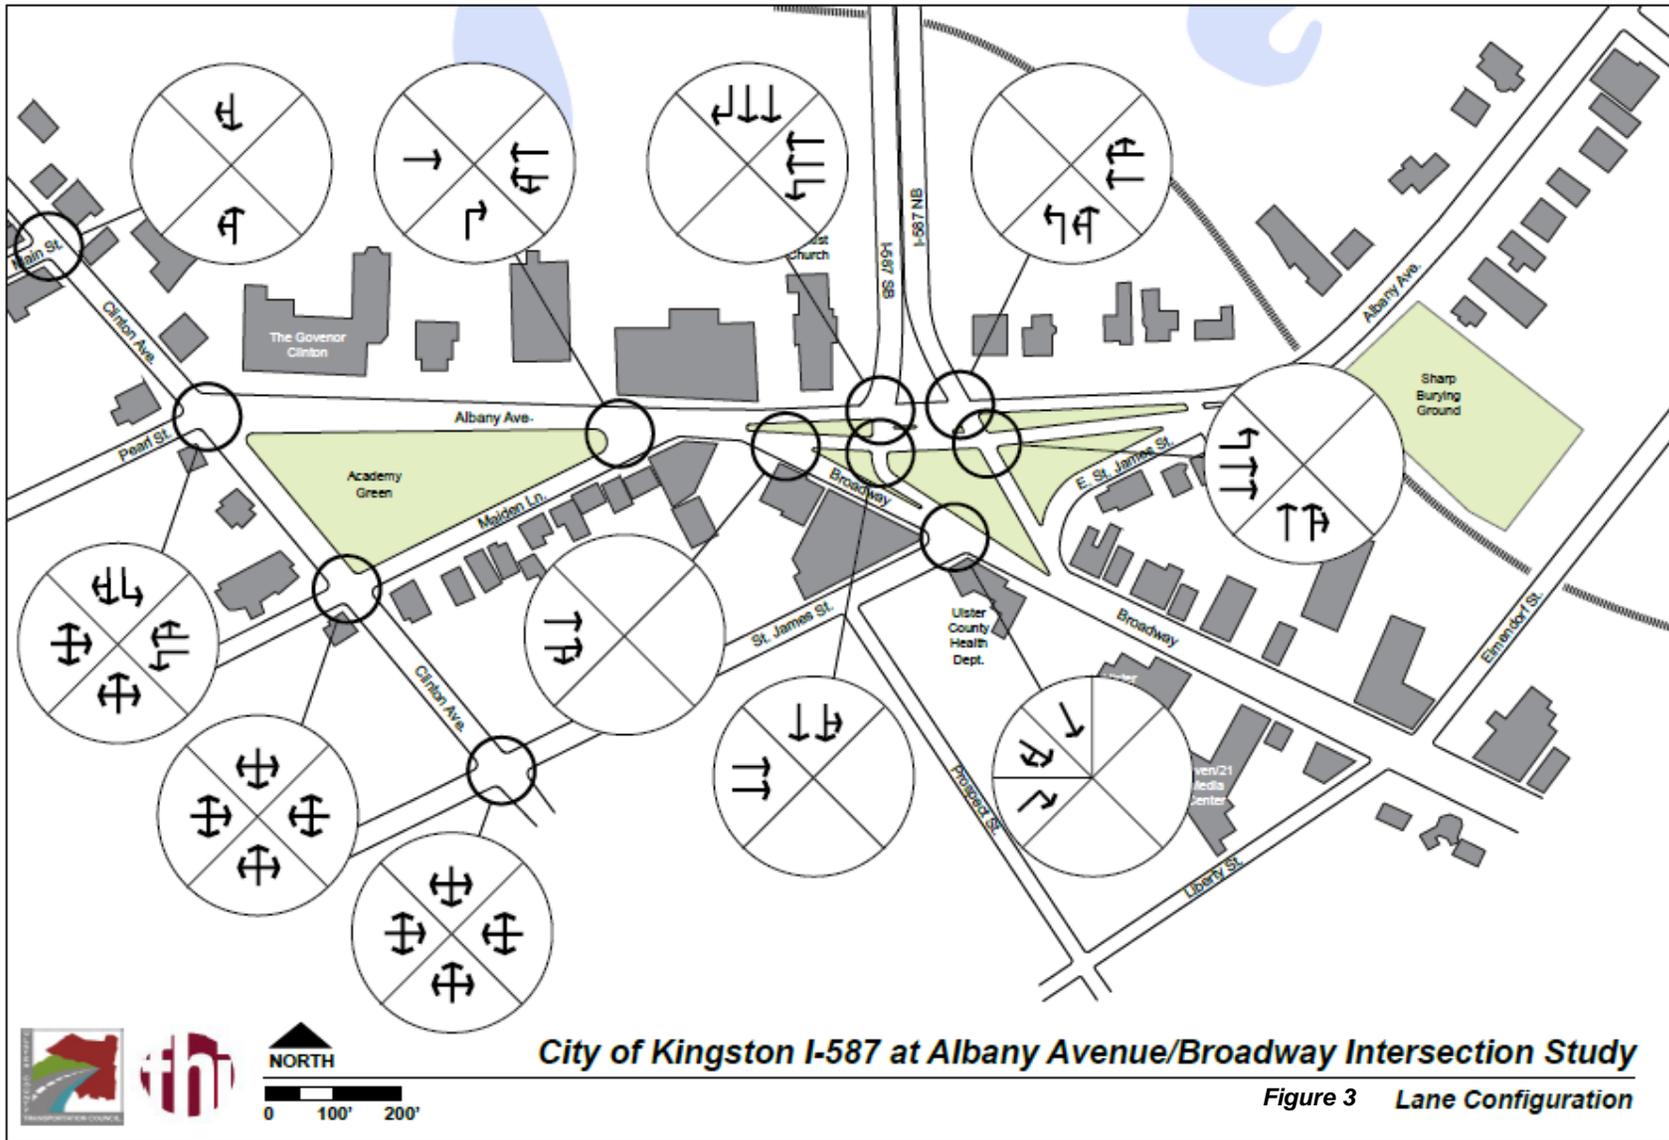
Figure 3 Lane Configuration

Lane arrangement at study area intersections have been inventoried for the purpose of understanding intersection capacity. Figure 3 illustrates the lane arrangements at study area intersections.

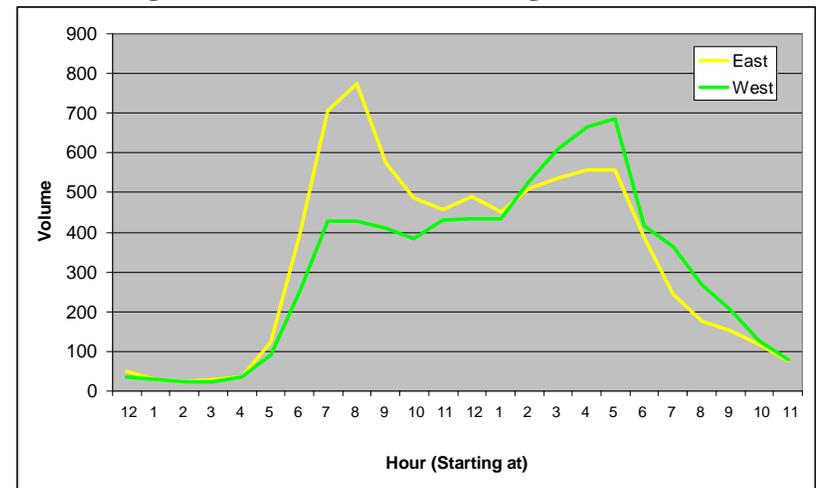
**Figure 5: Traffic Volume along I-587**

Traffic data provided by NYSDOT was recorded on I-587 east of Sawkill Road in September 2009. Daily traffic volume is approximately 15,300 vehicles. The data indicates that traffic on I-587 peaks in the eastbound direction between 8:00 and 9:00 AM and in the westbound direction between 5:00 and

6:00 PM. Figure 5 illustrates the traffic volume along I-587 by time of day.

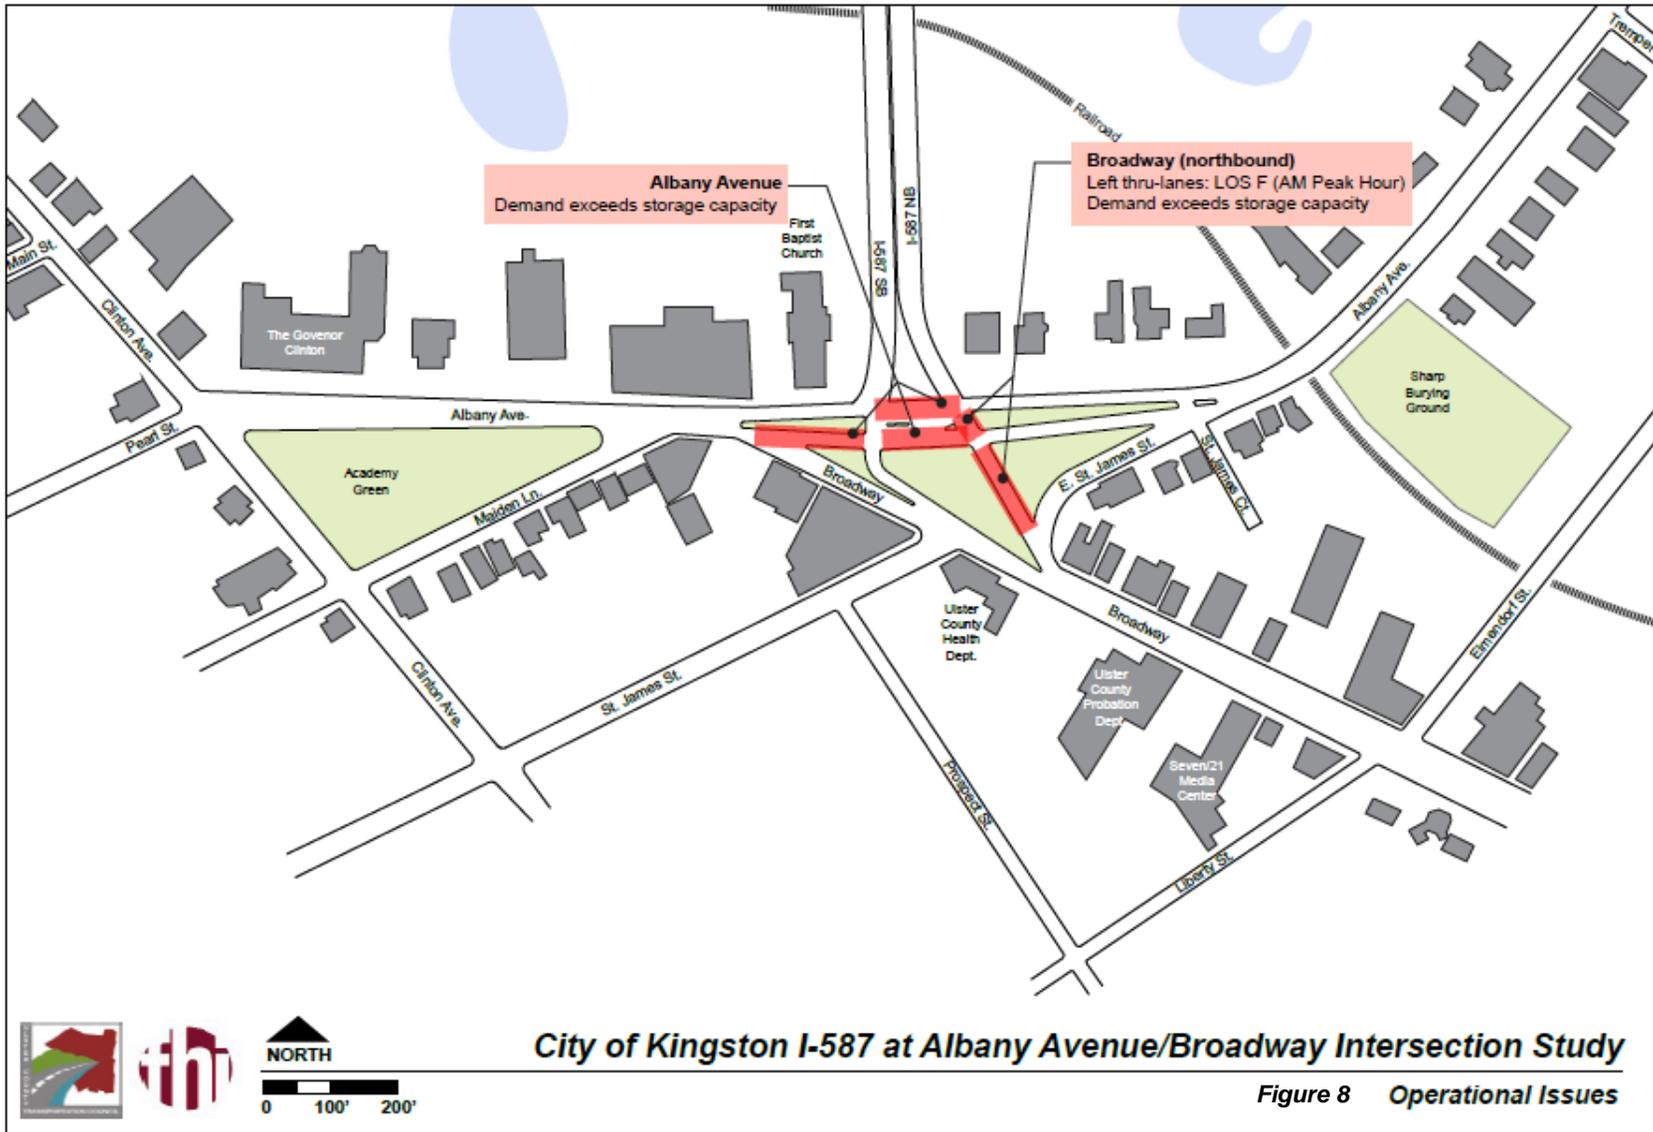
Figure 8 illustrates the segments of road where queued vehicles exceed available storage capacity. The result of vehicles spilling out beyond the lanes in which they are assigned is a blockage of adjacent lanes and intersections. When vehicle flow is blocked, the entire system of intersections can fail, even if there is sufficient capacity of each individual intersection to handle the demand.

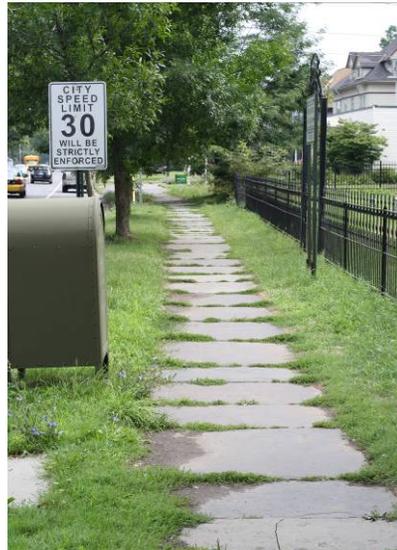
*Sidewalk on Albany Avenue*

Perhaps the single greatest deficiency of the sidewalk network is not the gaps mentioned above but rather the maintenance of the surfaces themselves. In the study area, the sidewalks are

composed of various materials including concrete, bluestone, pavers, and asphalt. Much of the sidewalk network is overgrown with weeds and grass and sections of bluestone and asphalt are raised from tree roots. These uneven and cluttered surfaces provide additional obstacles for pedestrians, especially those with disabilities or pushing strollers. At the August 2010 field visit, the FHI team observed a person in a wheelchair scooter traveling on the Clinton Avenue roadway, where there is significant motor vehicle traffic, rather than on the bumpy, disjointed sidewalk.

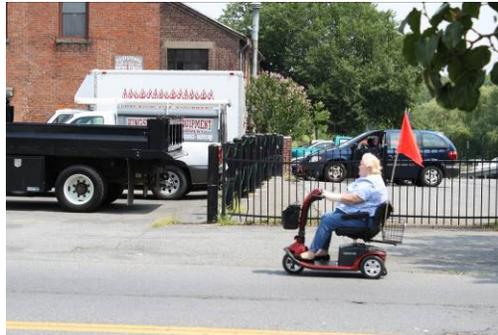
*Person riding in the roadway on Clinton Avenue*

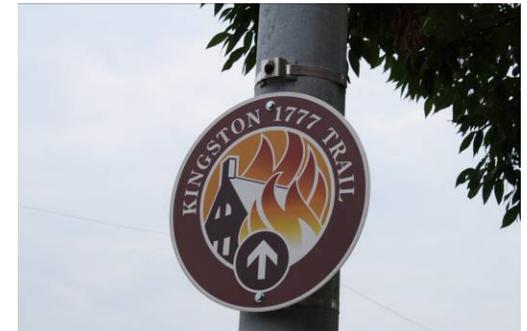
*Kingston 1777 Trail Sign*

In addition, there are a number of Kingston 1777 trail markers along the roadways in the study area. This on-road, interpretive, and recreational trail directs users who want to walk, bike or drive the path taken by British troops when they burned Kingston in 1777.

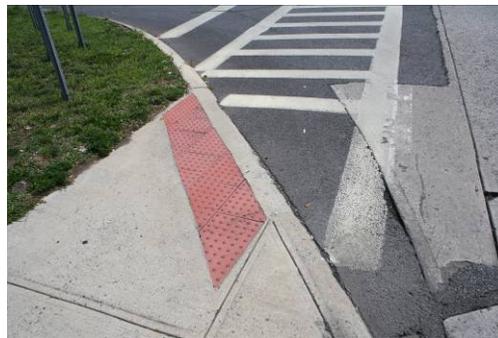
*Detectible warning surface at Albany Avenue and I-587 intersection*

The study area is extremely difficult for the blind or visually challenged to navigate. Very few of the signalized intersections have detectible warning surfaces on the ramps. Only the signalized intersection of Albany Avenue and the I-587 southbound ramp has such a feature. In addition, there is a detectible warning surface ramp at the intersection of Clinton Avenue and Main Street. There are no audible pedestrian signals in the corridor.

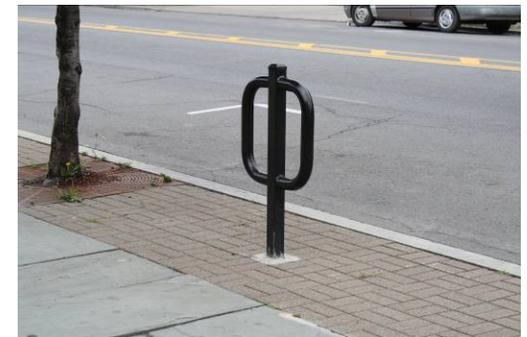
*Bicycle rack on Broadway*

As stated in the Pedestrian Facilities section, the I-587 study area has a number of streets that function as complete streets, in that they are shared by all users. Motorists, truck drivers, bus transit users, pedestrians, and bicyclists utilize these travel corridors to access various destinations within and outside the study area, such as retail, restaurants, transit stops, and other community facilities. In particular, the study team observed a large number of bicyclists on Albany Avenue and Broadway. Bicyclists appeared to be using their bicycles as a form of transportation, and only a few appeared to be recreational cycling. In addition, there are numerous bicycle racks on the sidewalks along Broadway.

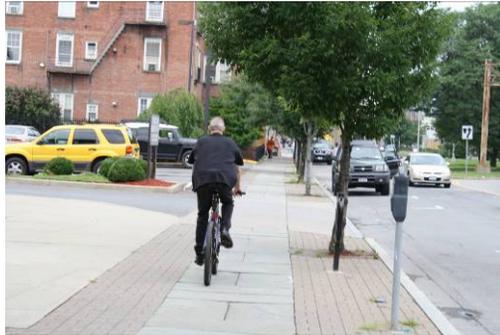
*Bicyclist on sidewalk*

This is likely because of a number of factors including the high traffic volumes, the large percentage of truck traffic, and narrow lanes in the study area, as well as bicyclist and motorist education. Bicycle riding on the sidewalk is a hazard not only to the bicyclist as motorists do not

expect to find them in crosswalks, but also to pedestrians who do not expect to be overtaken by the bicyclists from behind. As on all roadways, bicyclists should ride with traffic in the rightmost lane that serves their destination. In addition, very few cyclists were observed wearing helmets.

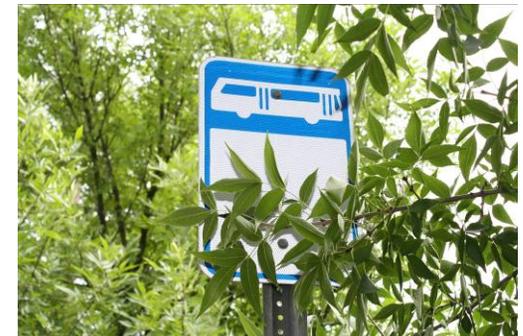
*Bus route sign on Albany Avenue*

Route A provides regular service along Broadway, and on portions of Clinton Avenue, Pearl Street, and Main Street in the study area. Route B provides regular service along Albany Avenue and Clinton Avenue in the study area. There is a signed Route B bus stop on westbound Albany Avenue at Tremper Avenue. This bus drops off and picks up at 20 minutes after each hour during operating hours. Route C provides regular service along Albany Avenue, Clinton Avenue, and Pearl Street in the study area. There is a signed bus stop on eastbound Albany Avenue at the cemetery between Broadway and Tremper Avenue. This bus drops off and picks up at 50 minutes after each hour during operating hours. During the field visit, it was observed that this sign was obstructed by the branches of a large tree and the bus route is not identified on the sign.

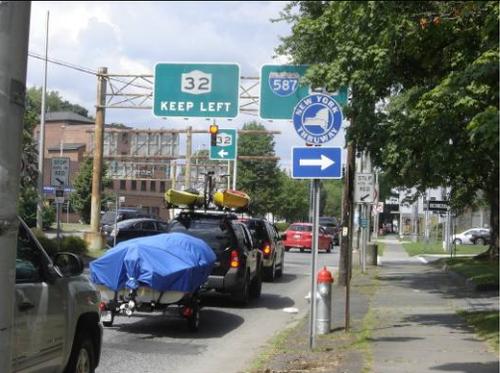
<p>Intersection of I-587, Albany and Broadway</p>	<p>Within the intersection, the views are shortened by the signage and infrastructure that surround this area. The views are dominated by roadway pavement and signage. These urban elements contrast the landscaped Academy Green that forms a triangle among the varied roadway segments.</p>
