APPENDIX A – EXISTING CONDITIONS AND PROPOSED PLANS

GENERAL PLANS

APPENDIX B – ENVIRONMENTAL INFORMATION

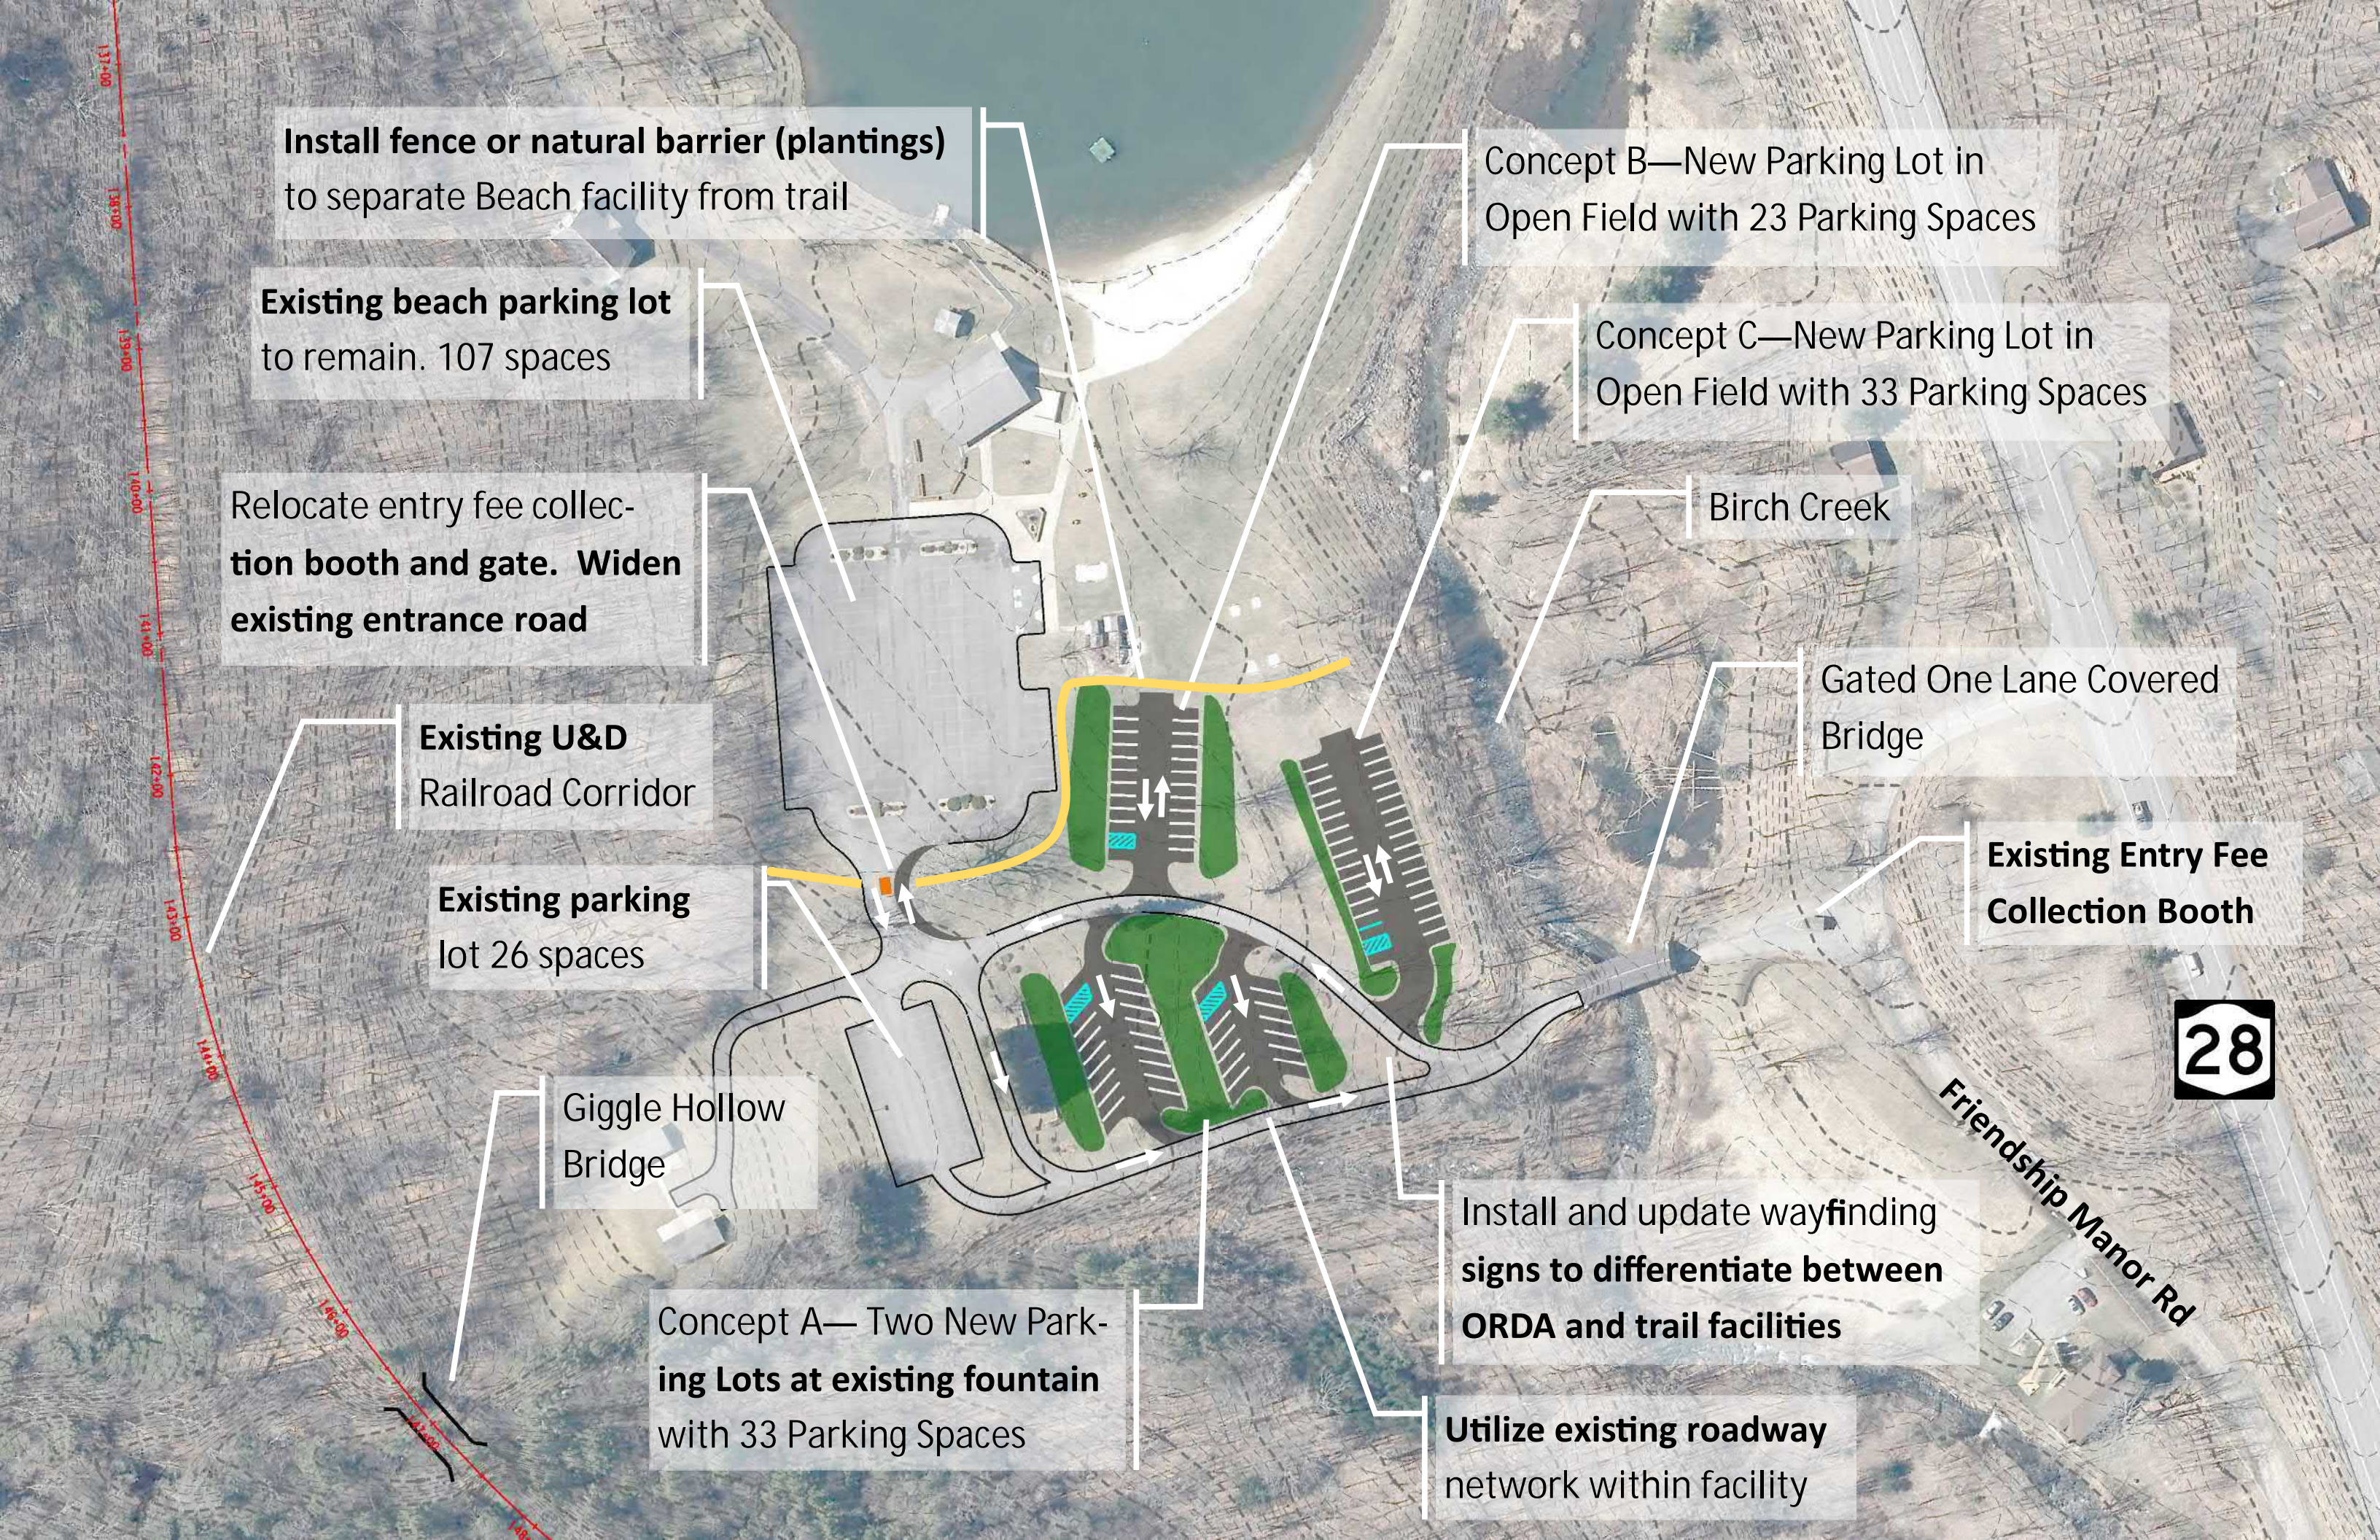
Install fence or natural barrier (plantings)
to separate Beach facility from trail

Relocate entry fee collec-
tion booth and gate. Widen
existing entrance road

Concept A— Two New Park-
ing Lots at existing fountain
with 33 Parking Spaces

Concept B—New Parking Lot in
Open Field with 23 Parking Spaces

Concept C—New Parking Lot in
Open Field with 33 Parking Spaces

Install and update wayfinding
signs to differentiate between
ORDA and trail facilities

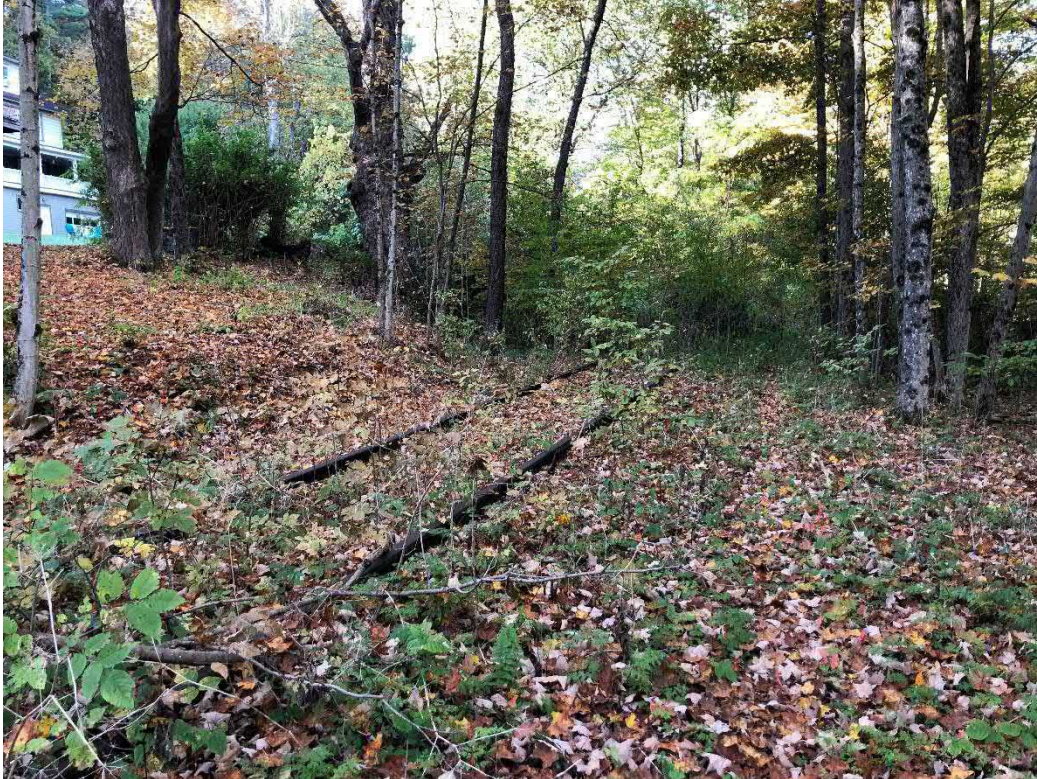
Photo 6. Existing abandoned rail.

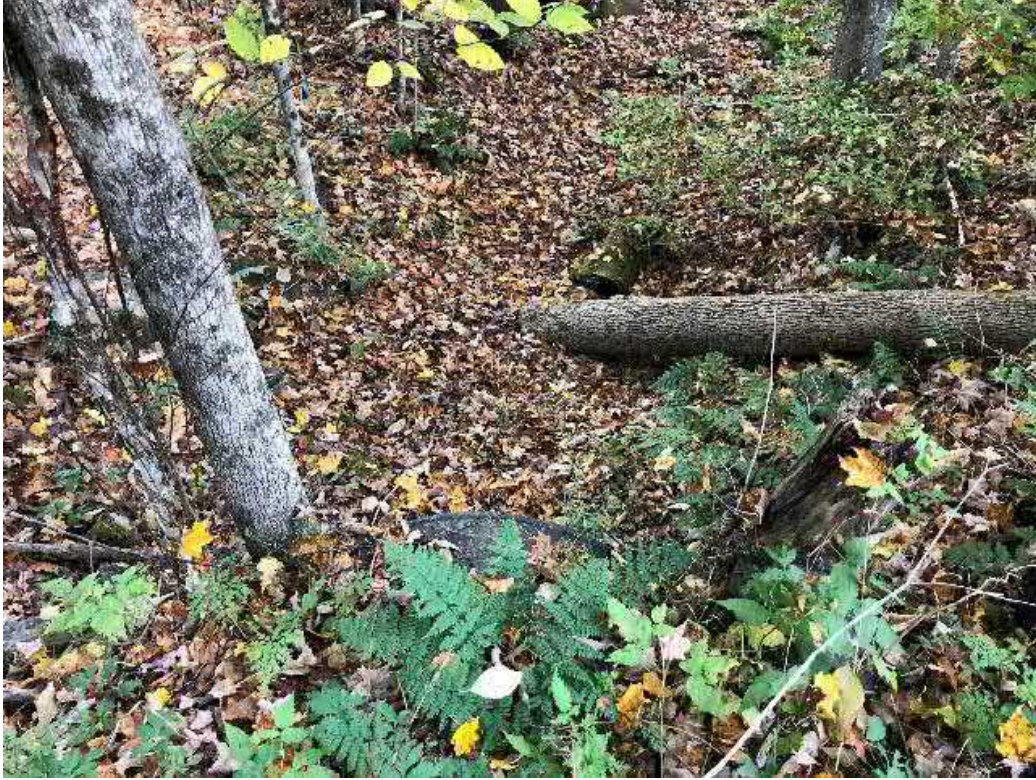
Photo 7. Steel pipe culvert under rail – no evidence of hydrology/stream, inlets or outlets identified.

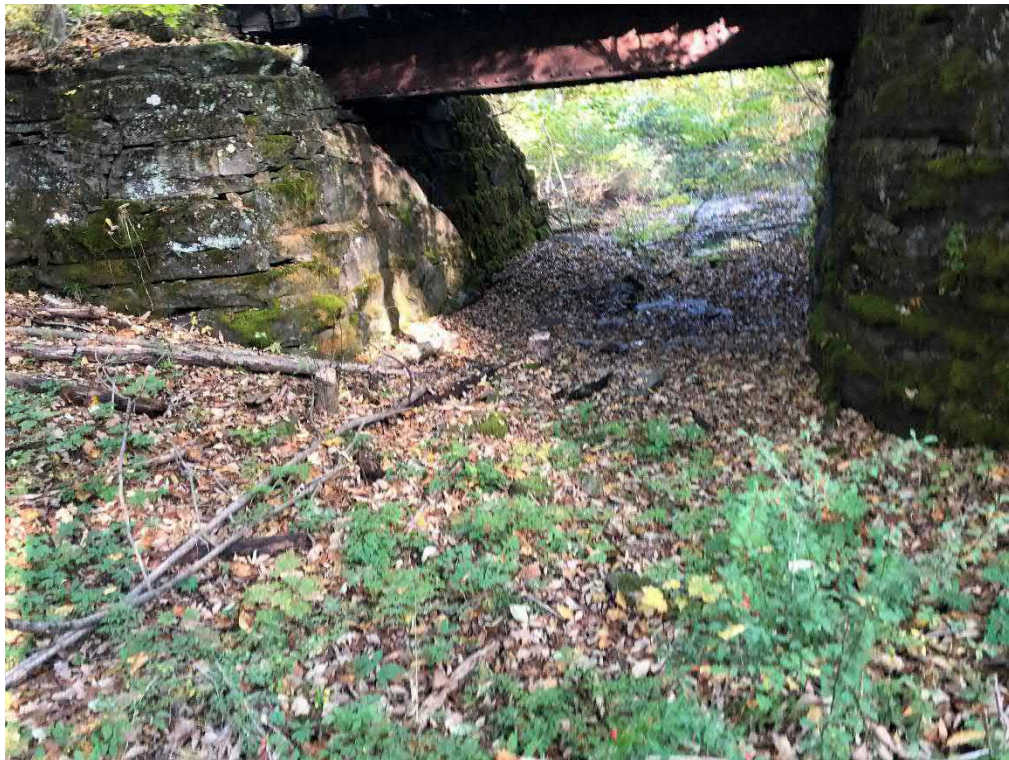
Photo 8. Old cattle crossing/access road. Water is pooled 20 feet north of structure in depression – no stream features or hydrologic connections observed.

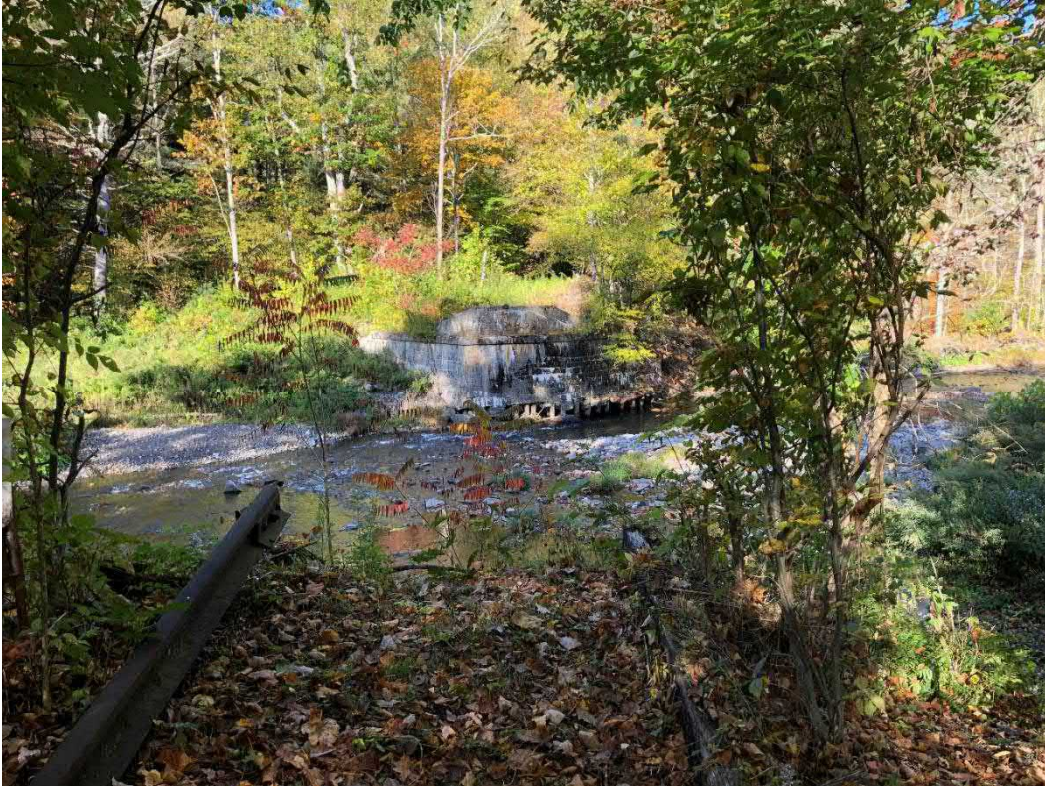
Photo 9. Esopus Creek bridge crossing; structure to be replaced.

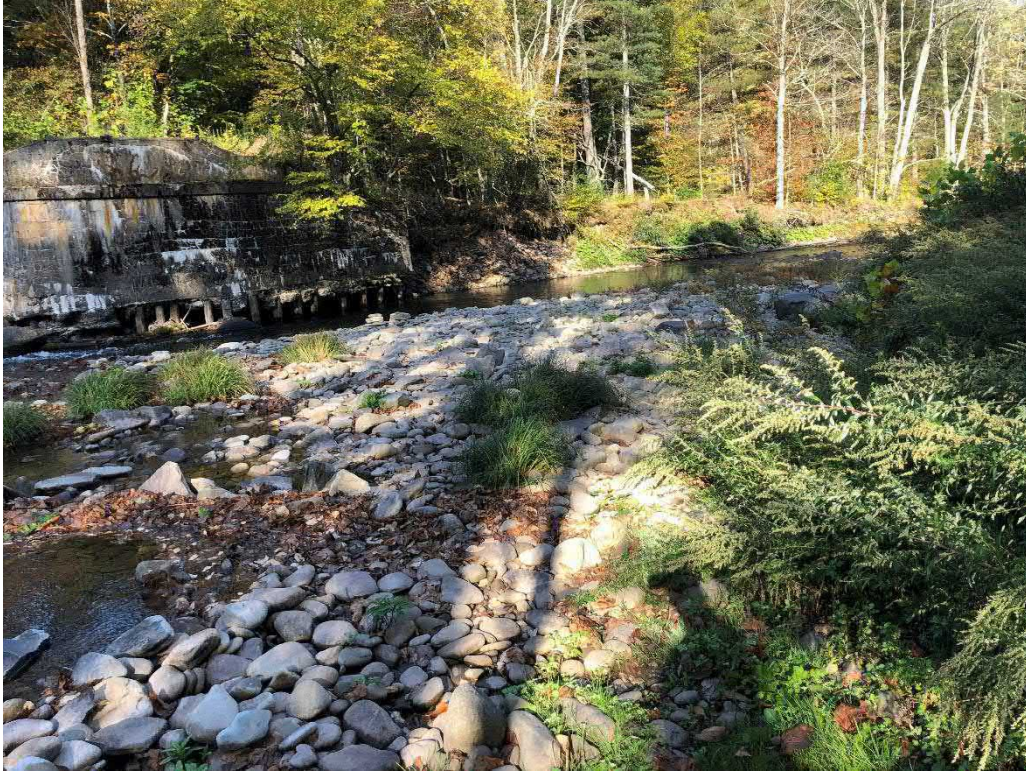
Photo 11. Remains of former railroad bridge over Espous Creek.

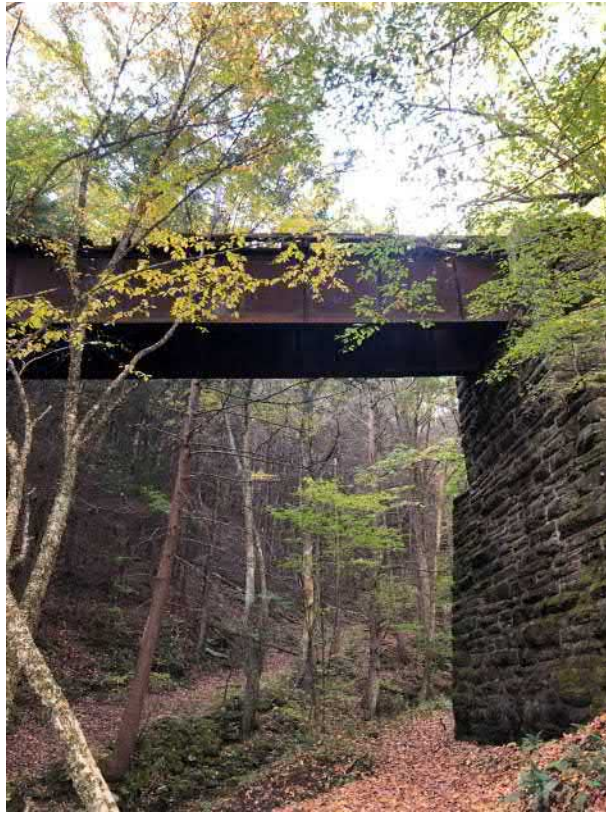
Photo 15. Railroad bridge crossing Giggle Hollow Brook (Stream 8).

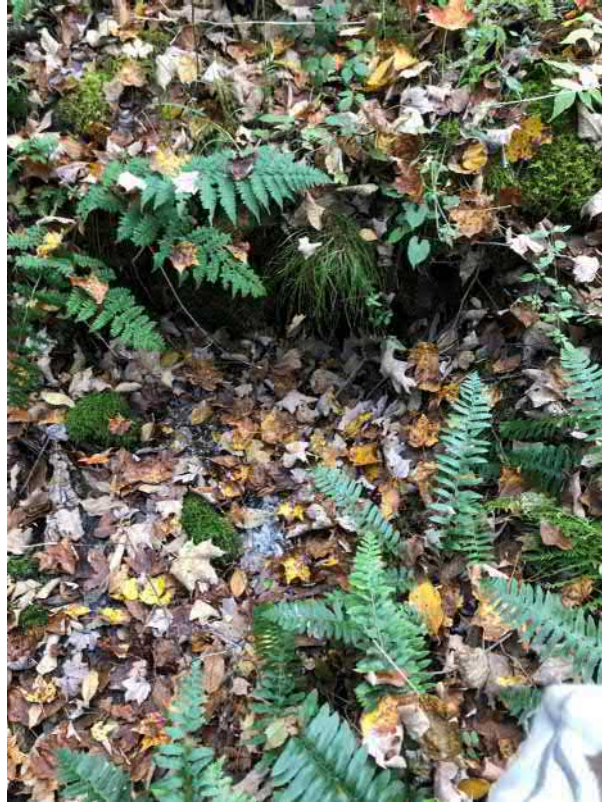
Photo 19. Stream 9 – leaf clogged culvert inhibiting flow.

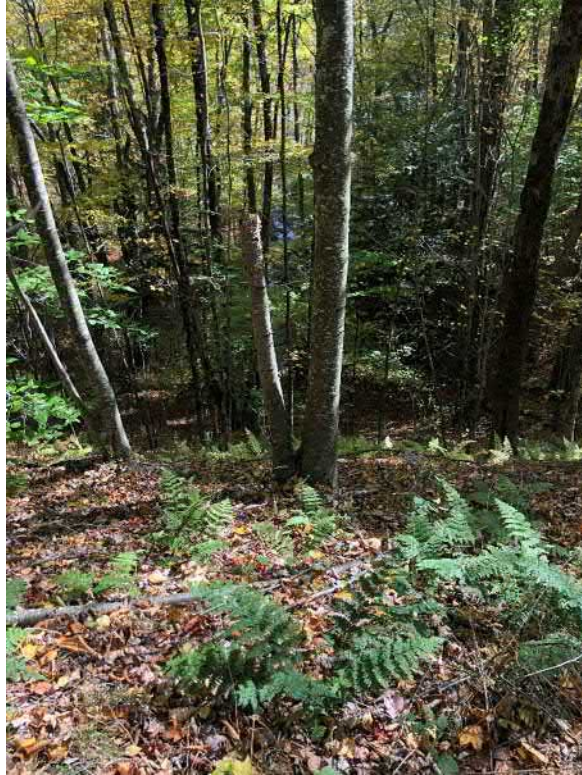
Photo 27. Stream 2, looking southeast from top of culvert crossing.

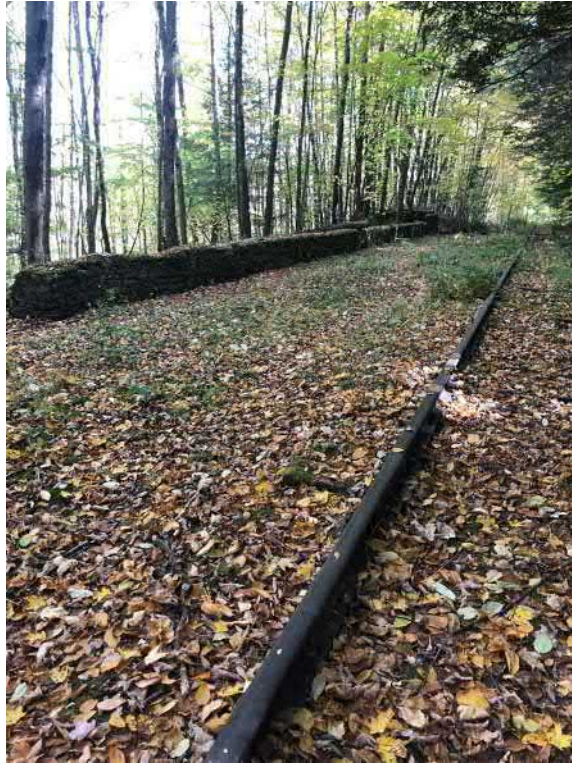
Photo 33. Remains of old mill along tracks to be preserved.

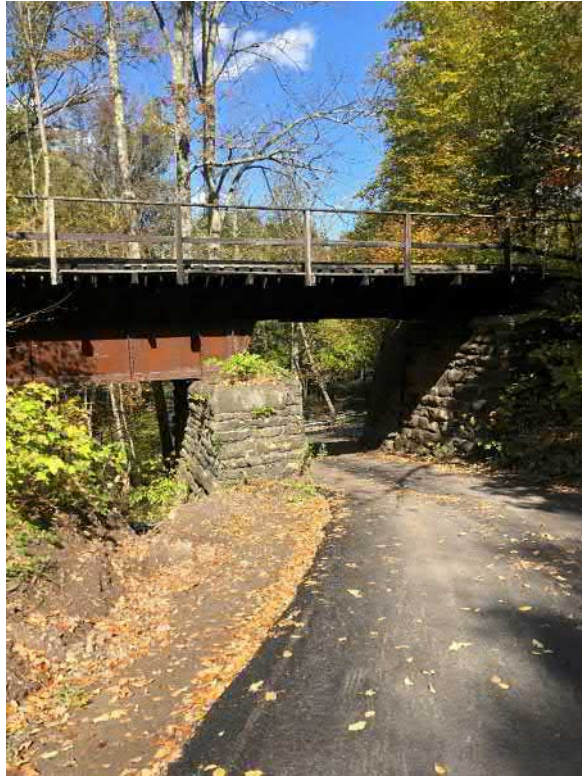
Photo 35. Railroad bridge over Stream 5 (to left) and Mill Street.

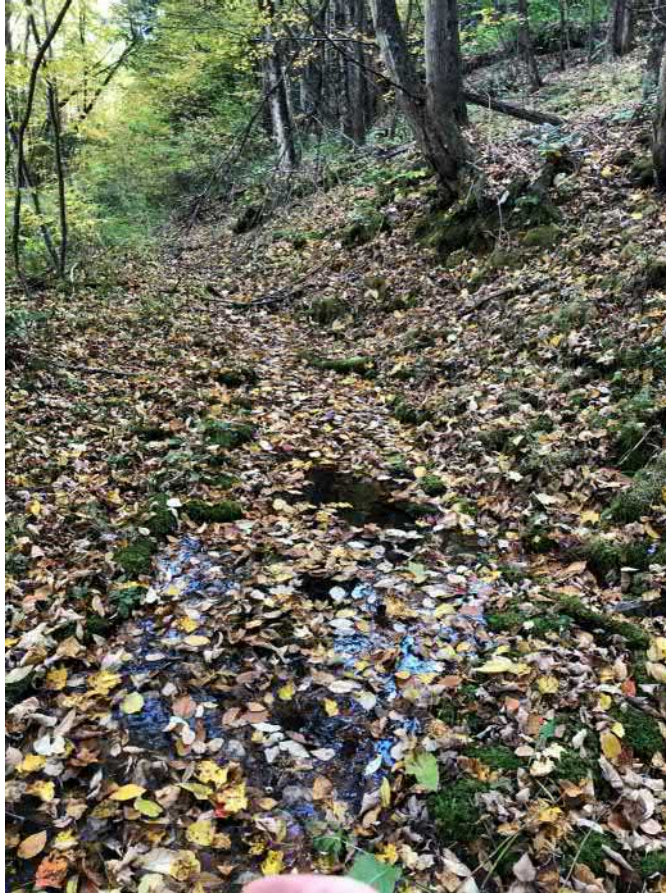
Photo 37. Stream 6 looking north from culvert outlet.
