Attachment C –SWPPP

Appendix S
NYS DEC Permit

Facility:
ASHOKAN RAIL TRAIL
BASIN RD TO RTE 28A
HURLEY, NY 12443

Project Location: Ulster Delaware Railroad corridor - Wetland AS-19 (II) & Wetland AS-20 (III)

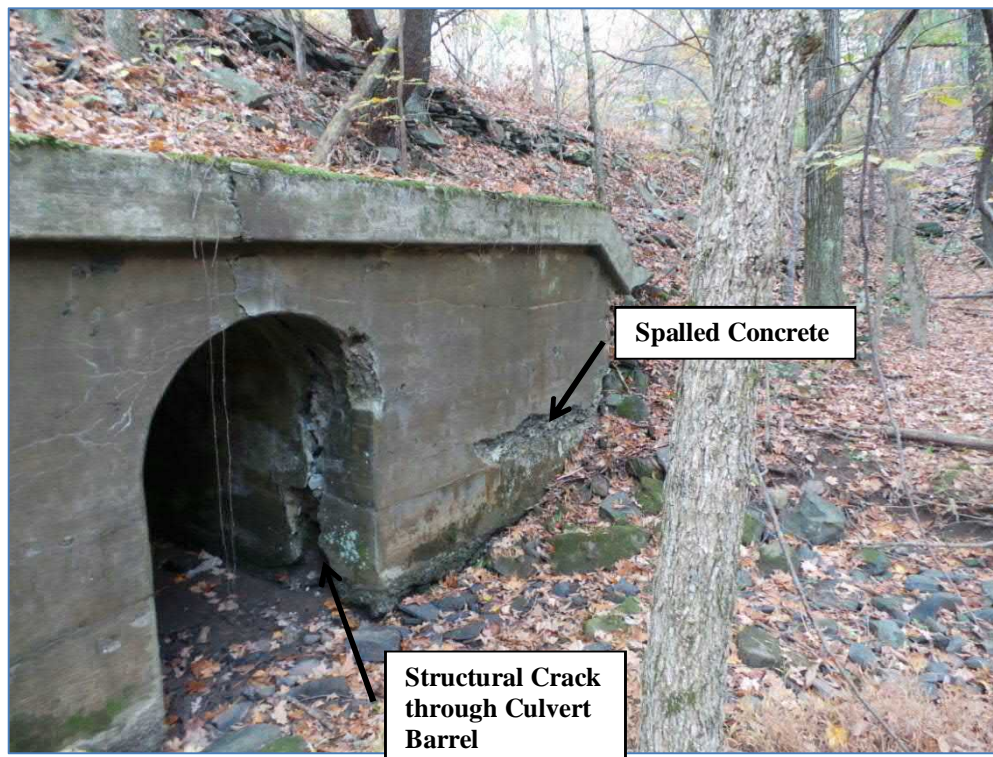
General View of Existing Deterioration: Culvert #3

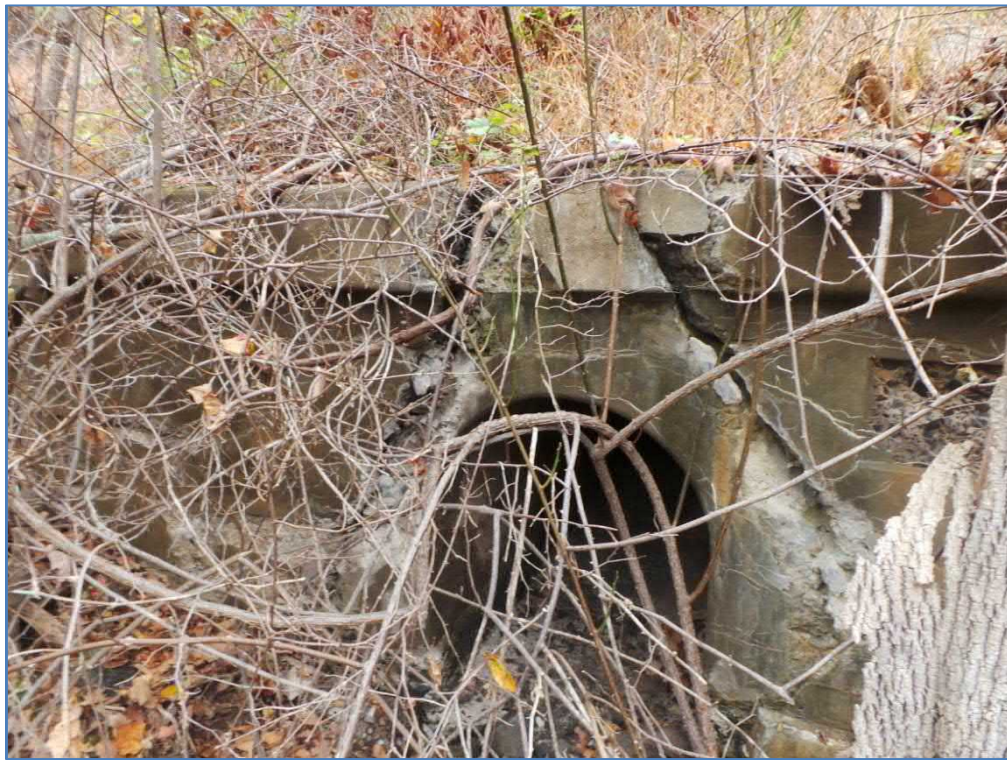
Downstream Culvert Elevation and Deterioration: Culvert #4

The repair location is directly over the open area for flows so depending on stream flows during the time of work, multiple adjustments may be required to the temporary waterway diversion structure to ensure work is completed and dry ground and stream flows are diverted as best as possible, while still allowing for passage of flows and aquatic organisms. The length of the diversion structure is estimated to be 30 linear feet in total, 10 feet into the culvert and 20 feet extending from the fascia. Assuming two placements of the diversion structure results in 60 linear feet of temporary impacts. All stone fill will be placed below OHWM resulting in approximately 40 linear feet (10 linear feet, 2 banks, 2 ends) and a total of 4 cubic yards.

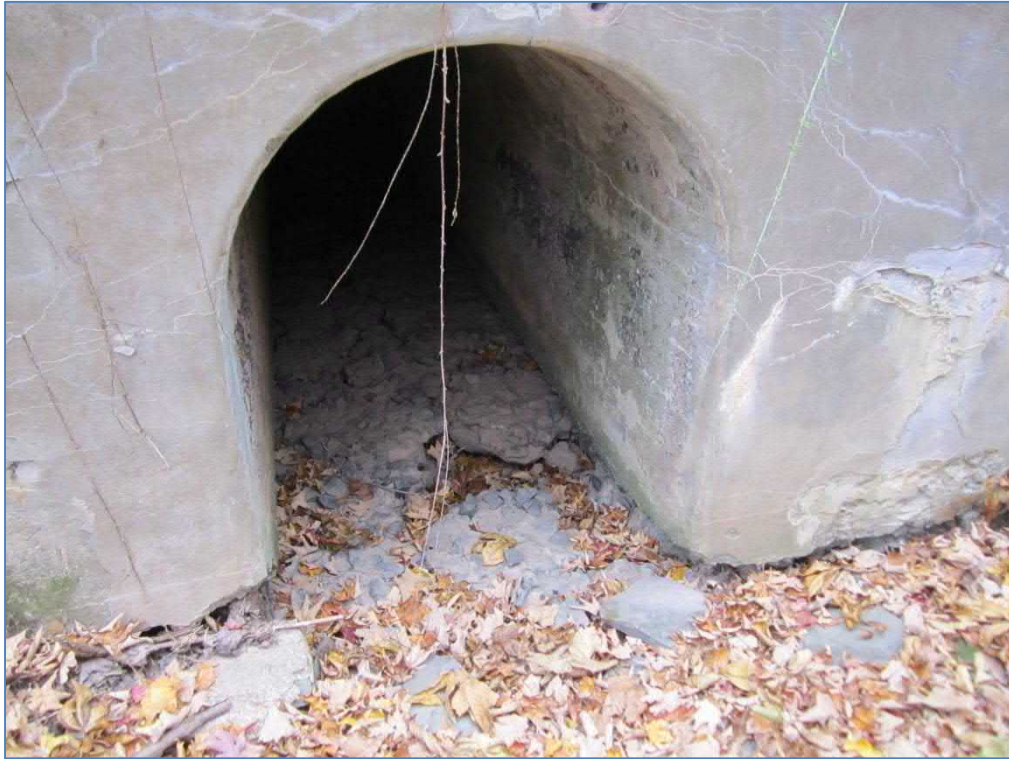
View of Upstream Scour at Concrete Bottom Slab: Culvert #4

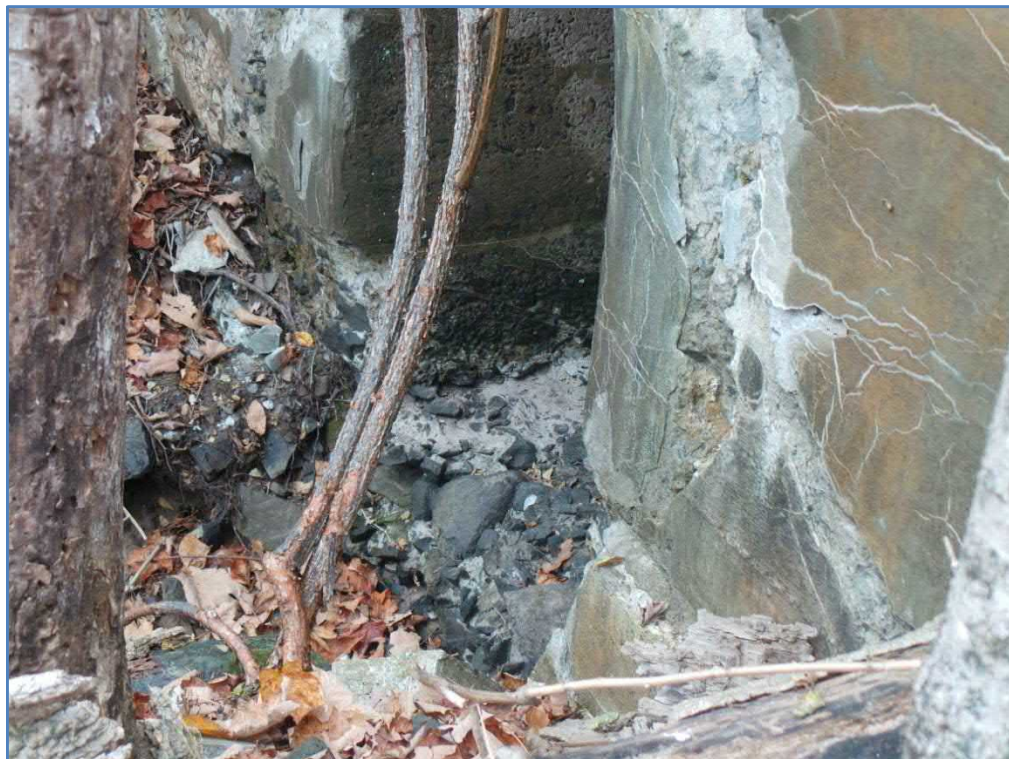
View of Scour at Downstream Culvert Fascia: Culvert #4

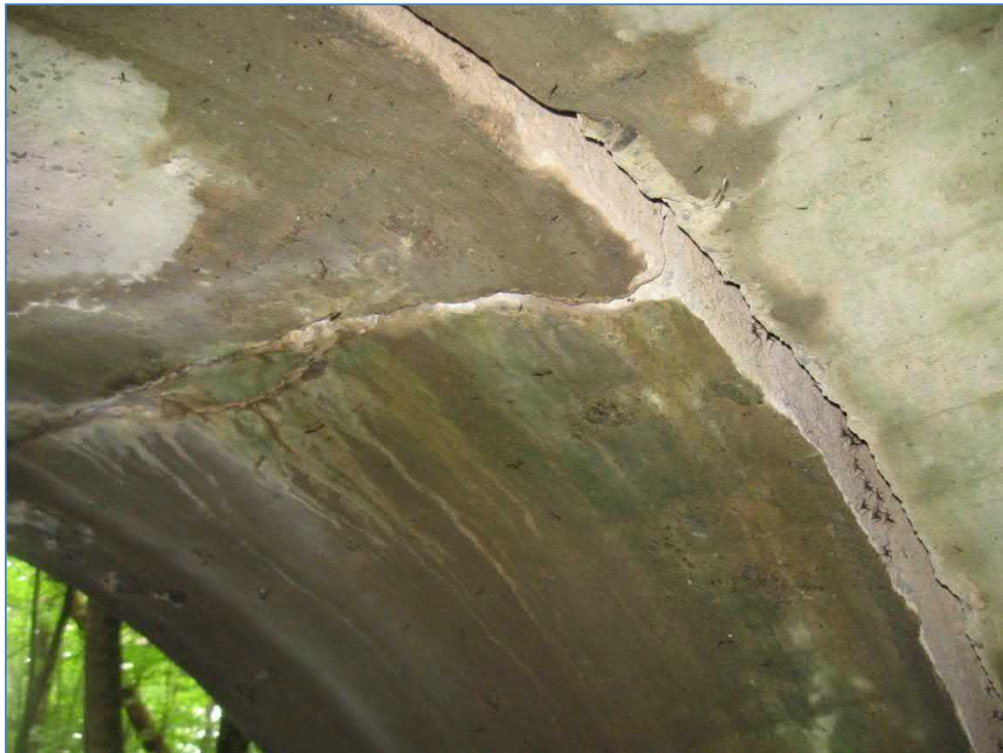
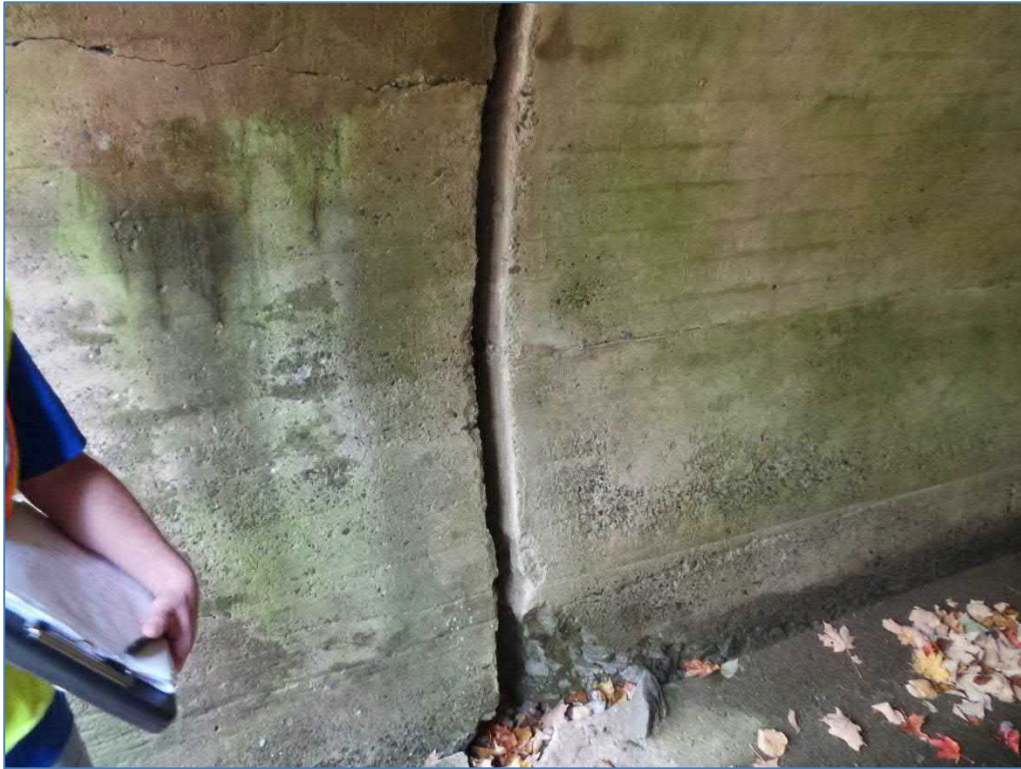
Crack in Culvert Barrel: Culvert #5

each end, plus 10 feet into culvert for structural crack repair, 2 total placements). All stone fill to be placed at the culvert will be below OHWM resulting in approximately 24 linear feet (12 linear feet, 2 banks) and a total of 10 cubic yards.

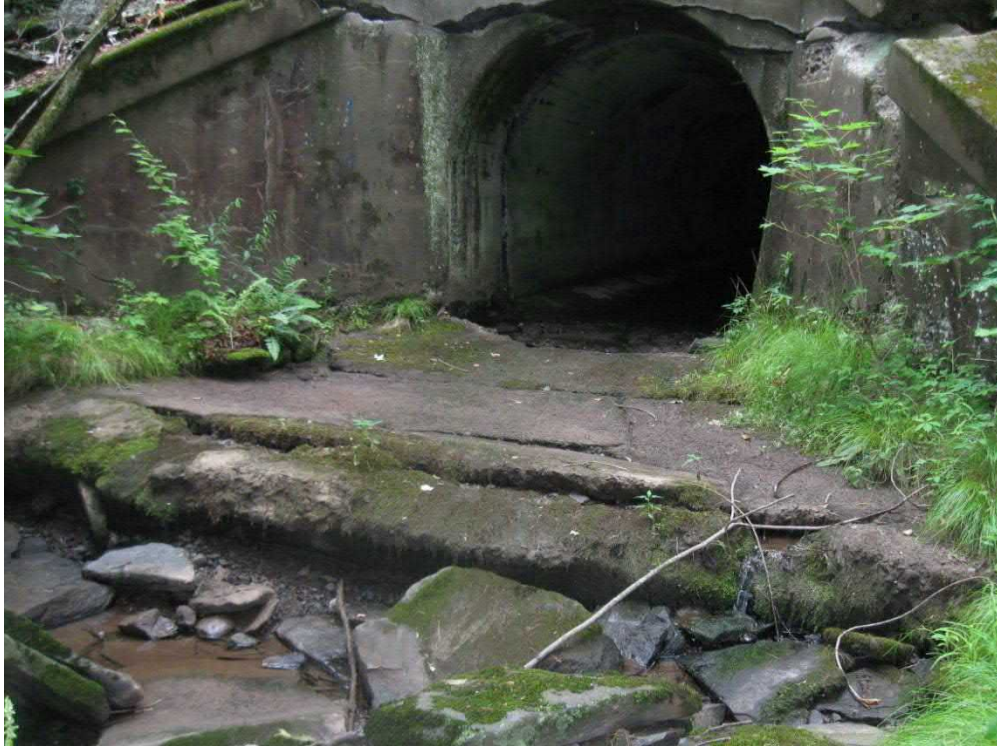
Scour/Erosion at Downstream Wingwall Apron: Culvert #7

The total linear feet of temporary impacts due to diversion below OHWL is estimated to be 100 linear feet (20 foot length at each end, plus 10 feet into culvert for structural crack repair, 2 total placements). All stone fill to be placed at the culvert will be below OHWL resulting in approximately 20 linear feet (10 linear feet, 2 banks) and a total of 20 cubic yards.

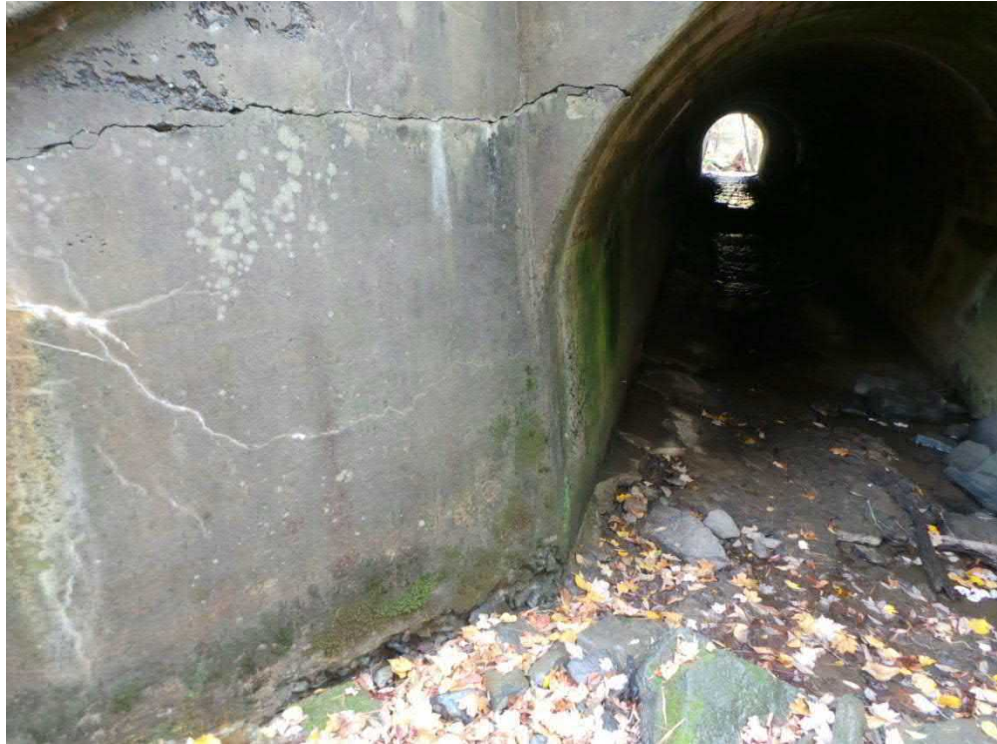
Silicone Crack Sealing Location at Upstream Wingwalls: Culvert #7

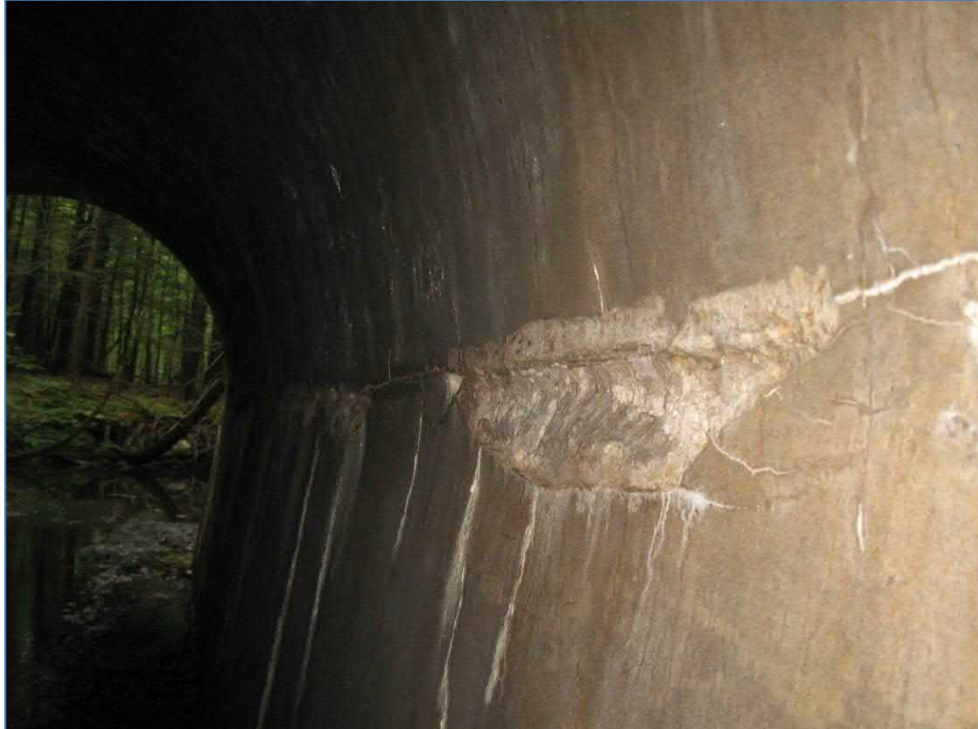
Spalled Concrete Inside Culvert Barrel: Culvert #12

The total linear feet of temporary impacts below OHWM is estimated to be 120 linear feet (20 foot length at each end, plus 20 feet into culvert for Class D concrete repairs, 2 total placements) for the cofferdams. There are no proposed placements of fill below OHWM.

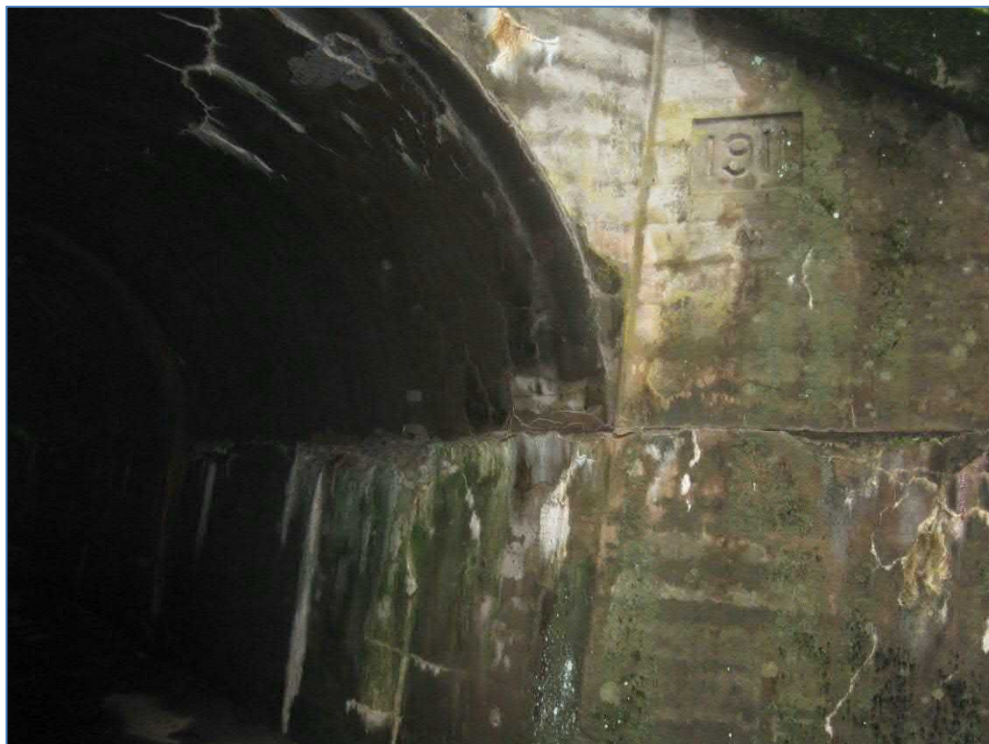
Cracked Concrete at Wingwalls: Culvert #12

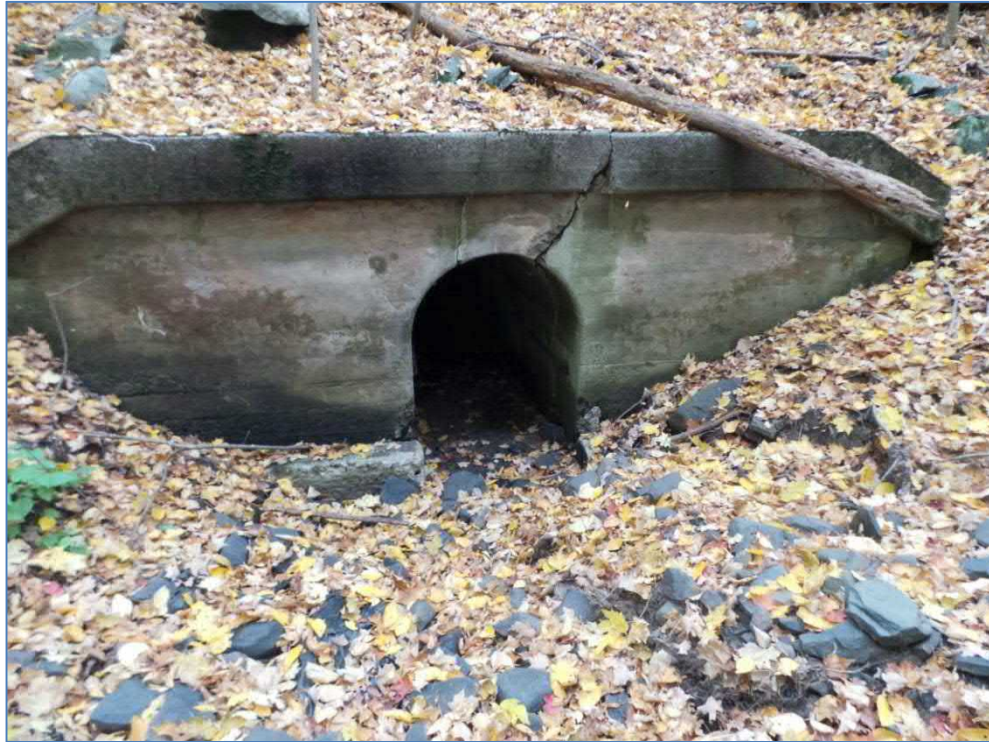
Upstream Culvert Elevation, Showing Existing Cracks: Culvert #19

It is anticipated that the crack repairs can be completed using one waterway diversion while the stone fill installation will require two waterway diversion placements. As such, the total linear feet of temporary impacts below OHWM is estimated to be 50 linear feet (10 feet for crack repair, 20 feet for stone fill with 2 placements). All stone fill to be placed at the culvert will be below OHWM resulting in permanent stream disturbance of approximately 20 linear feet (10 linear feet, 2 banks) and a total of 5 cubic yards.

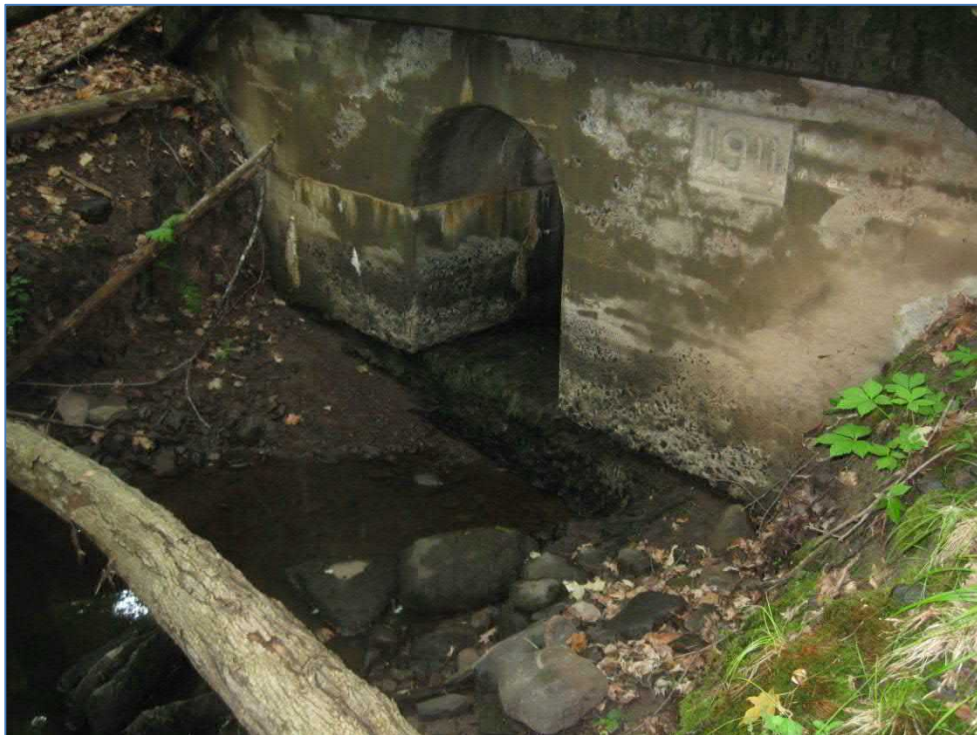
Downstream Culvert Elevation, Showing Scour and Erosion: Culvert #19

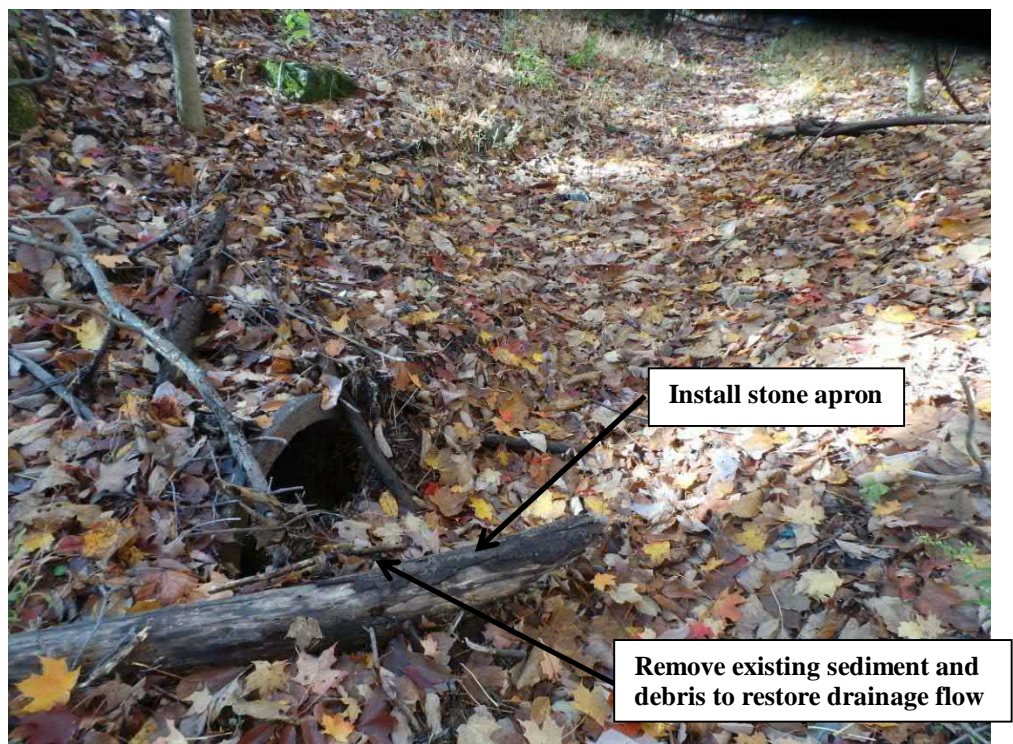
Upstream Culvert Invert conditions: Culvert #21

It is anticipated that repairs will be completed in less than one day of work which will result in minimal impacts to the stream. As such, the total linear feet of temporary impacts below OHWM is estimated to be 30 linear feet (15 foot length at each end for temporary waterway diversion, 2 total placements). The total linear feet of permanent impacts to the stream below OHWM is 24 ft. (6 feet at both the inlet and outlet of the culvert, on both stream banks) and 3.7 cubic yards of permanent fill is proposed to be placed.

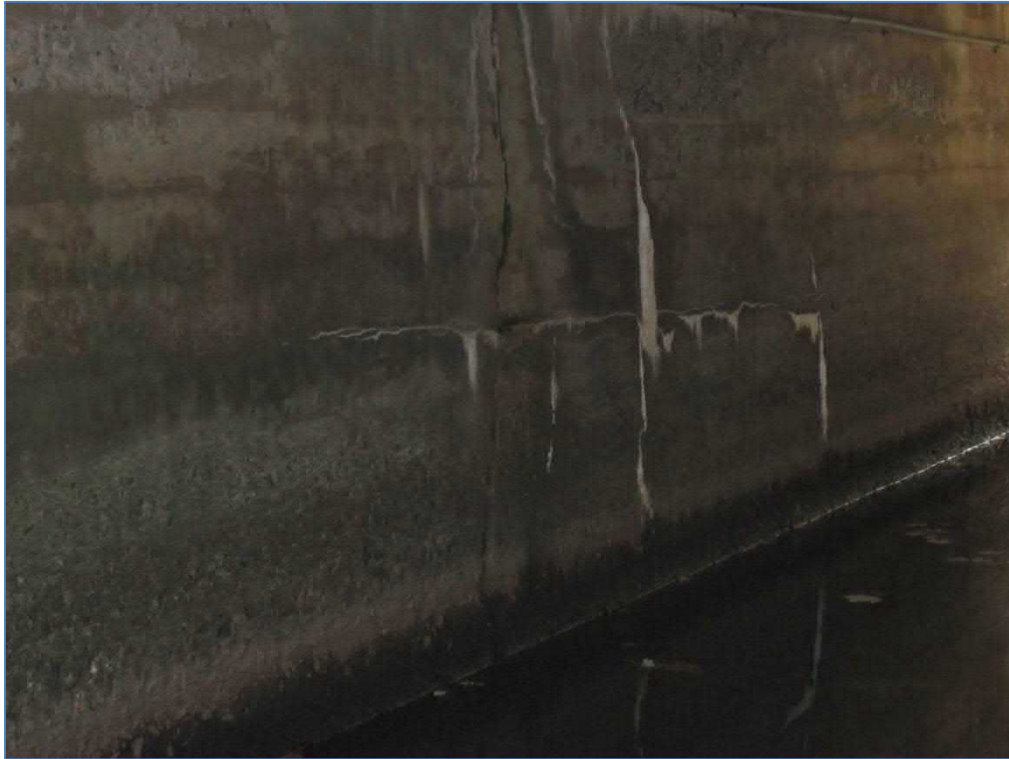
Cracks in Vertical Wall of Culvert: Culvert #22

The total linear feet of temporary impacts below OHWM is estimated to be 100 linear feet (10 feet at each end, 30 foot total length of culvert, 2 placements) due to the diversion. There are no proposed placements of fill below OHWM.

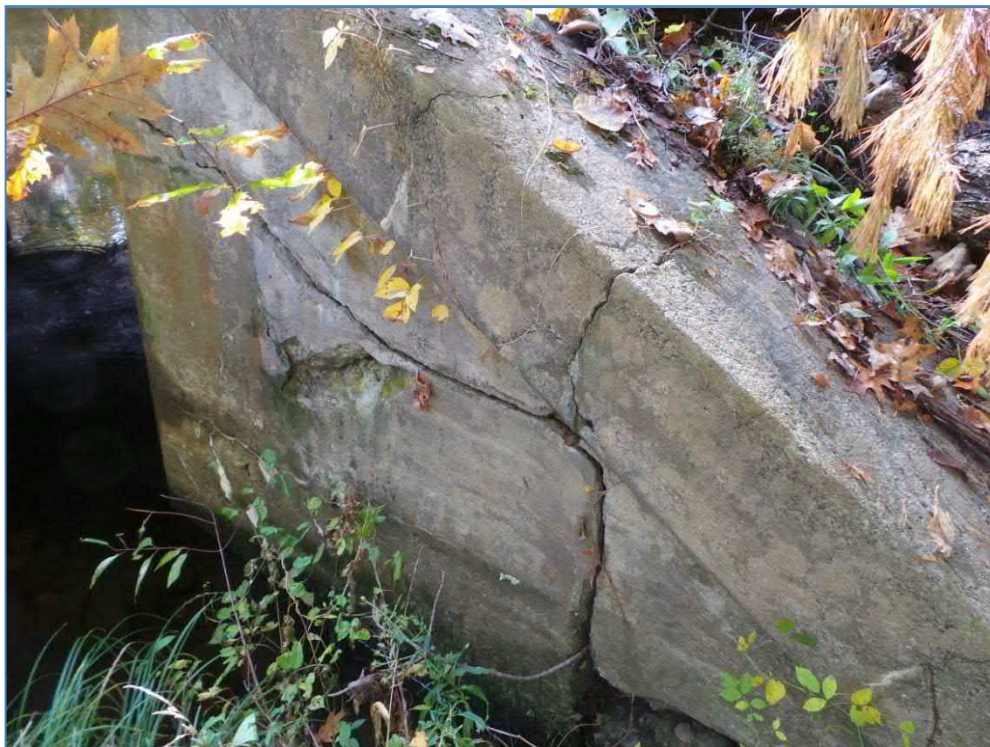
Cracks in Wingwall: Culvert #22

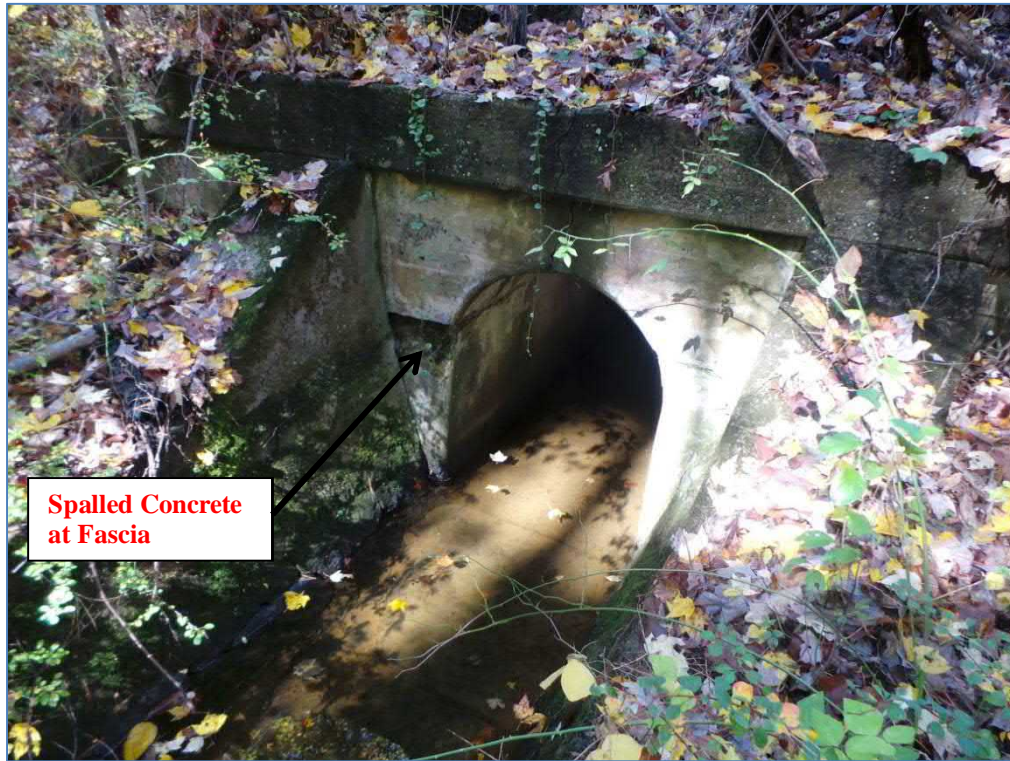
**Spalled Concrete
at Fascia**

Downstream Culvert Fascia: Culvert #23

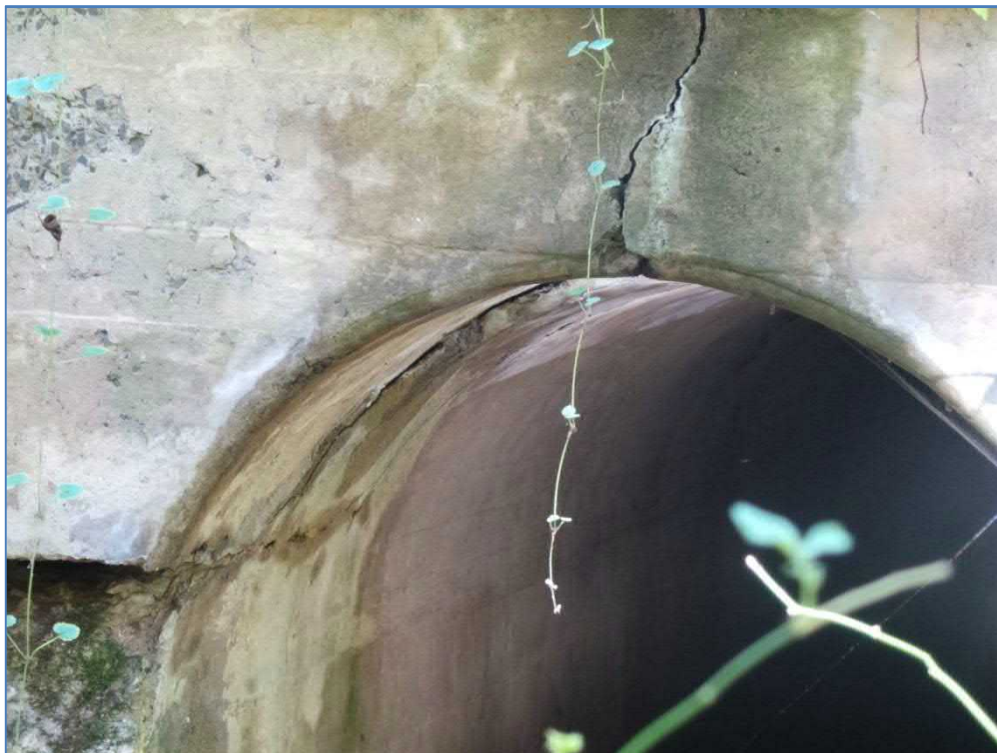
Downstream Culvert Fascia, Showing Cracks in Headwall: Culvert #23

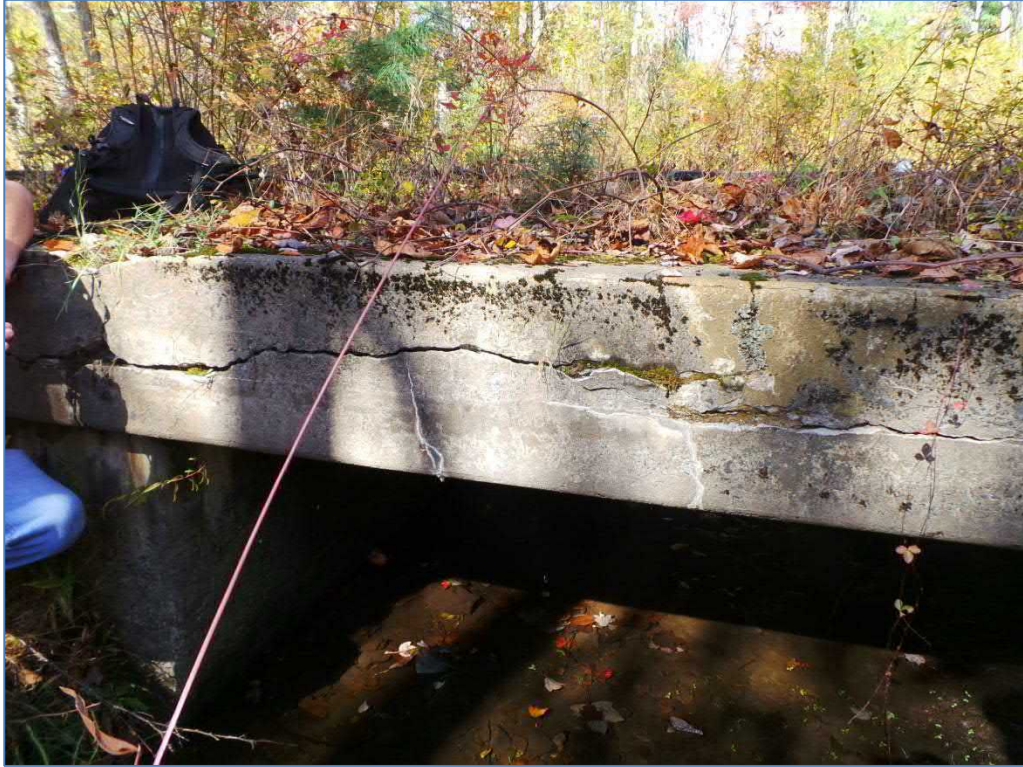
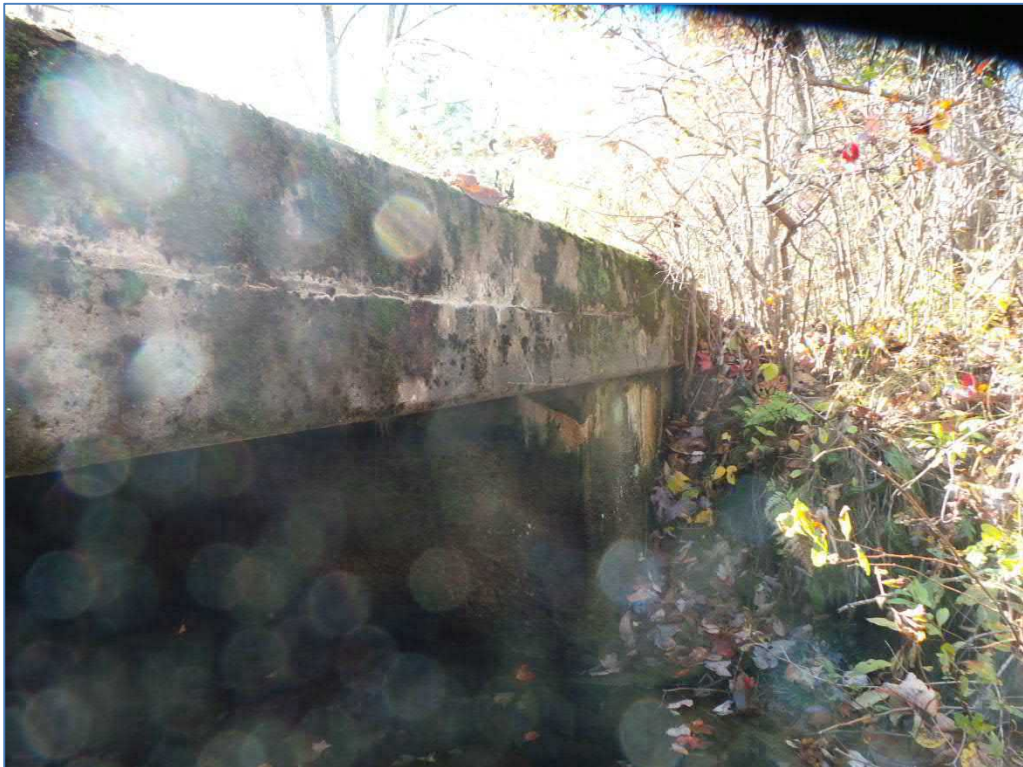
Cracks in Concrete Headwall: Culvert #24

The total linear feet of temporary impacts below OHWM is estimated to be 40 linear feet (10 feet at each end, 2 placements) due to the diversion. There are no proposed placements of fill below OHWM.

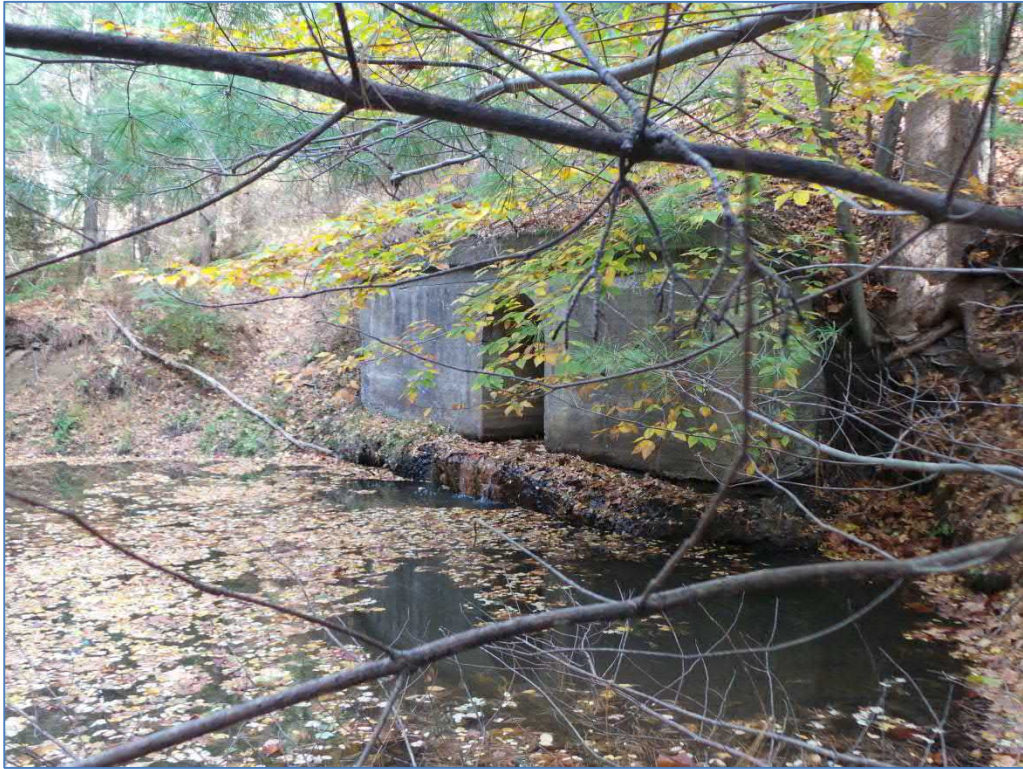
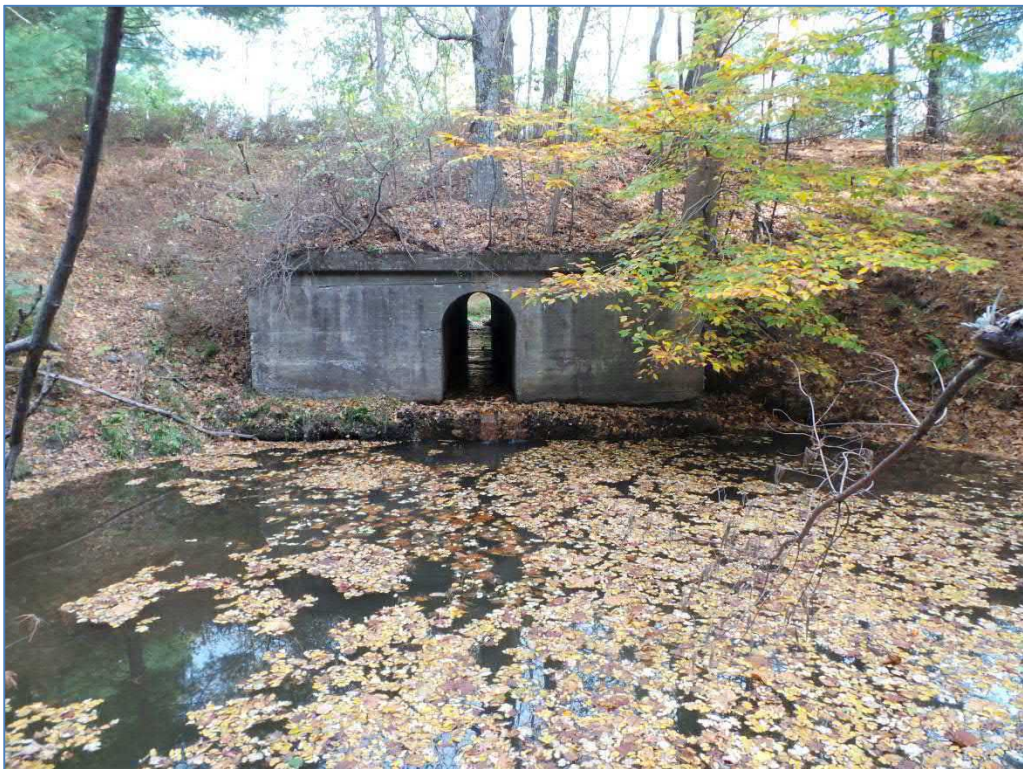
Downstream Culvert Fascia, Showing Drop Off to Stream Bed: Culvert #29

The total linear feet of temporary impacts below OHWM is estimated to be 40 linear feet (20 foot length at downstream end, 2 total placements) due to the diversion. All stone fill to be placed at the culvert will be below OHWM. Therefore, the permanent stream disturbance below OHWM is approximately 20 linear feet (10 linear feet, 2 banks) and a total of 40 cubic yards.

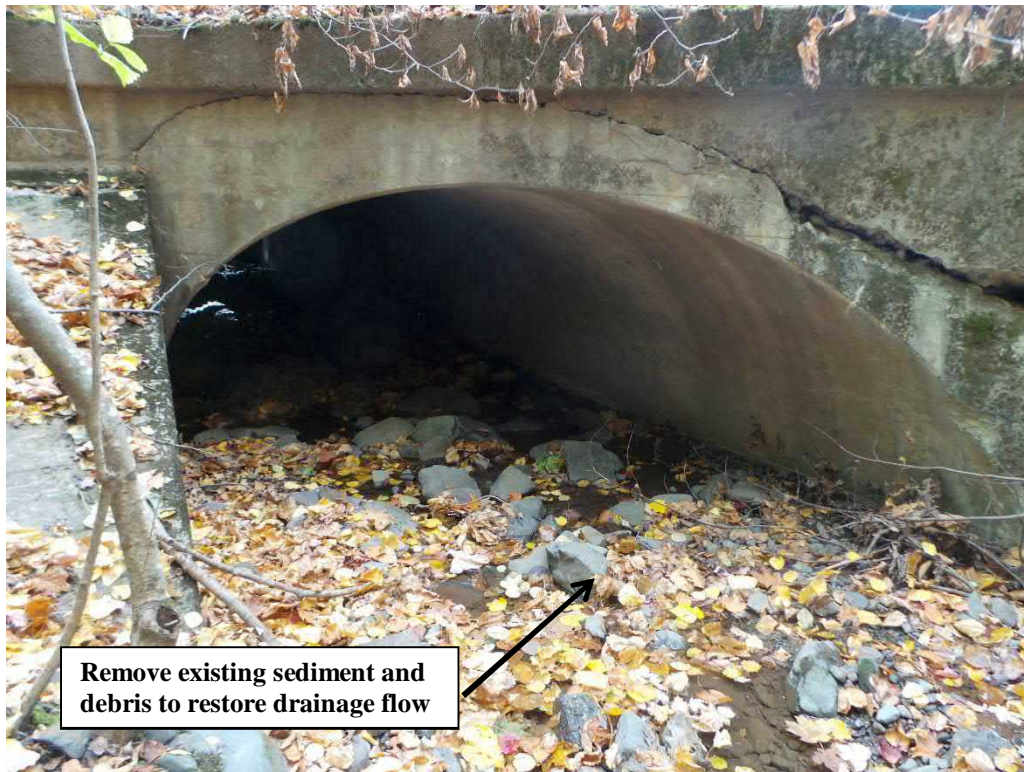
Upstream Invert conditions: Culvert #36

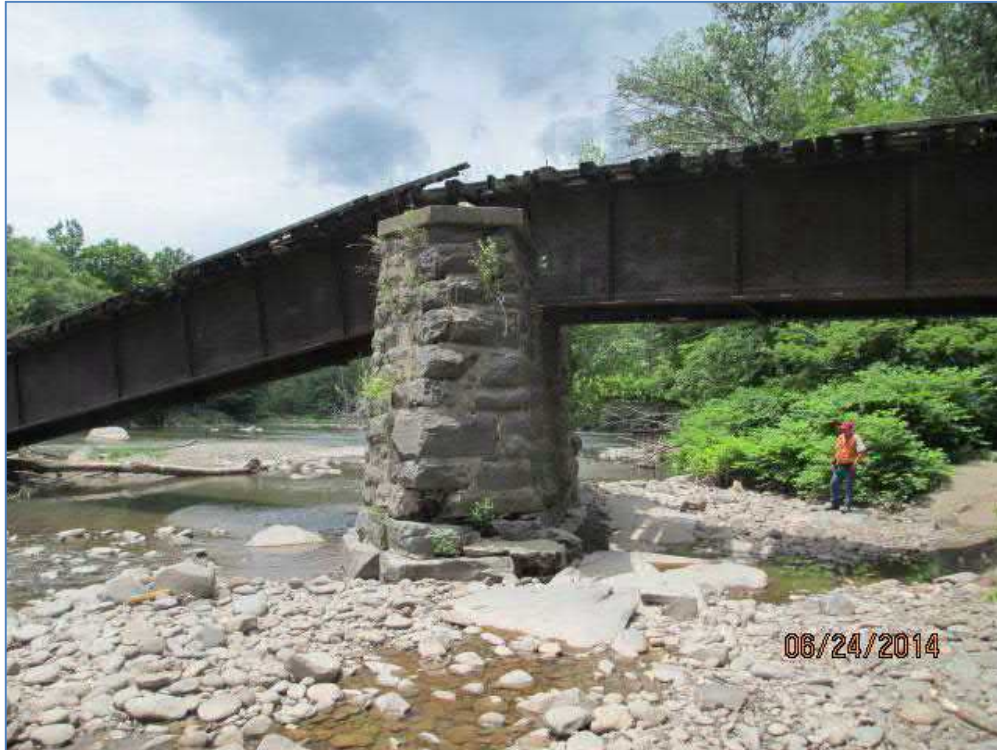
View Looking at Existing Pier 1 (Span 1 on Pier, Span 2 Resting on Ground): Boiceville Trestle

The total volume of stone fill to be placed along the stream banks and the piers for the proposed bridge is approximately 406 cubic yards, of which, 158 cubic yards will be placed below OHWM. The total linear feet of stream banks that will be disturbed as a result of this project is 120 linear feet.

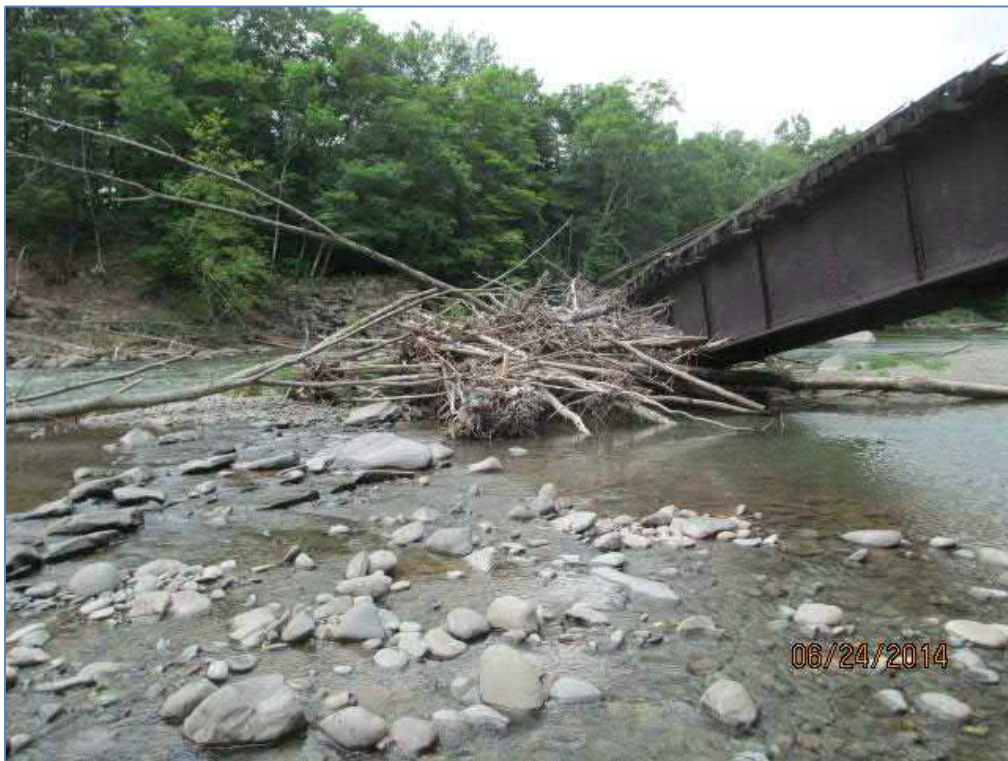
View Looking at End of Span 2 Resting on Creek Bed: Boiceville Trestle

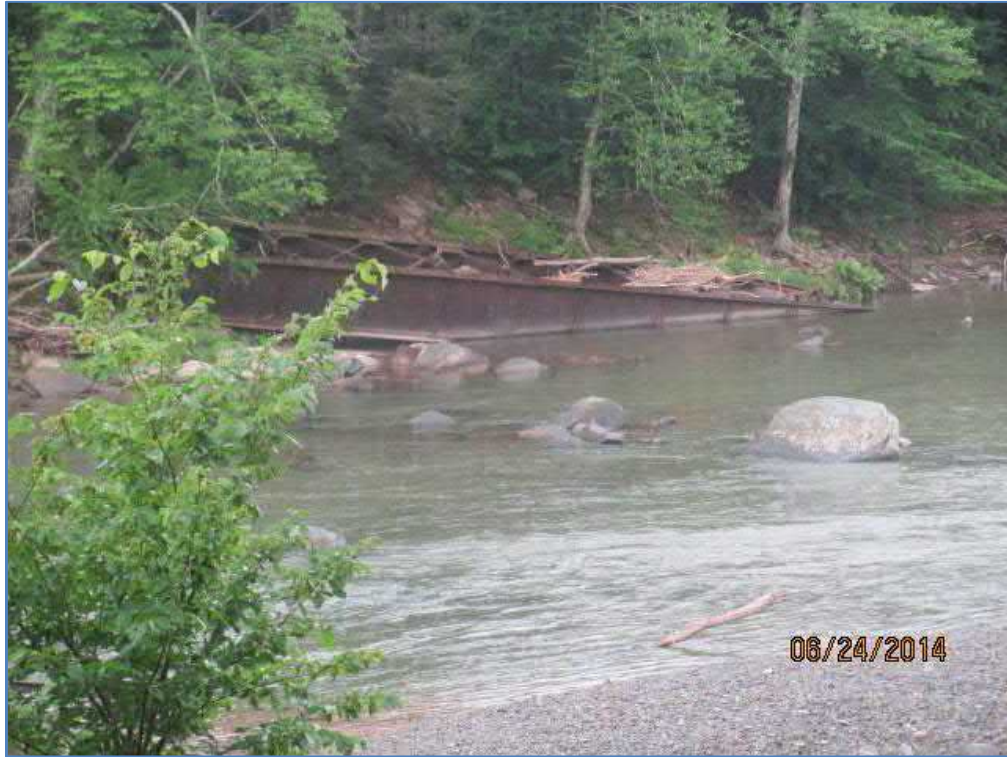
View Looking Towards Girders Resting Along South Stream Bank: Boiceville Trestle

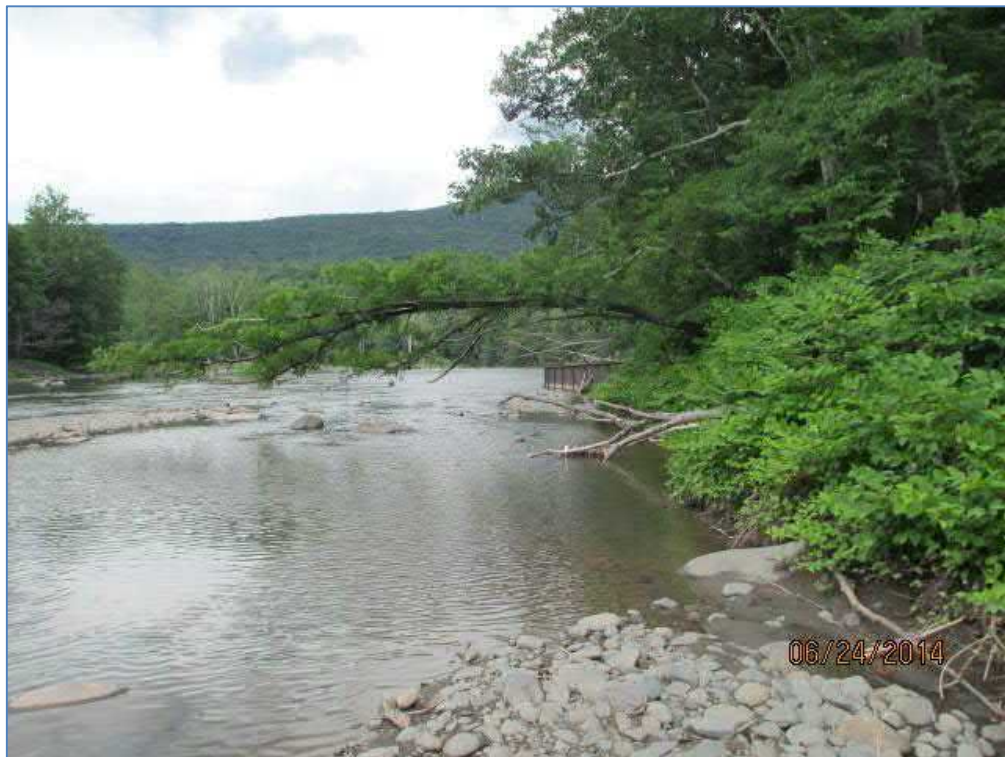
View Looking Downstream, Towards Girders Resting on North Stream Bank: Boiceville Trestle

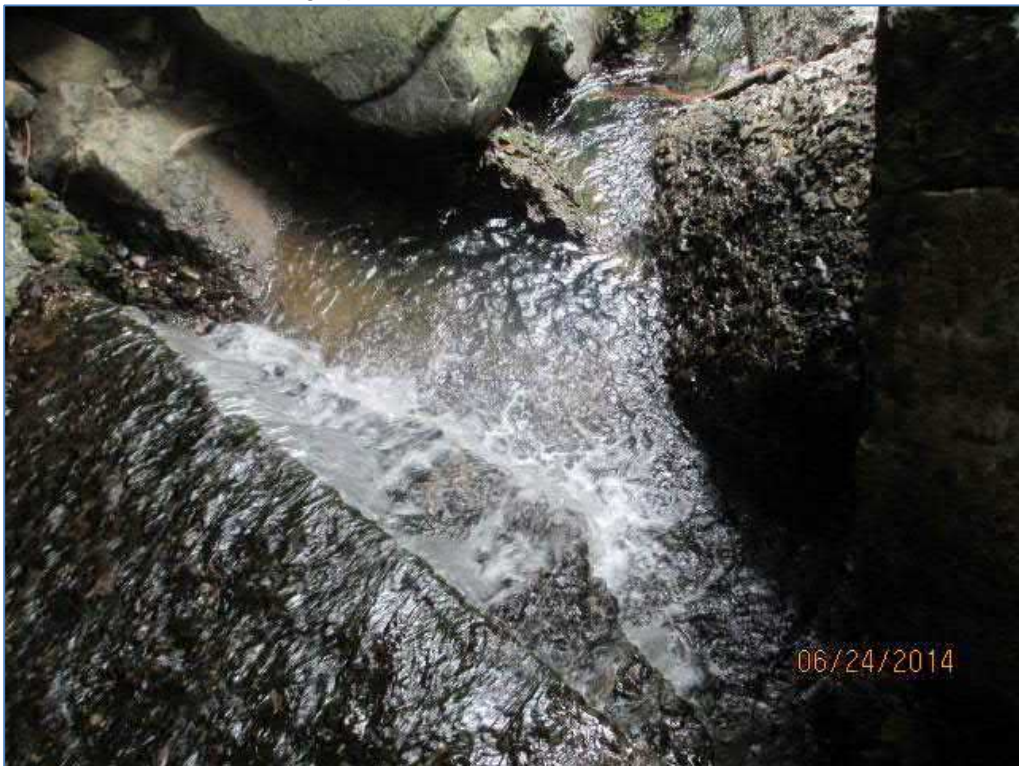
Existing Scour and Erosion at Downstream Fascia: Butternut Culvert

Upon full removal of the existing culvert, medium stone fill will be placed along the stream banks for the full length of the existing culvert. The stone fill will be placed to provide scour and erosion protection to the stream banks. Adjacent grounds will be re-vegetated and restored to their preconstruction conditions. The total volume of stone fill to be placed along the stream banks is approximately 400 cubic yards of which 174 cubic yards will be placed below OHWM. The total linear feet of stream banks that will be disturbed as a result of this project is 150 linear feet.

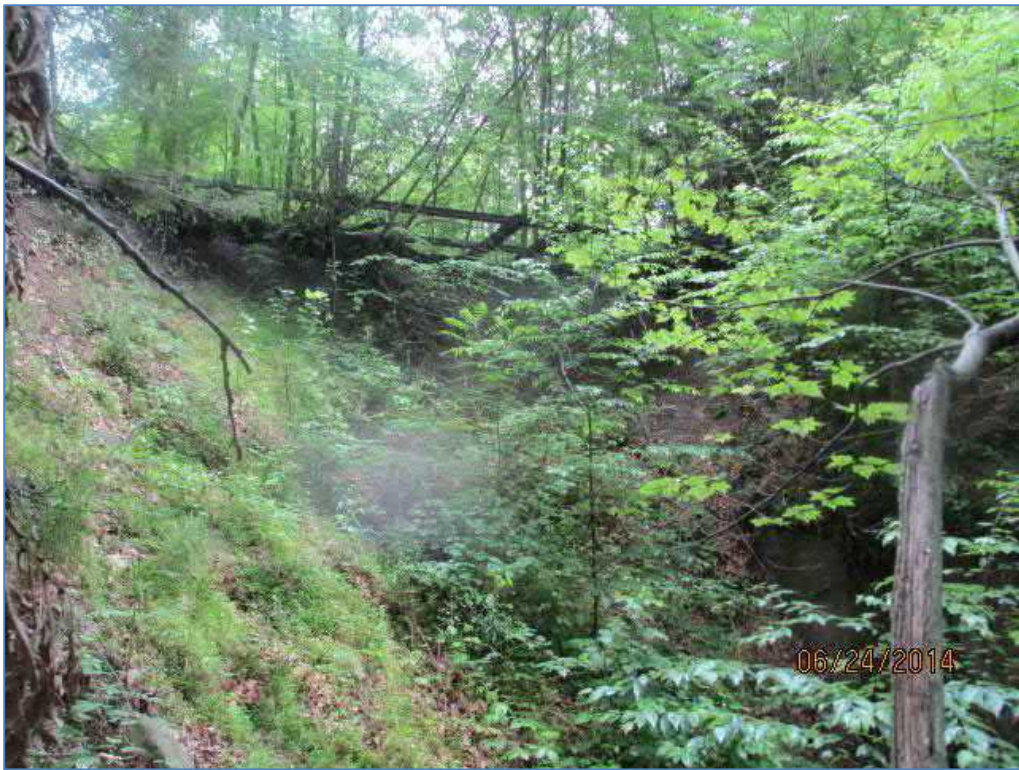
Existing Scour and Erosion Along Trail Above Culvert: Butternut Culvert
