Re: 2015 Follow-up Inspection of the Ulster County Rail Corridor

HDR Engineering, Inc. (HDR) conducted a follow-up track inspection on behalf of Ulster County to determine compliance with Title 49, Part 213, Subpart A to F for Class 1 and Non-Class Specific Standards (hereafter Track Safety Standards) as required per agreement with the Catskill Mountain Railroad (CMRR). Inspections were conducted on foot on the Ulster and Delaware Corridor (hereafter the Corridor) between Downs Street in Kingston, NY and Bridge Street in Phoenicia, NY with two (2) HDR inspectors on Thursday, September 3 and Friday, September 4, 2015.

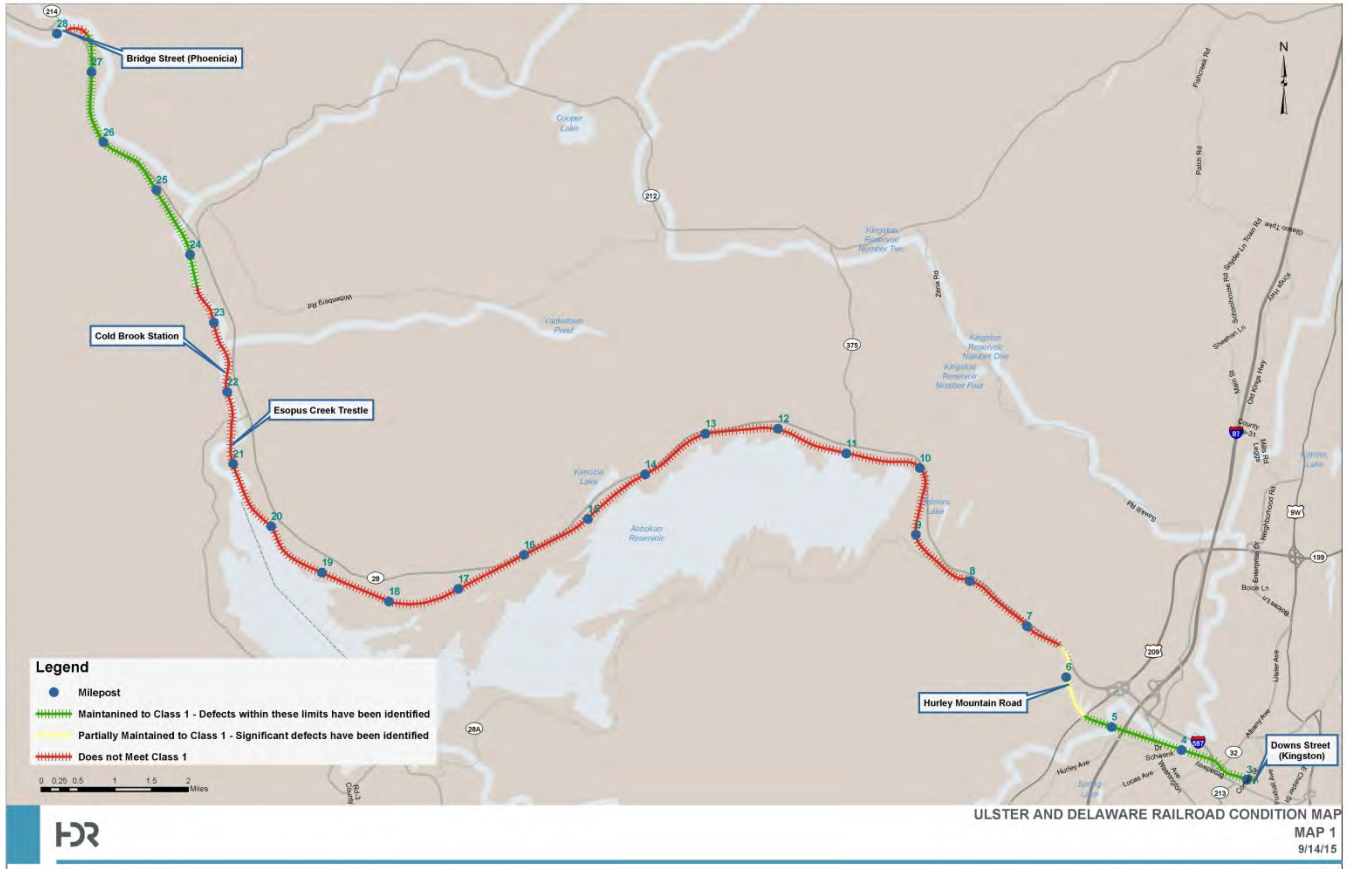
Map 1: Ulster and Delaware Railroad Corridor Condition Map 2015 Follow-up Inspection

From	To	Approximate Distance	Condition Assessment
1.	Downs Street (MP 3.23)	Rt. 209 (MP 5.4)	2.2 miles	Maintained to Class 1 Standards; passenger trains operate in this section. Other defects were observed that are not Class 1 compliant. *

2.	Rt. 209 (MP 5.4)	Hurley Mountain Road (MP 5.93)	0.5 miles	Tie condition generally meets Class 1 Standards; section was restored by CMRR in 2014. Other defects were observed that are not Class 1 compliant. *

3.	Hurley Mountain Road (MP 5.93)	MP 6.45	0.5 miles	Ties are currently being installed by CMRR to meet Class 1 Standards. However, other conditions will need to be addressed to meet Class 1 Standards. *

4.	MP 6.45	East End Esopus Creek Trestle (MP 21.26)	14.8 miles	Does not meet Class 1 Standards, poor tie conditions observed, loose joint bars, center cracked joint bars, drainage work required, no vegetation management. *

5.	East End Esopus Creek Trestle (MP 21.26)	West End Esopus Creek Trestle (MP 21.31)	290 ft	Bridge is washed out. *
6.	West End Esopus Creek Trestle (MP 21.31)	Cold Brook Station (MP 22.16)	0.9 mile	Does not meet Class 1 standards, poor tie conditions observed, loose joint bars, center cracked joint bars, drainage work required, and no vegetation management. *

7.	Cold Brook Station (MP 22.16)	MP 23.50	1.3 miles	Tie condition generally meets Class 1 Standards, however due to washouts, track segment is inoperable, loose joint bars, center cracked joint bars were observed, and no vegetation management. *

8.	MP 23.50	MP 27.53	4.03 miles	Maintained to Class 1 Standards; passenger trains operate in this section. Other defects were observed that are not Class 1 compliant. *

9.	MP 27.53	Bridge Street (MP 27.77)	0.24 mile	Does not meet Class 1 Standards, poor tie conditions noted, vegetation not maintained. *
