Draft Feasibility Report

Ulster & Delaware Corrison Revitalization Study Shandaken Section

Ulster & Delaware Corridor Revitalization Study – Shandaken Section Ulster County, New York

April 2021

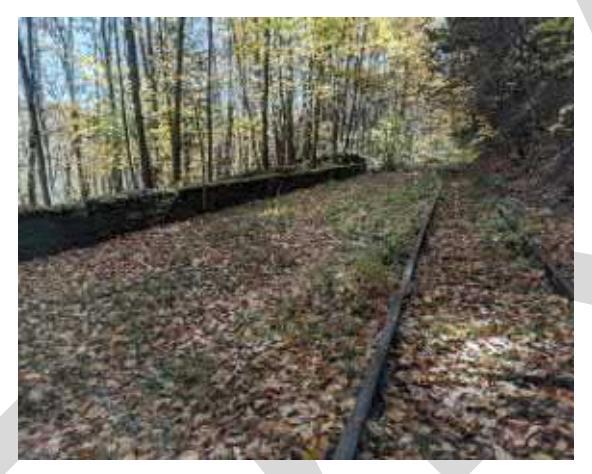
Figure 1-19: Foundation remains

There are many historical elements that could be chosen to showcase on interpretative panels throughout the corridor, beginning with the significance of the railroad on the development of the local communities such as at Highmount, Pine Hill, and in Big Indian. Existing physical elements such as the foundation adjacent to the railroad tracks at Pine Hill (figure 1-18) is just one example of an opportunity to highlight. Other examples include the Grand Hotel (figure 1-19) at Highmount, industry in Pine Hill such as the Tanneries, lodging at Inns and Hotels, the Crystal Spring Water Company, and the engineering feats of the corridor such as the grade and the significance of the segment commonly referred to as the "double horseshoe curve." A historical assessment will be further developed to highlight additional opportunities.

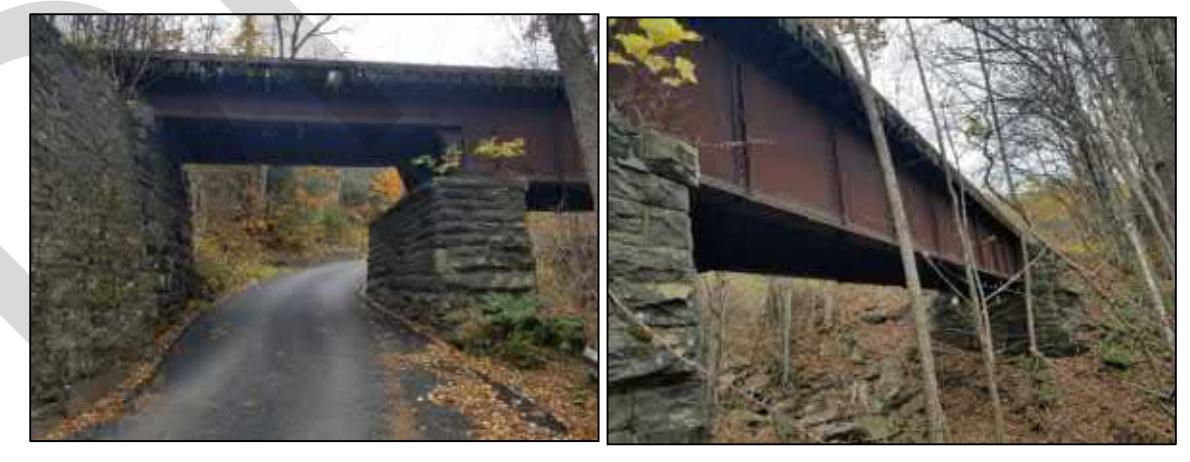
Figure 2-2: Elevation view of Woodchuck Hollow Bridge, Span 1

The existing bridge (BIN 7713410) was originally built in 1896 (as evidenced from the date on the cornerstone) and carries the railroad corridor over Mill Street and an unnamed stream. The structure consists of a two-span continuous steel girder superstructure, supported by stone masonry abutments and one pier. Span 1 is approximately 23 feet in length with two steel girders spaced at 8 feet on center and are 28 inches deep. The Span 1 girders haunch down to a depth of 6 feet at the pier, where 6 feet deep girders are carried over Span 2. The length of Span
