**Ulster County Rail Trail Project – Ashokan Reservoir Section
 (“Ashokan Rail Trail”)**

Feasibility Study

July 2015

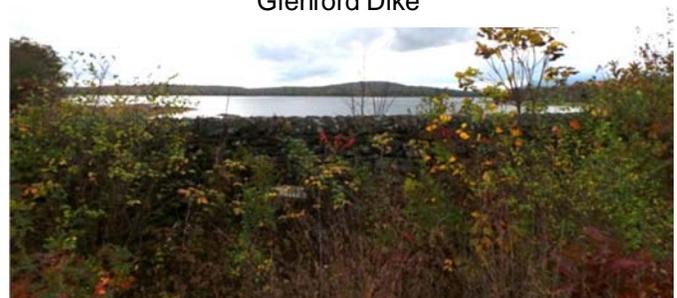
Photo 1-8 – View from top of the Glenford Dike

Scenic Overlook Locations: This segment of trail provides the opportunity for at least two scenic overlooks of the Ashokan Reservoir. One of these locations is at the top of the Woodstock Dike which is near the existing gravel parking area mentioned in the trail access section. Another location for a scenic overlook is at the top of the Glenford Dike. The existing tracks traverse the top of this Dike making it a natural location for a scenic overlook. (See photo 1-8).

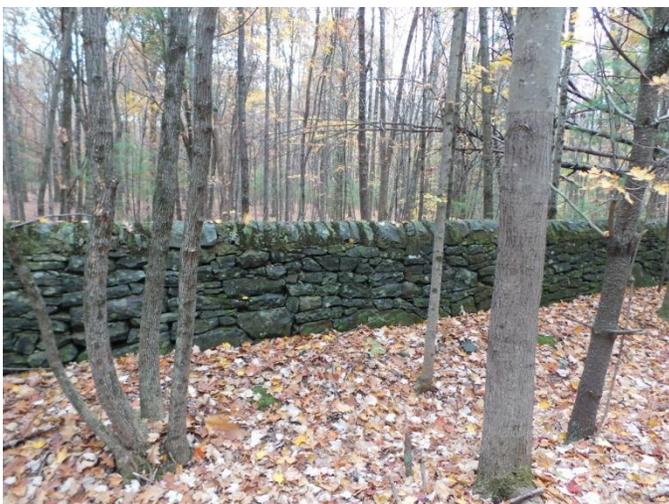
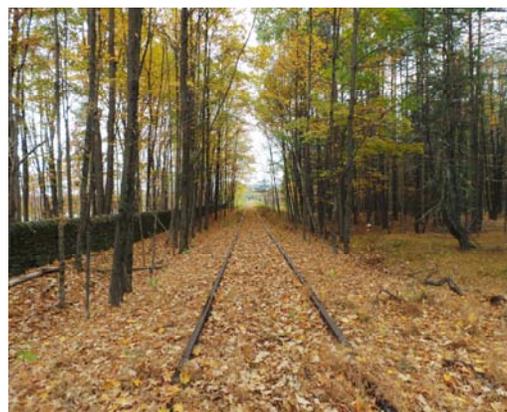
Unique features: In addition to the features mentioned above, this segment features a 3 feet high rock wall known locally as “the Chinese Wall.” The Wall is offset approximately 14 feet from the southern steel rail and traverses the Glenford Dike as shown below in photos 1-9 A and B. This 2,800 feet long wall appears to have been constructed close to, or at, the same time that the railroad infrastructure was moved from near the bed of the Esopus Creek to allow the construction of the Ashokan Reservoir in this area in the early 1900’s.

Photos 1-9 A and B
Hand built Rock Wall
a.k.a. “the Chinese Wall”

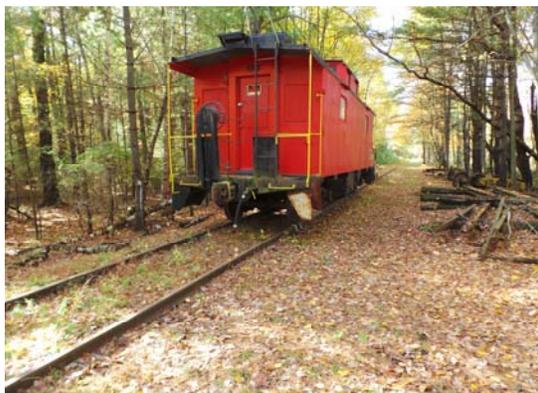
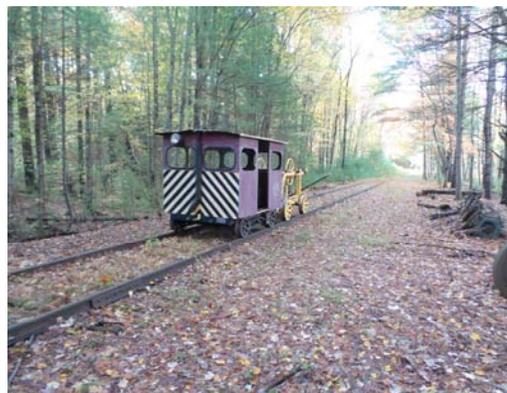
are rotted remnants. Other railroad infrastructure noticed through this segment is a small building in disrepair that was reportedly moved to the site several decades ago, approximately located at station 860+50 on the plans in Appendix A. Including along this section are rail cars on the existing tracks.

Photos 2-2 and 2-3 – Rail Cars in Segment 2

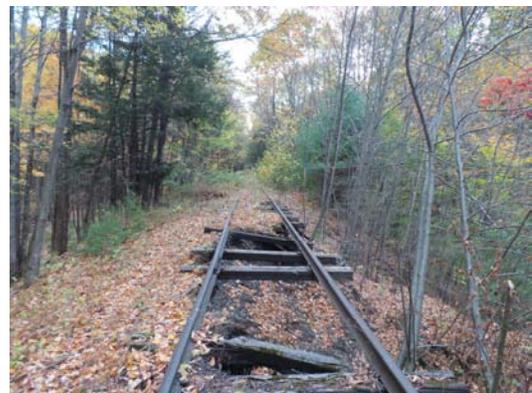
Railroad Infrastructure: The remaining railroad infrastructure in this segment consists of steel rails, wooden ties, concrete signal foundations and stone ballast. Existing steel rails remain attached in most areas to wooden ties. These wooden ties are in poor condition and exhibit significant deterioration. This is most apparent where stormwater flows in close proximity to the ties and the roadbed is saturated. The stone ballast is eroded in two locations through this segment, leaving the rails unsupported (See Photo 3-1 and additional photos in Appendix B).

Photo 3-1 - Severe Deterioration in Segment 3

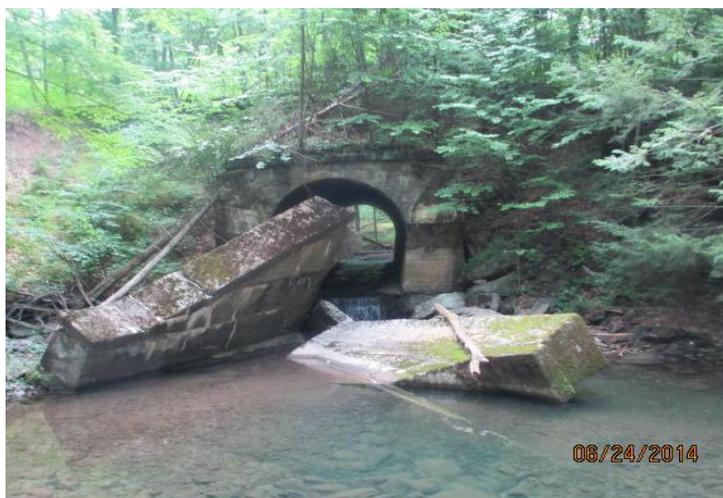
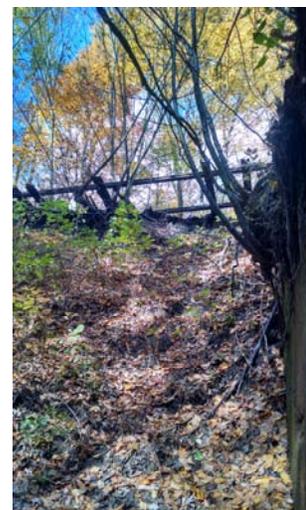
to other segments of the corridor. Within the cut sections, runoff flows into the valleys created by the railroad infrastructure and is collected in drainage swales and conveyed towards Butternut Creek. Some of the side slopes leading into the drainage ditches have experienced minor to moderate erosion and can be restored with careful grading and stabilization. Located at station 980+75, is a concrete culvert that conveys Butternut Creek under the railroad and into Butternut Cove. The culvert is heavily damaged on the downstream side and will require replacement. The culvert has

sustained a long period of deterioration beginning in the 1980's to the present day. The separation and collapse of the culvert wingwalls, has caused a major portion of the railroad embankment to also collapse. It appears that the material originally retained by the culvert wingwalls has eroded into the creek. A detailed investigation, report, and the estimated replacement costs for the Butternut Cove Culvert has been prepared by Barton & Loguidice and is included in Appendix E.

**Photo 3-2
Butternut Cove Culvert Southern Face**

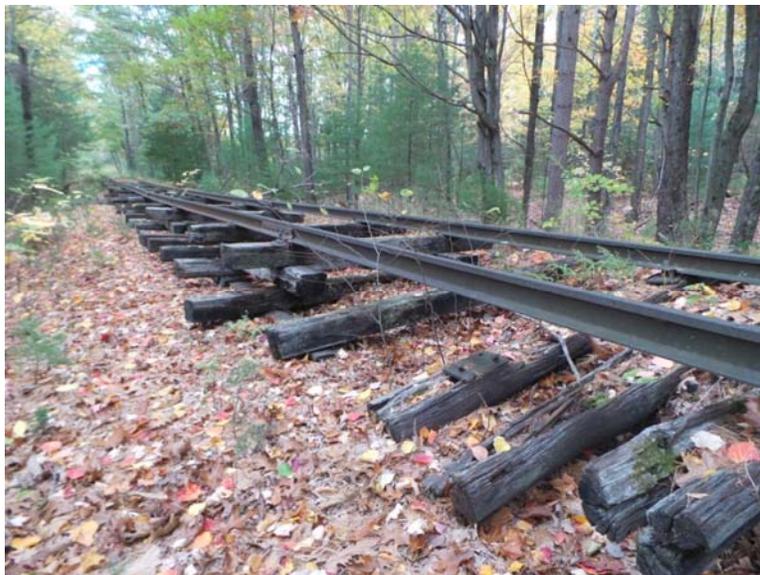
Unique features: In addition to the Butternut Creek washout, another section that appears to have been washed out is located west of Butternut Creek. The rails at this location are elevated approximately 3 feet above the ground for 100 feet at station beginning at Station 989+00 by way of stacking wooden ties on top of each other to support the rails (“cribbing”).

Photo 3-4 – “Cribbing” of the rails

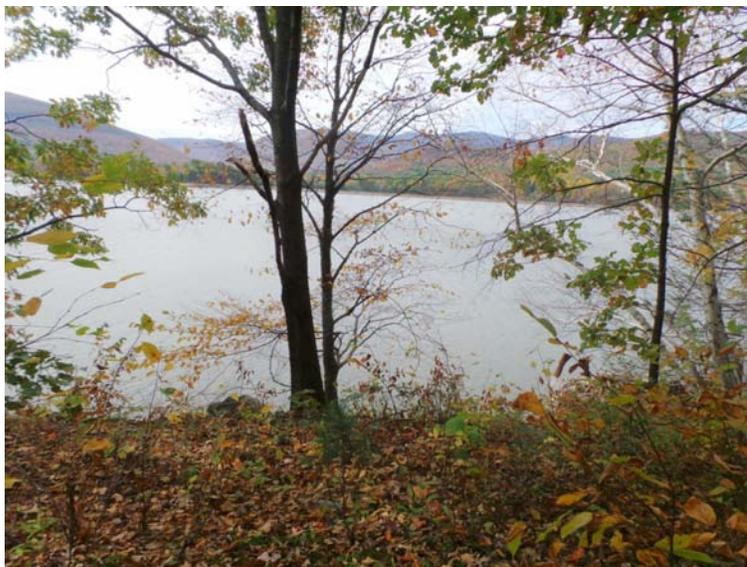
Photo 4-2
Potential Vista and Scenic Overlook in Segment 4

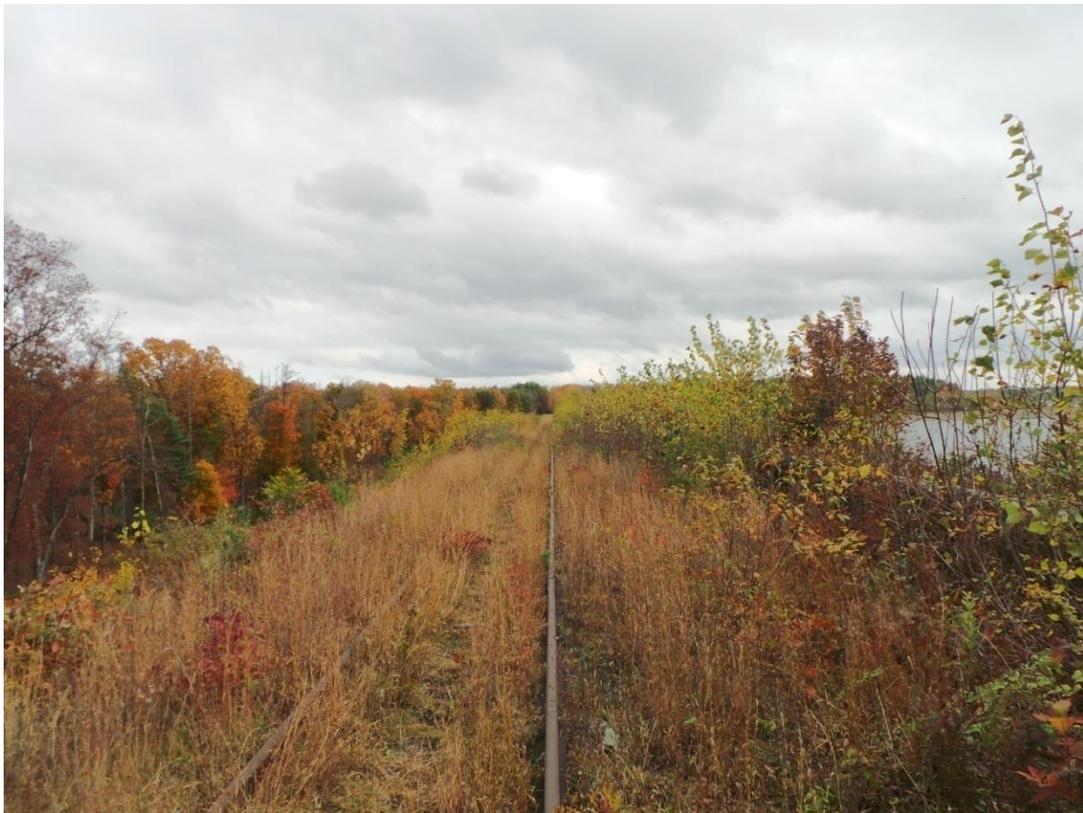
Photo 104 – Vegetation growth at the top of the Glenford Dike

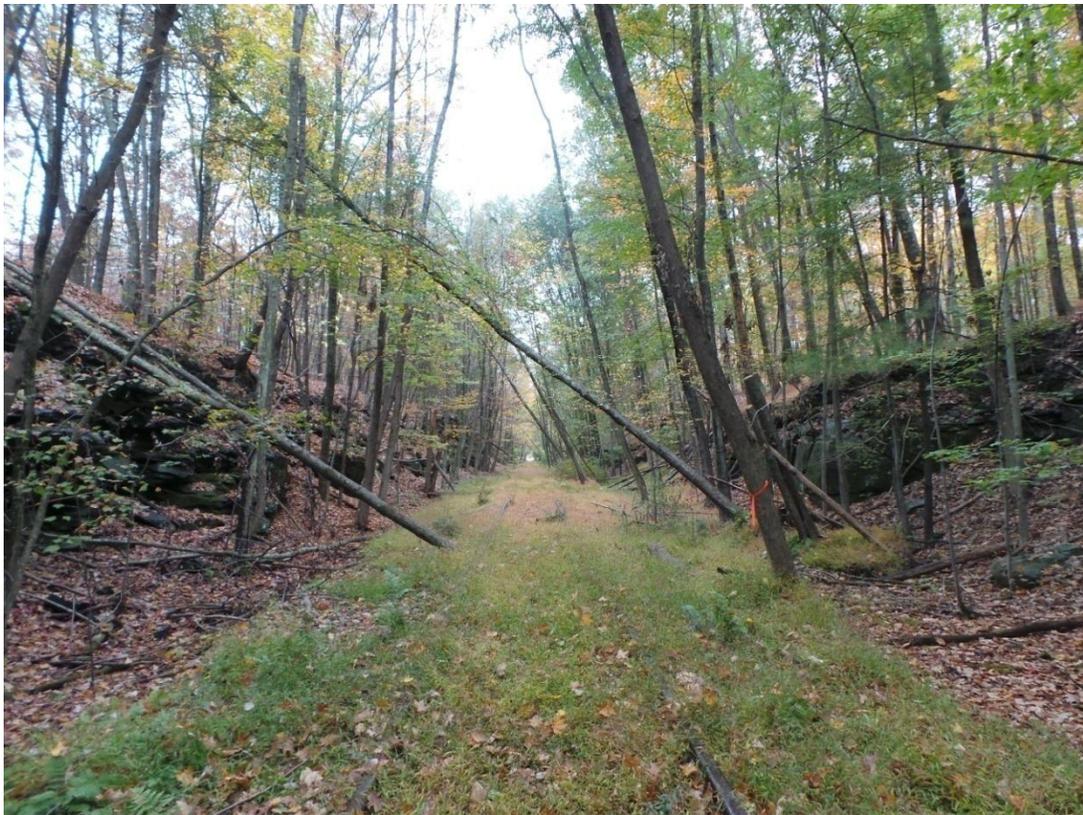
Photo 106 – Rock cut section/fallen trees

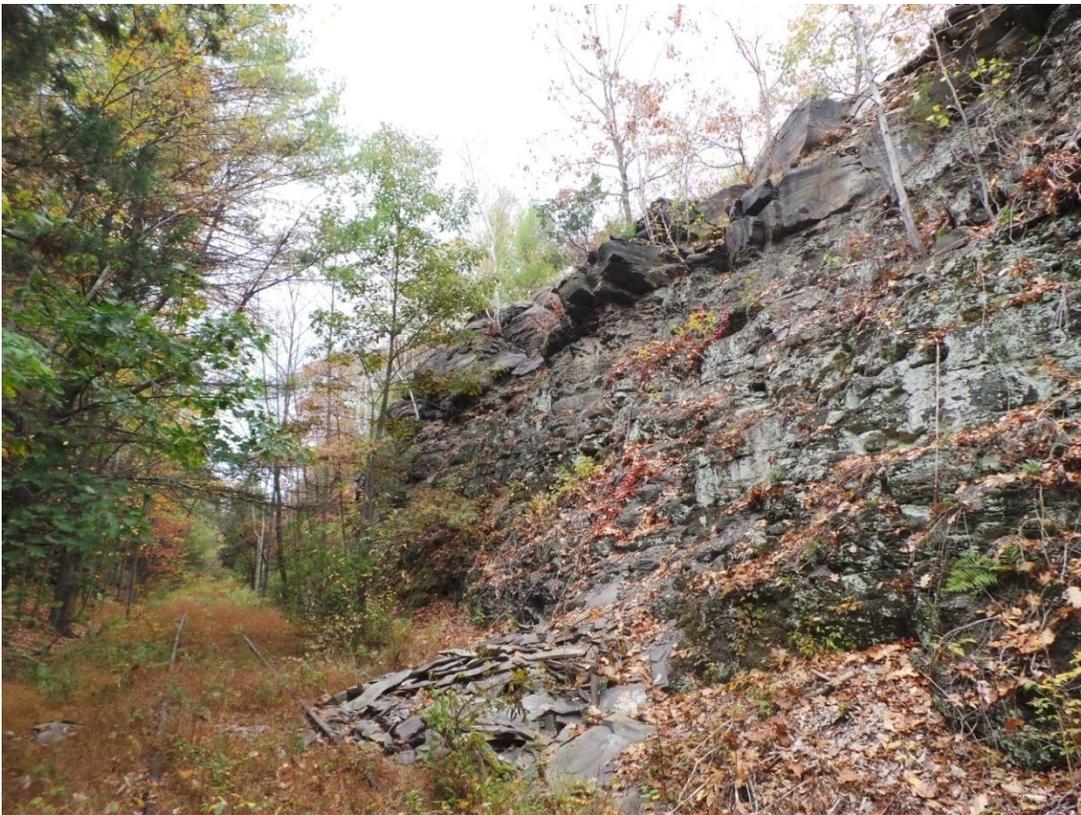
Photo 108 – Rock slide (station rr 550+00)

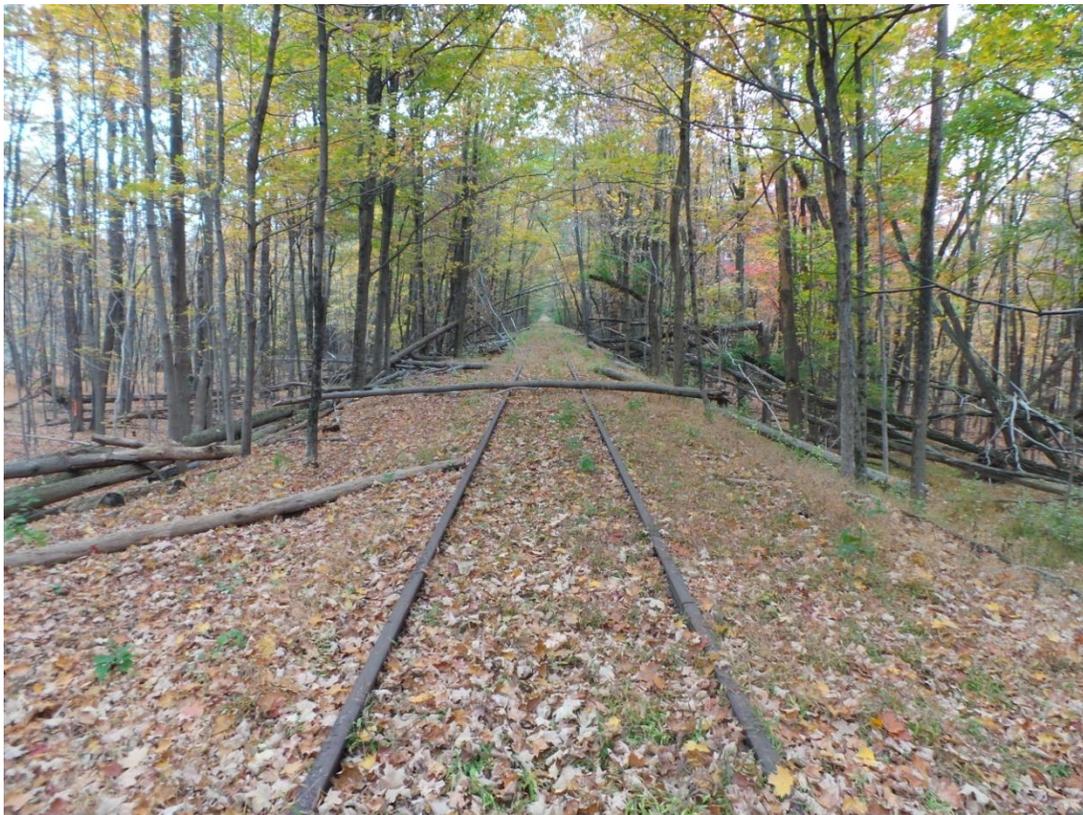
Photo 120 – Fill section requiring tree removal.

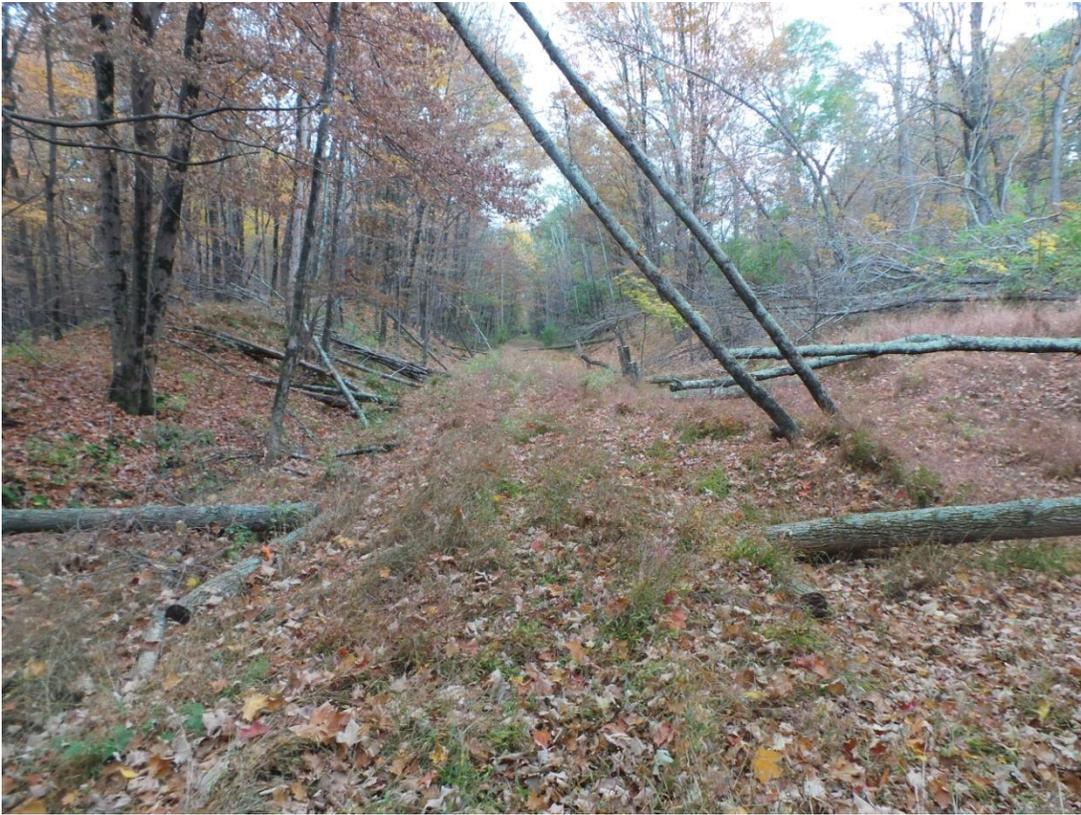
Photo 121 – section requiring debris removal

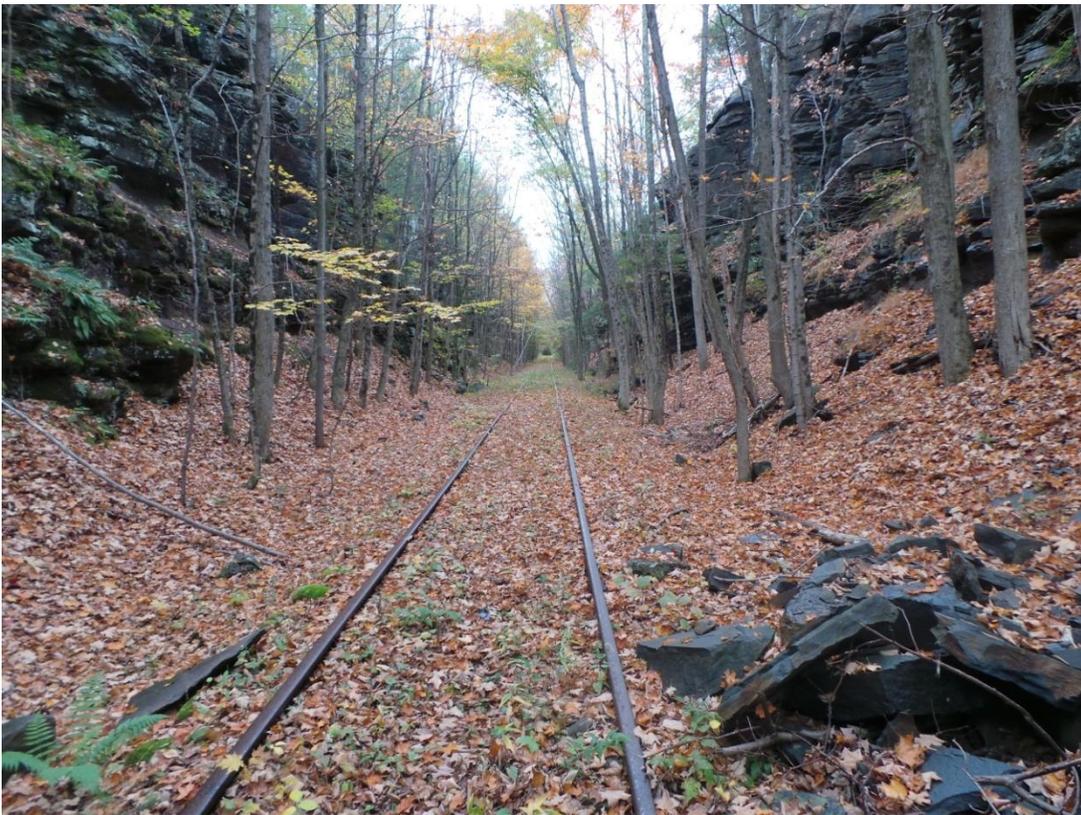
Photo 122 – Rock Slide (station 482+00)

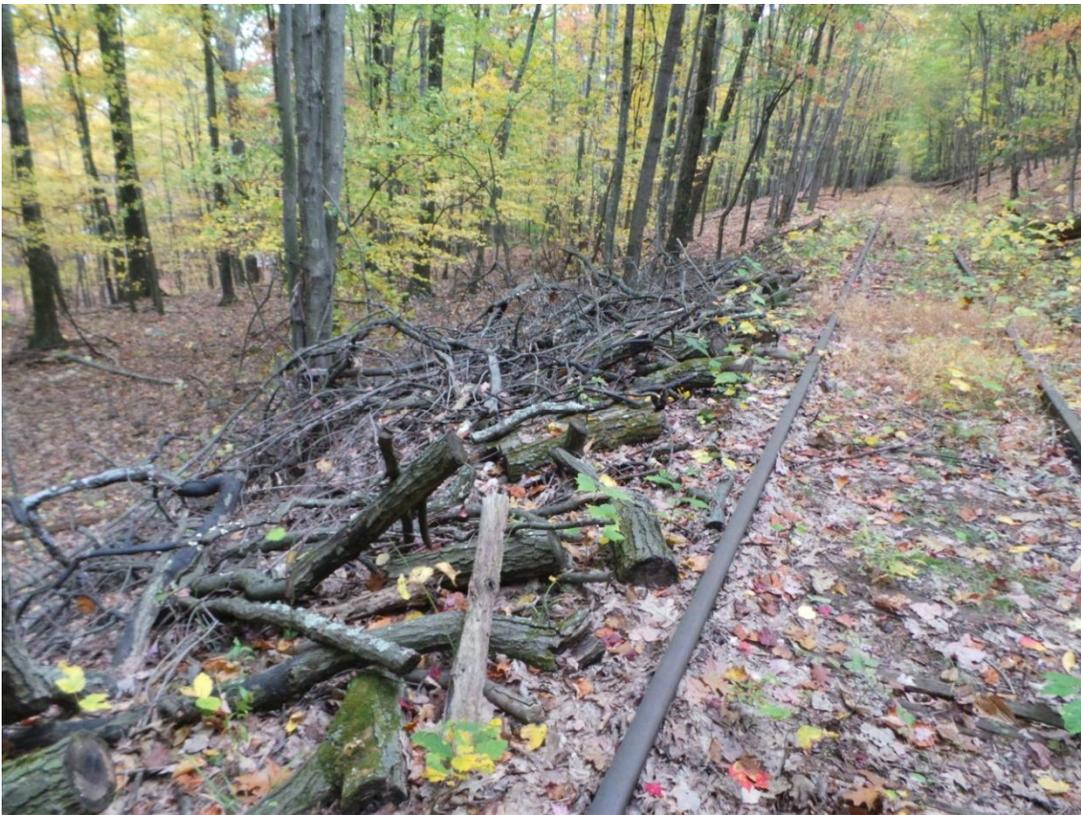
Photo 208 – Significant tree debris adjacent to tracks

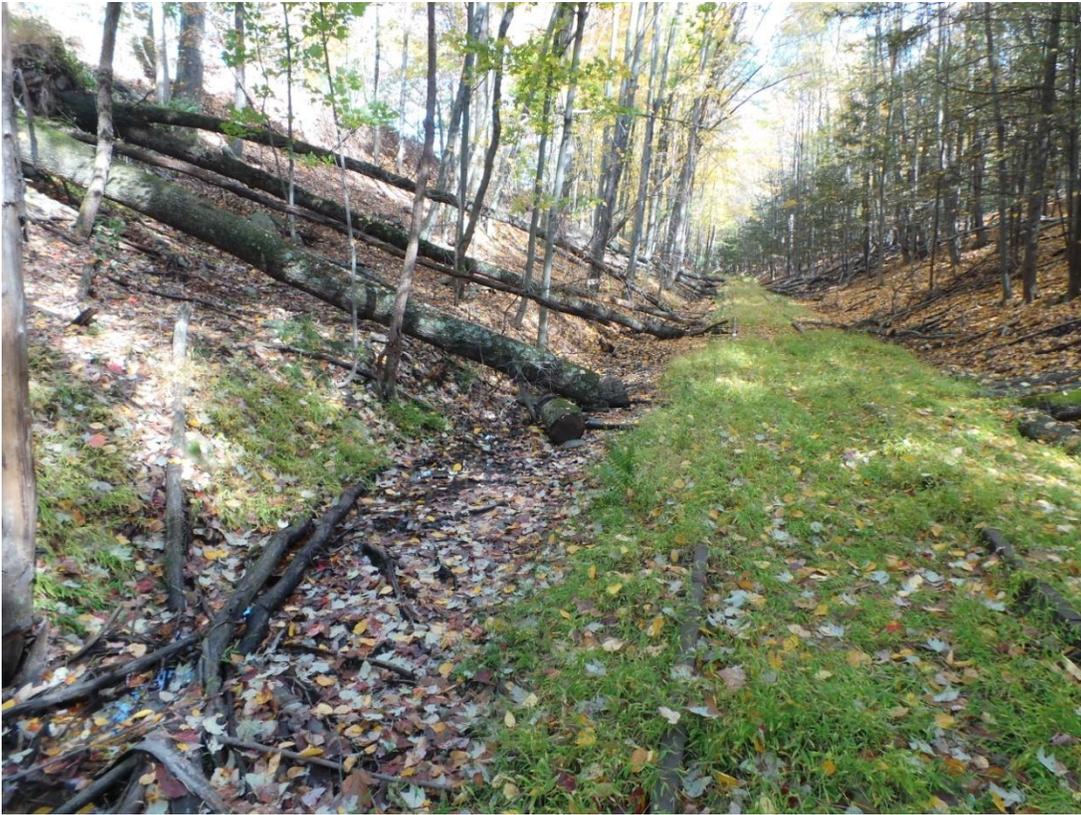
Photo 209 – Drainage ditch with significant debris accumulation

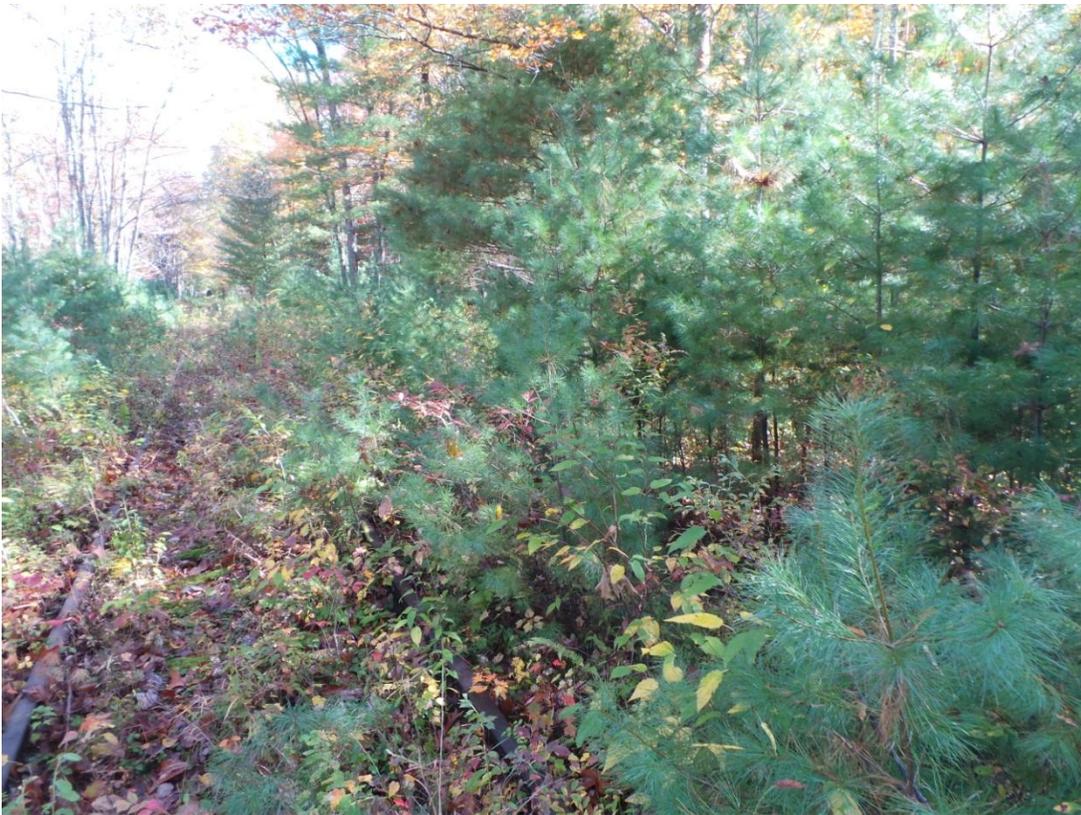
Photo 210 – Pine tree growth on rail bed and embankment

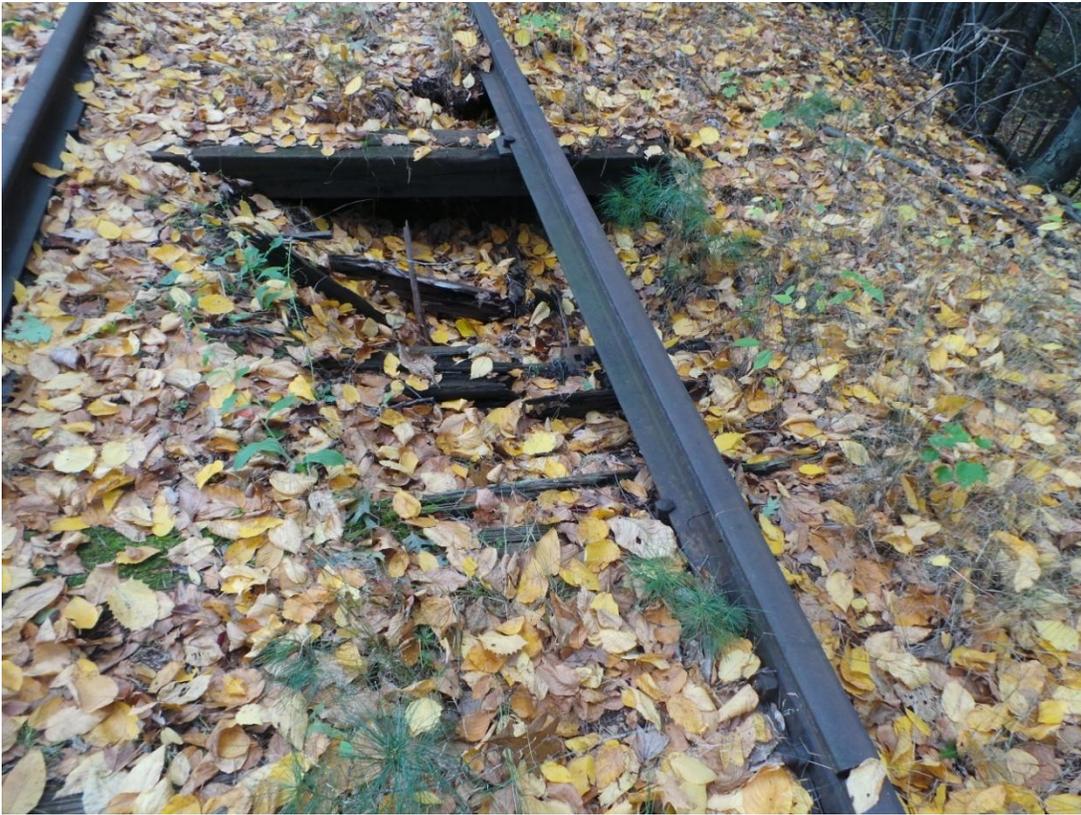
Photo 211 – Minor ballast erosion

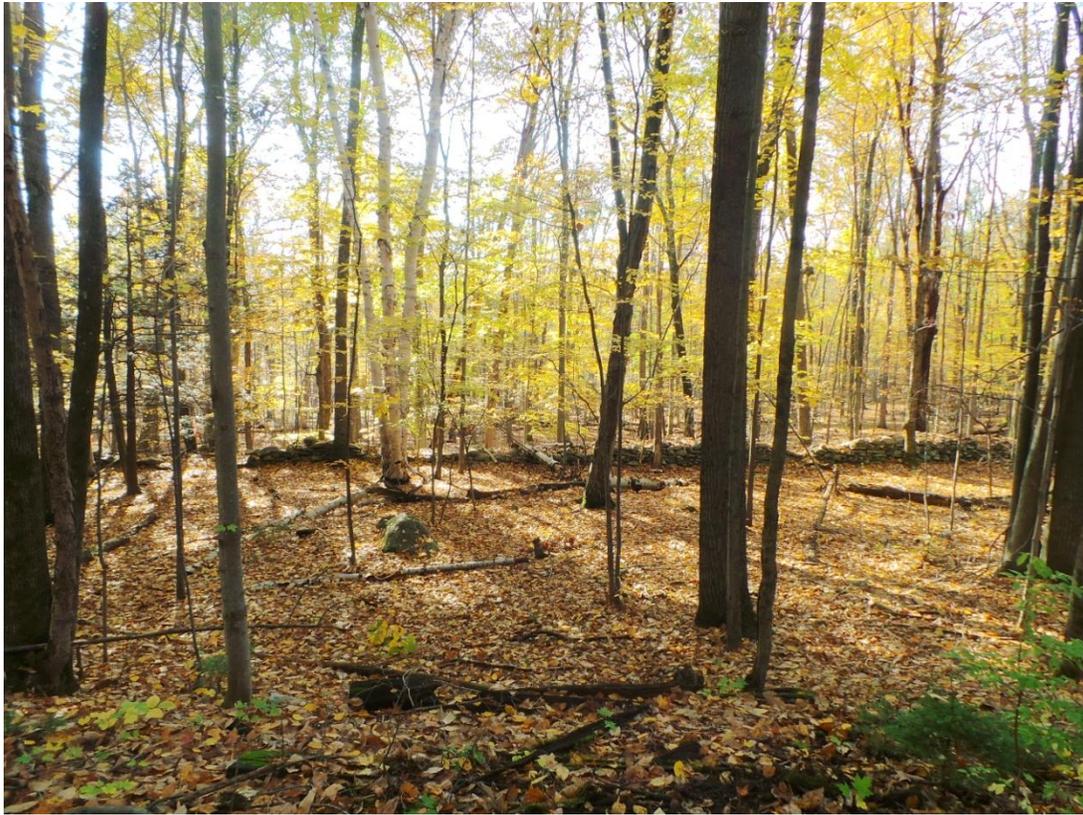
Unique features: This segment of trail traversed through woodlands that feature existing stone walls laid out throughout the woods outside of the railroad right-of-way. A photo of the wall can be found in Appendix B (photo 217).

Photo 217 – Stone walls through the woods

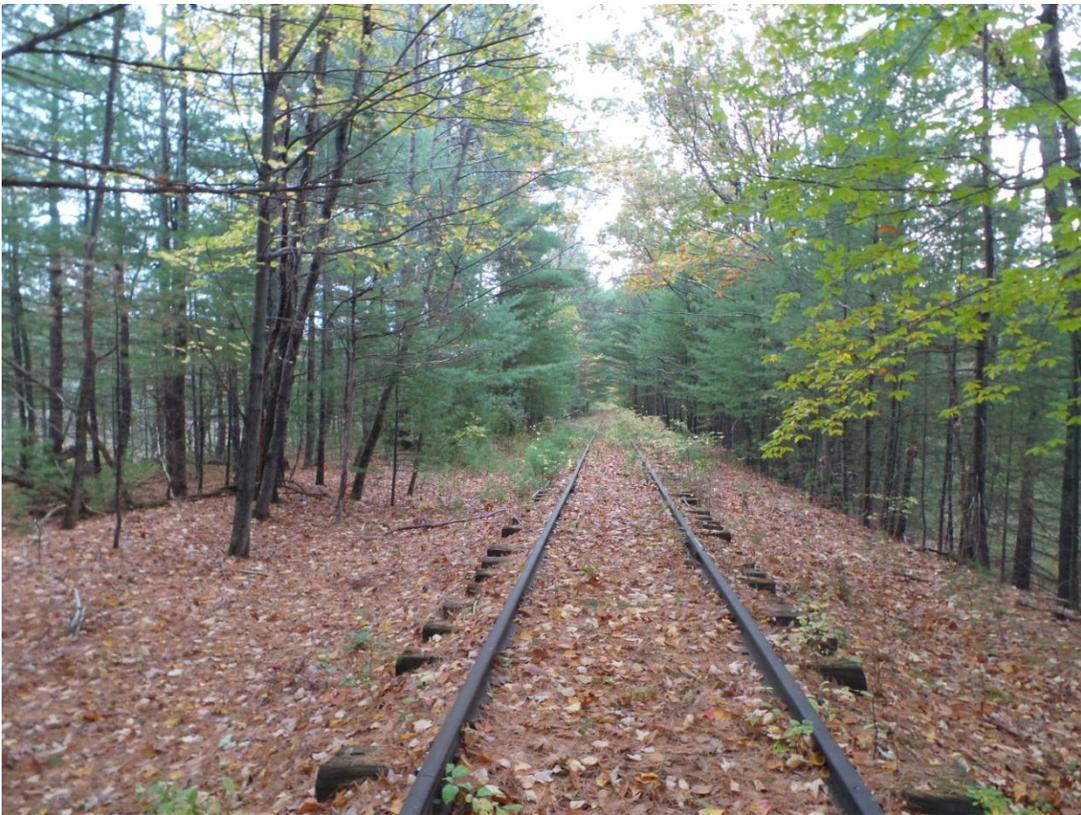
Photo 302 – General vegetation characteristics

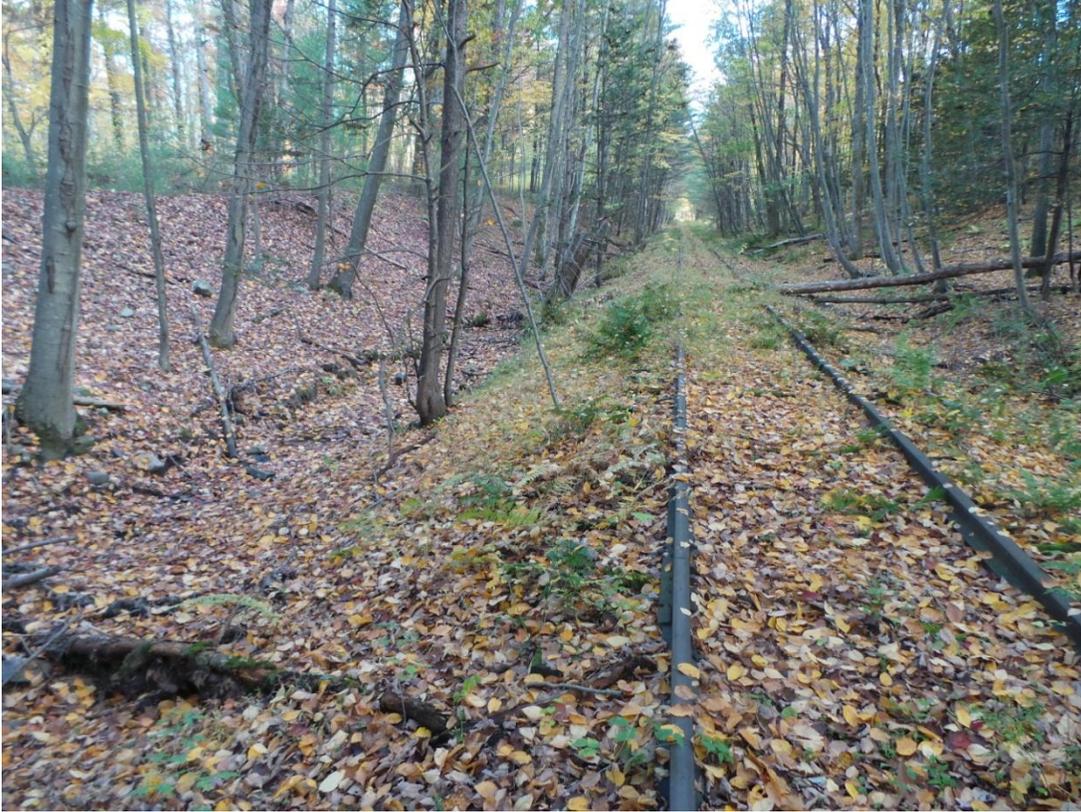
Side slopes: Segment 3 primarily exhibits of two types of side slopes: earth cut and earth fill sections. Earth cut sections are approximately 20 feet high on both sides of the railroad right-of-way which then transition to steep fill section with steep side slopes that are approximately 20 feet high. Areas of embankment have progressively eroded over time. The shape and construction of the side slopes are generally consistent with the photos of Segments 1 and 2, however, photos 303 through 306 in Appendix B can be viewed for a more detailed view of segment 3 slope conditions.

Photo 303 – Earth cut slopes with drainage ditches

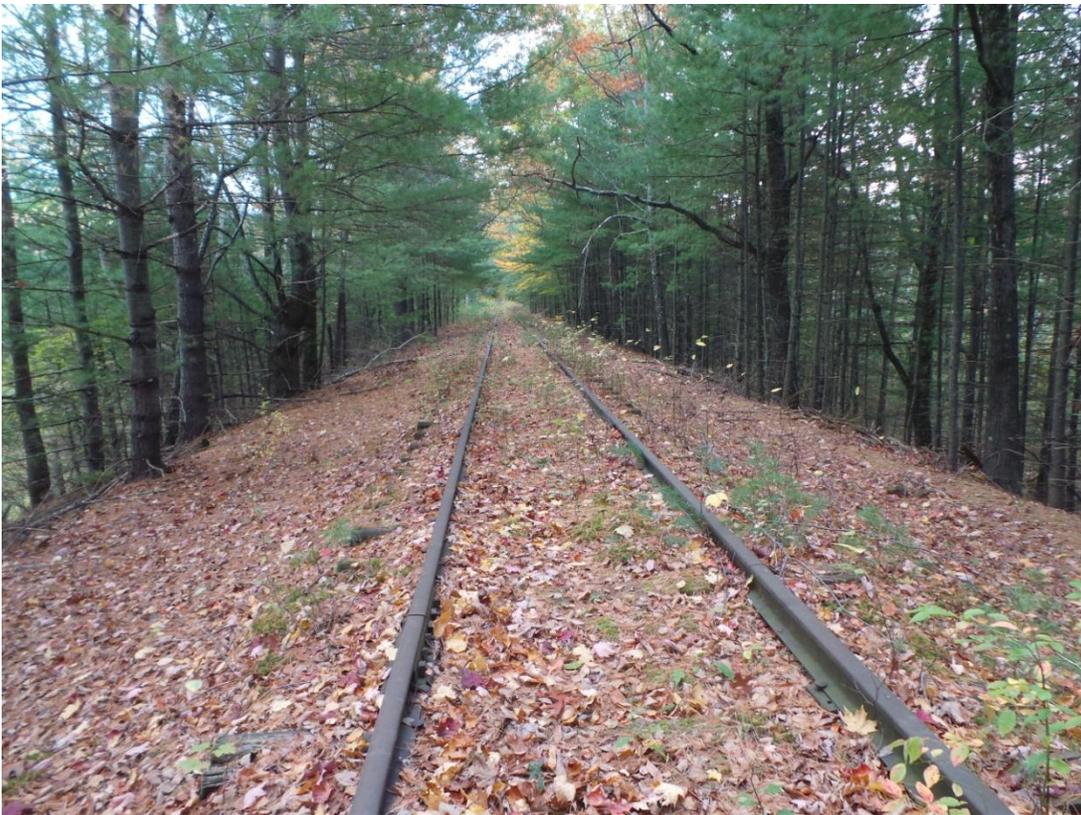
Photo 304 – Fill Slopes and wide top embankment

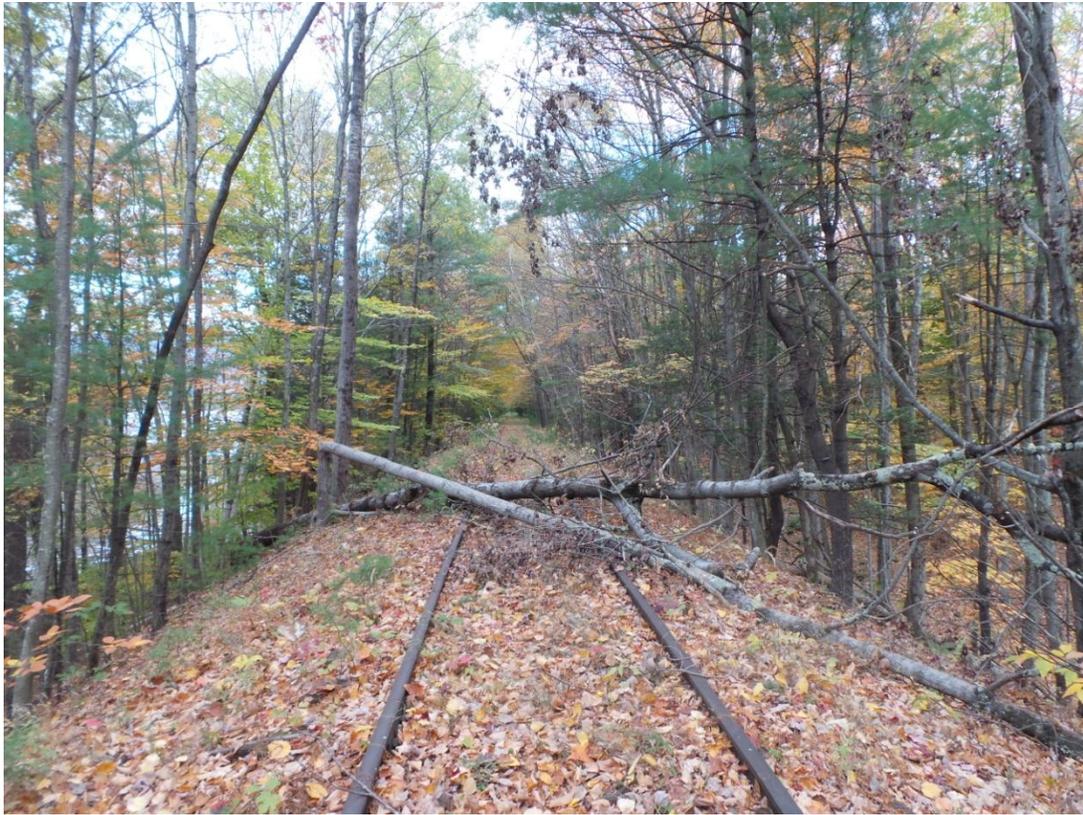
Photo 305 – Fill slopes and narrow top embankment

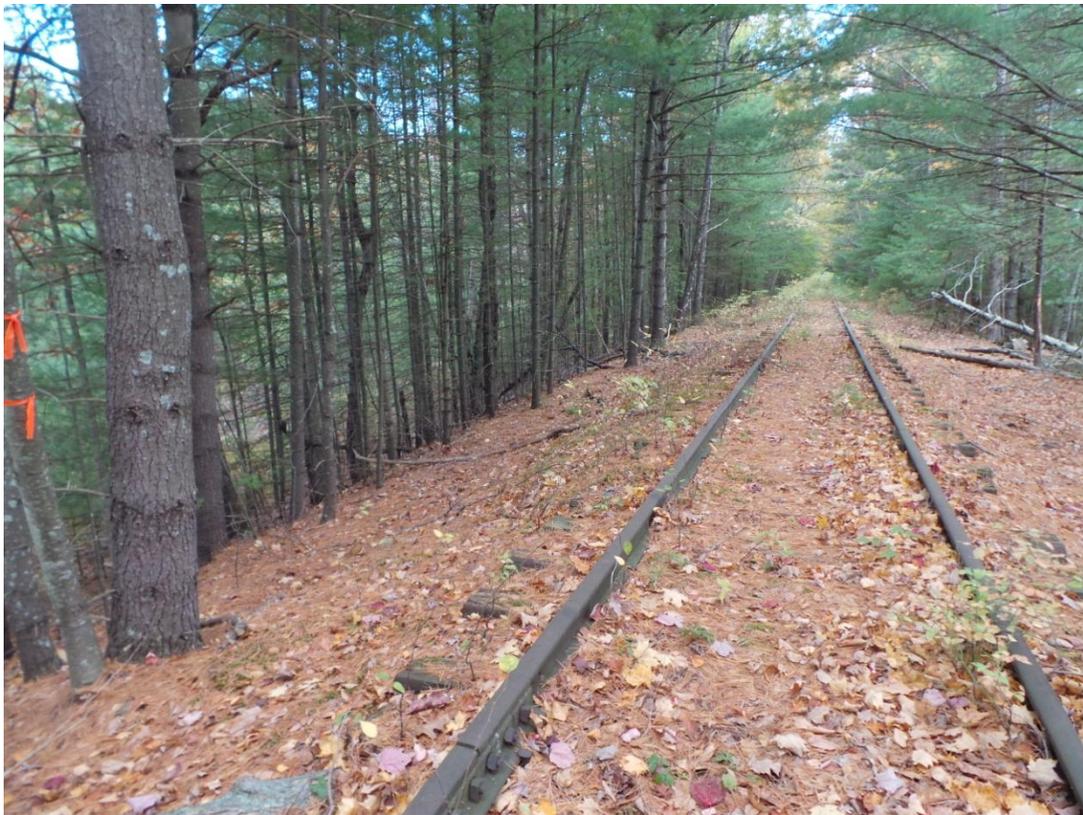
Photo 306 – Steep side slopes

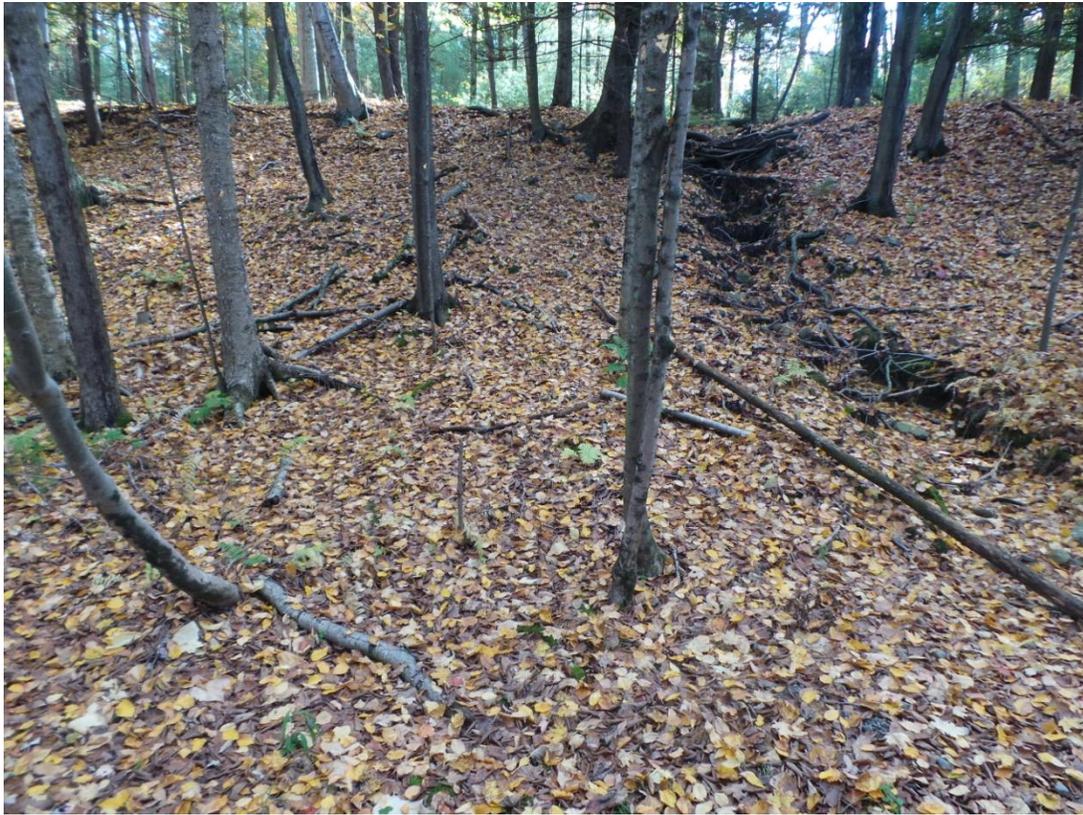
Photo 307 – Side slope erosion

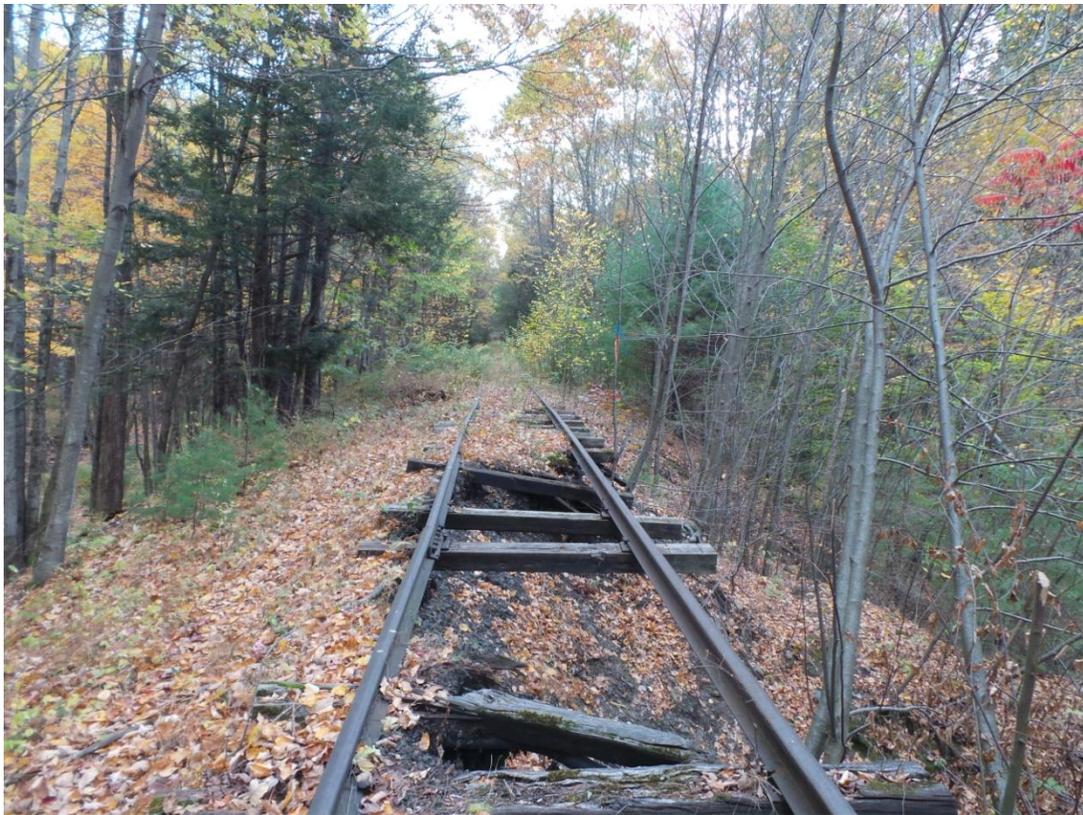
Photo 308 – Butternut Creek embankment washout

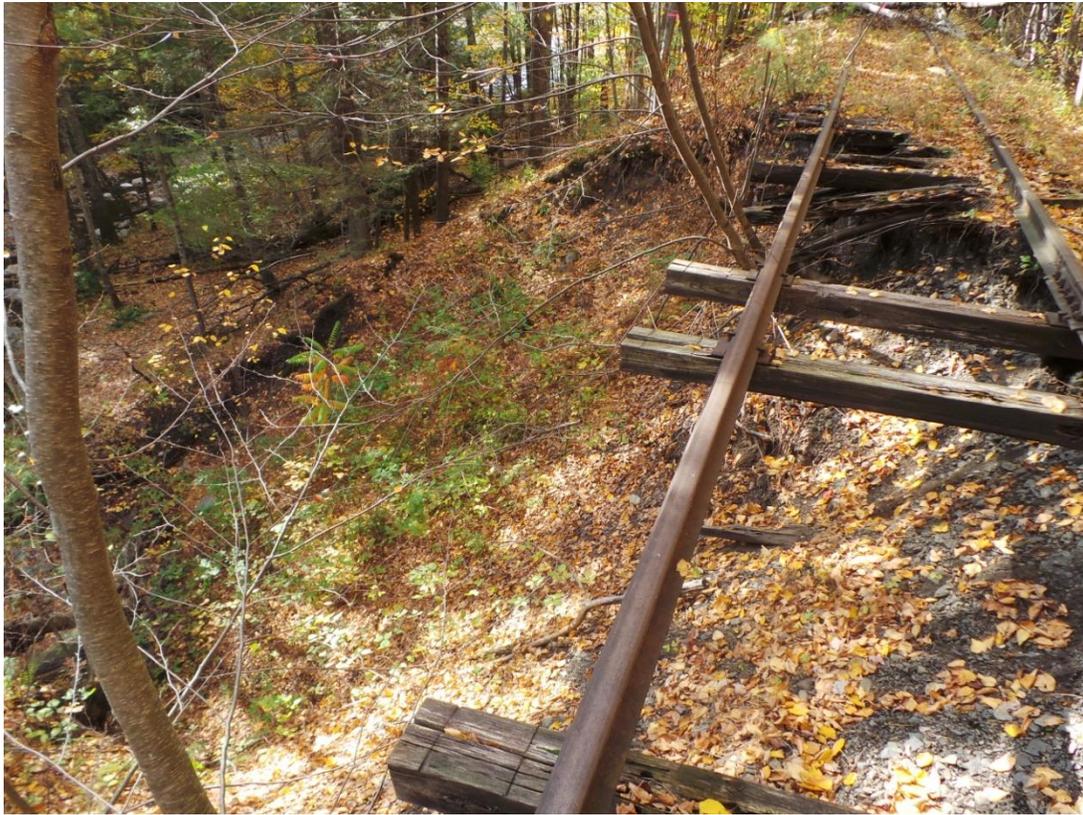
Photo 309 – Butternut Creek embankment washout

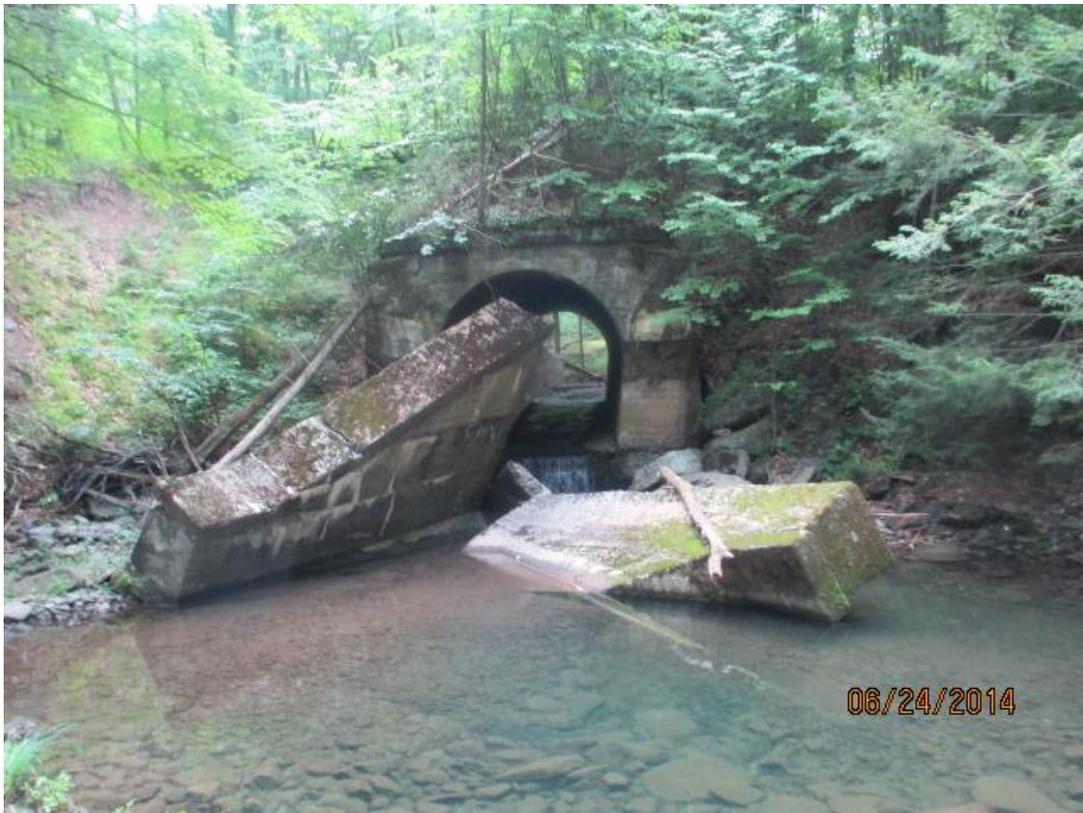
Photo 312 – Downstream side of Butternut Creek culvert

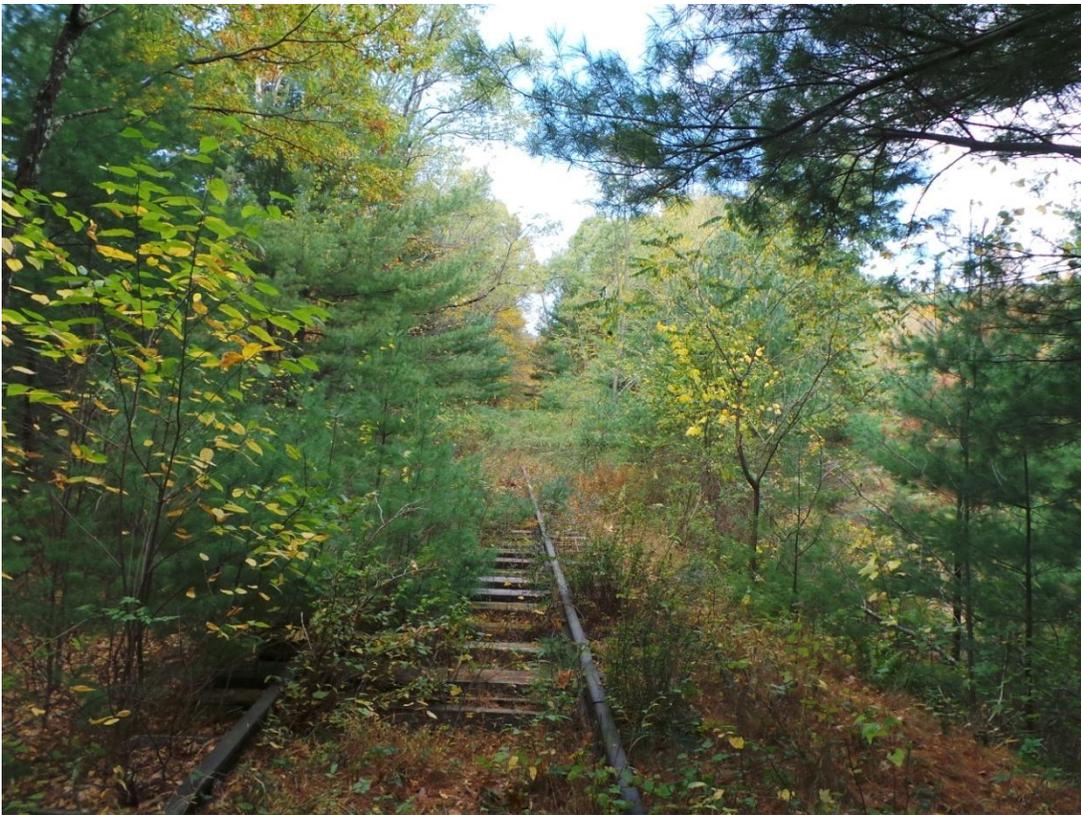
Photo 404 – Minor tree growth on rail bed and embankments
