**Ulster County Rail Trail Project – Ashokan Reservoir Section
 (“Ashokan Rail Trail”)**

Feasibility Study

July 2015

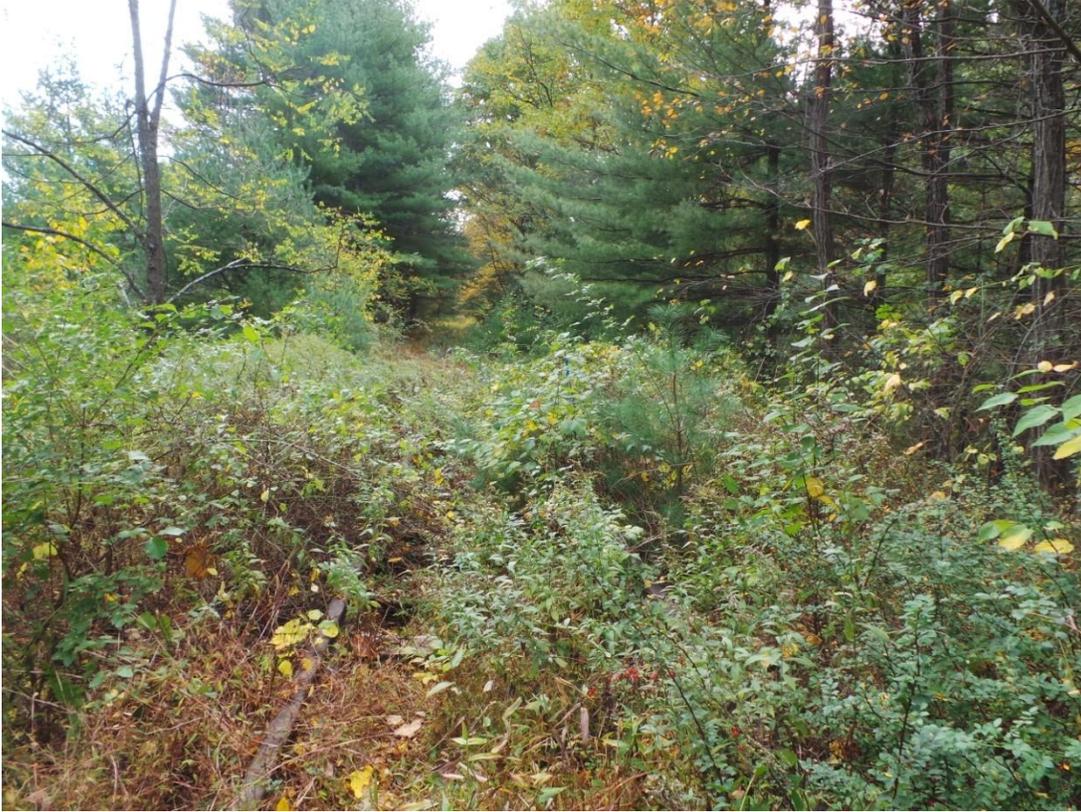
Photo 405 – Heavy brush growth on rail bed and embankments

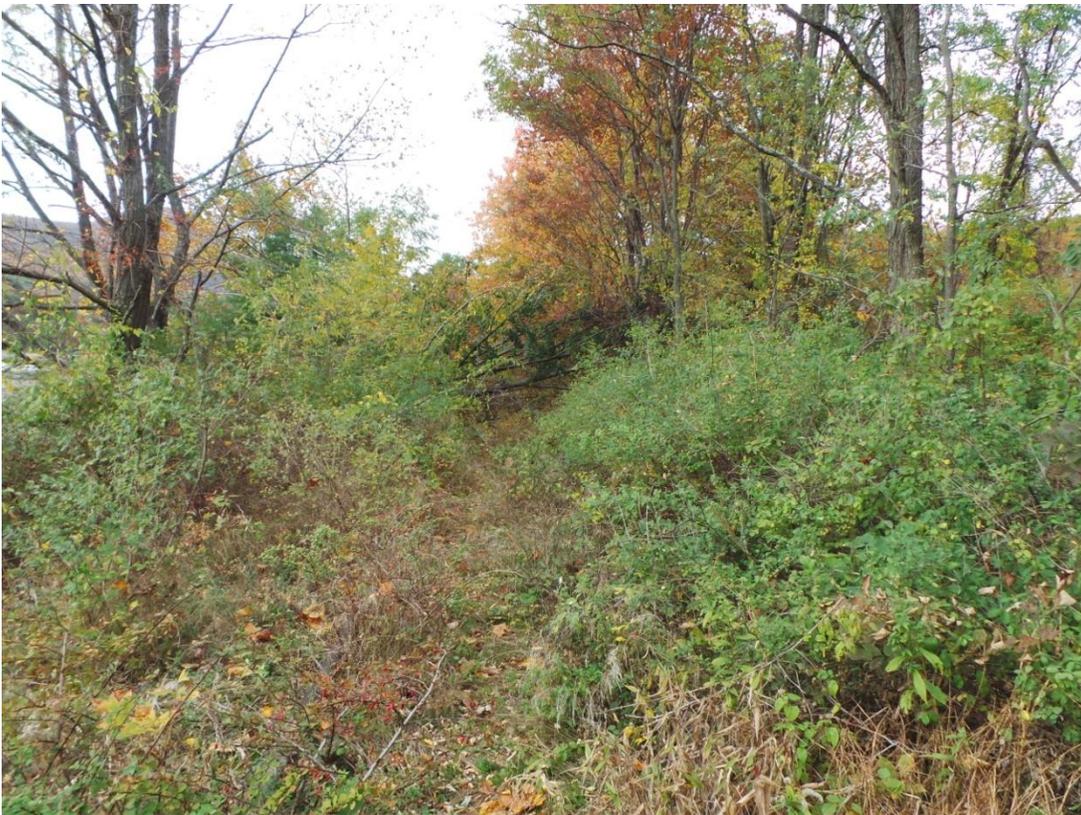
Photo 406 – Dense brush and fallen trees on tracks and side slopes

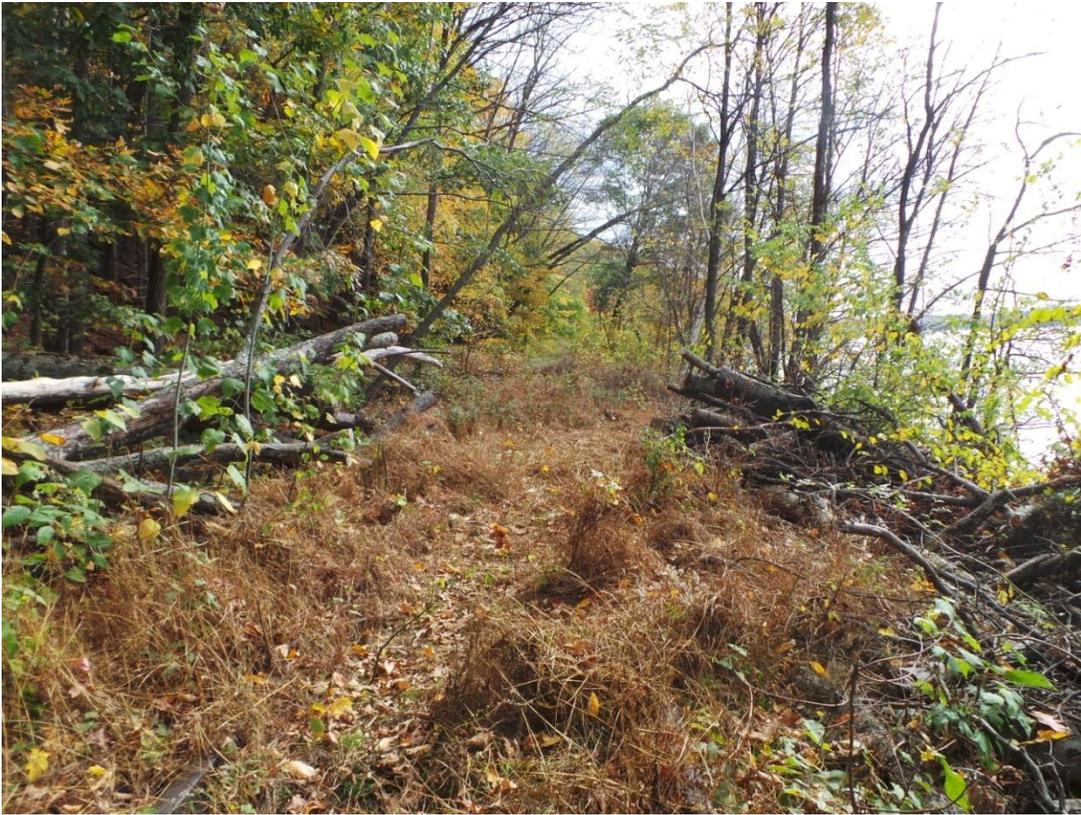
Photo 407 – Fallen trees on sideslopes

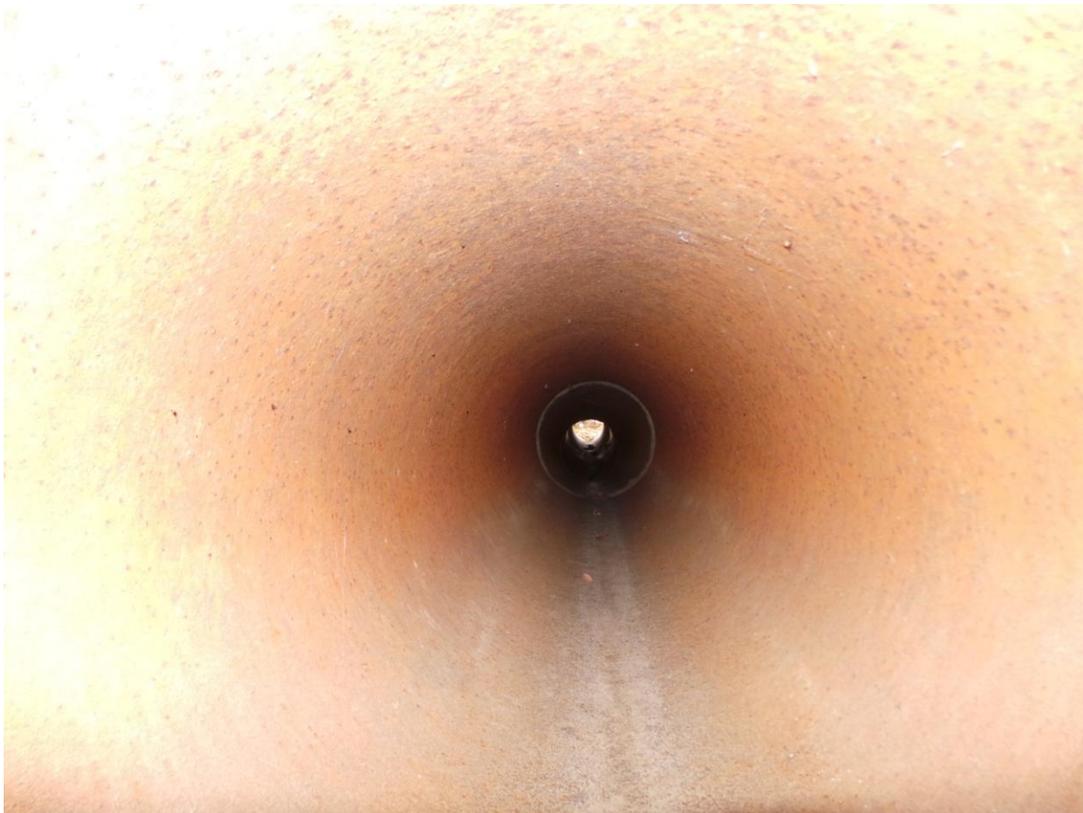
Photo 416 – Settlement/sag of steel culvert

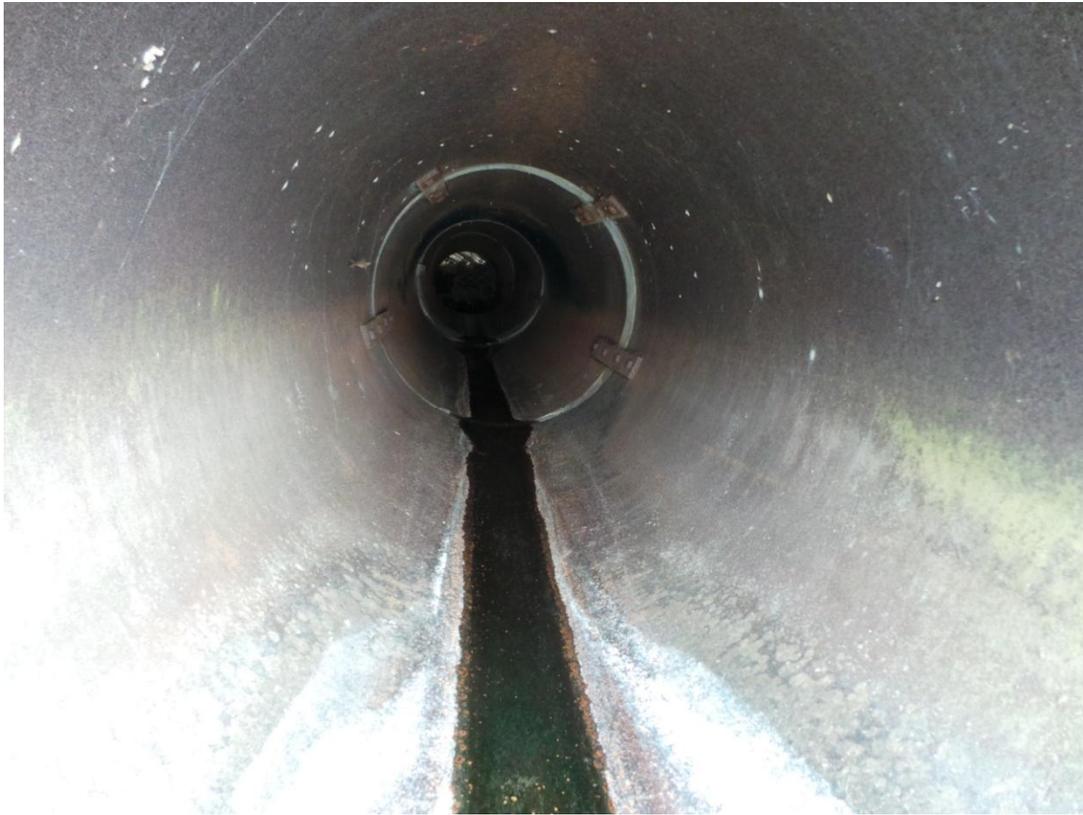
Photo 417 – 48” diameter steel culvert showing greater than 75% blockage

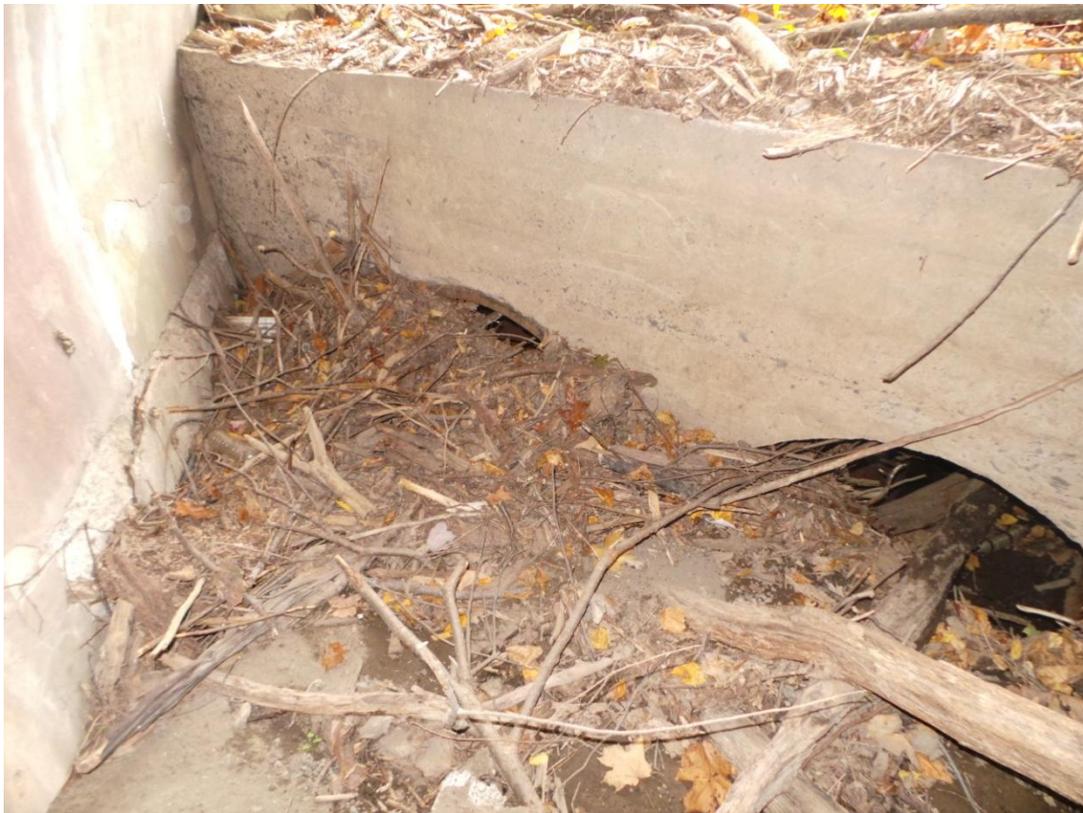
Photo 418 – Two 48” diameter steel culverts nearly 100% blocked with debris

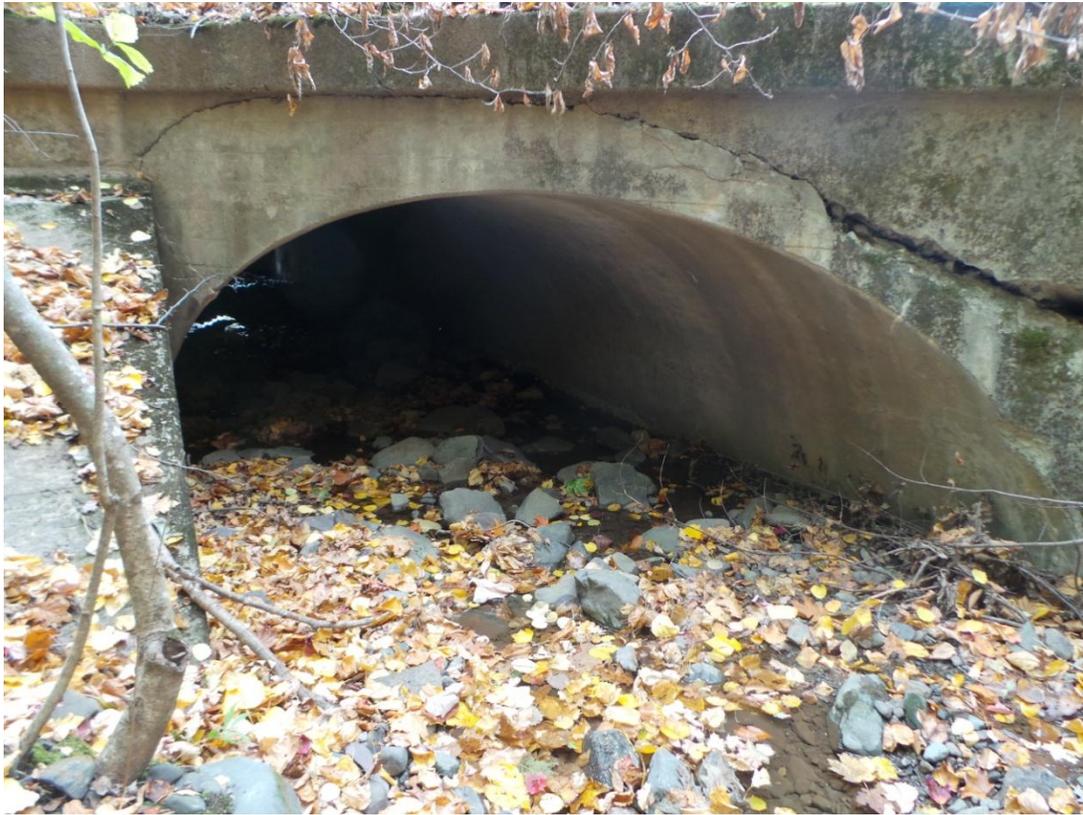
Photo 419 – Concrete culvert approximately 50% or greater filled with sediment

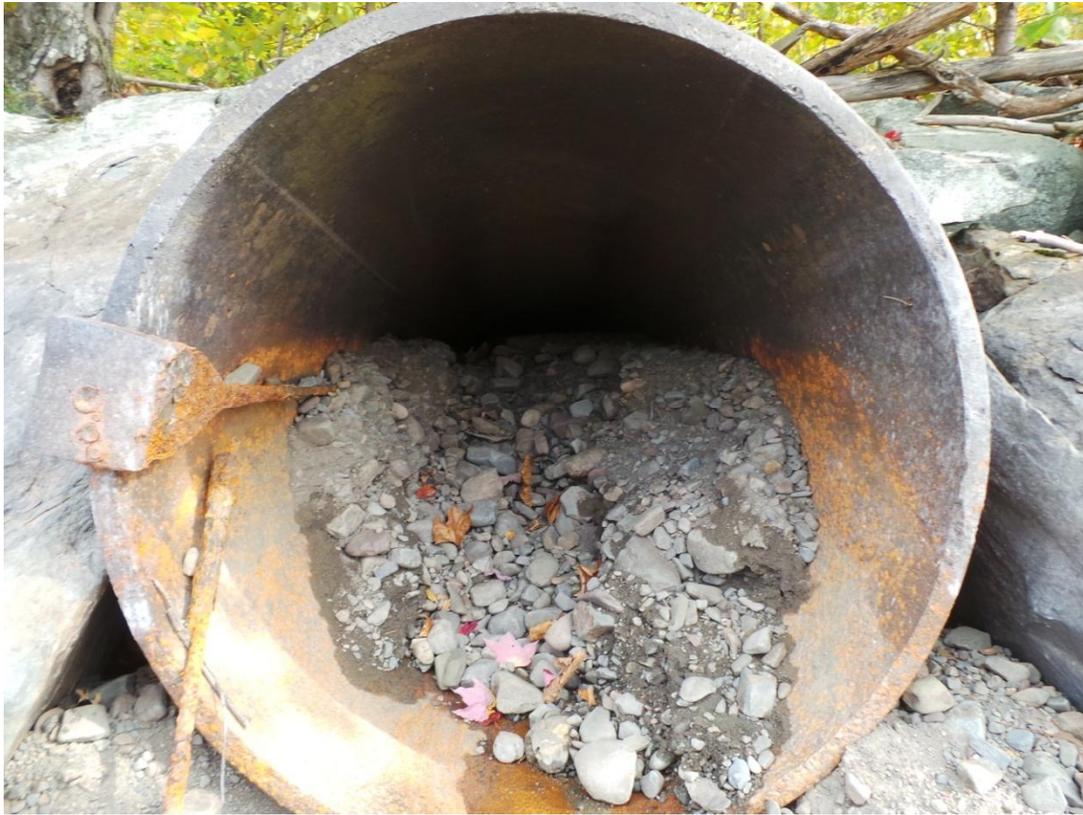
Photo 421 – Stone and sediment blockage at outlet of steel culvert

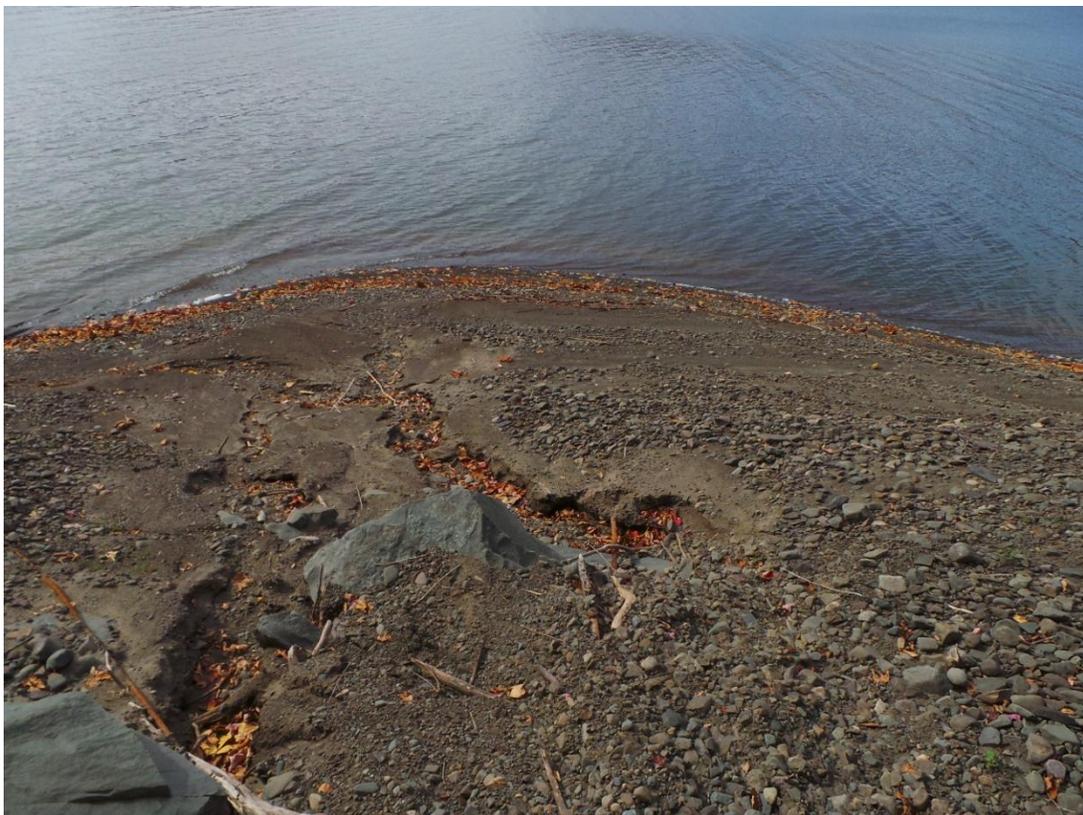
Photo 422 – Erosion and sediment deposition on the Ashokan Reservoir shore

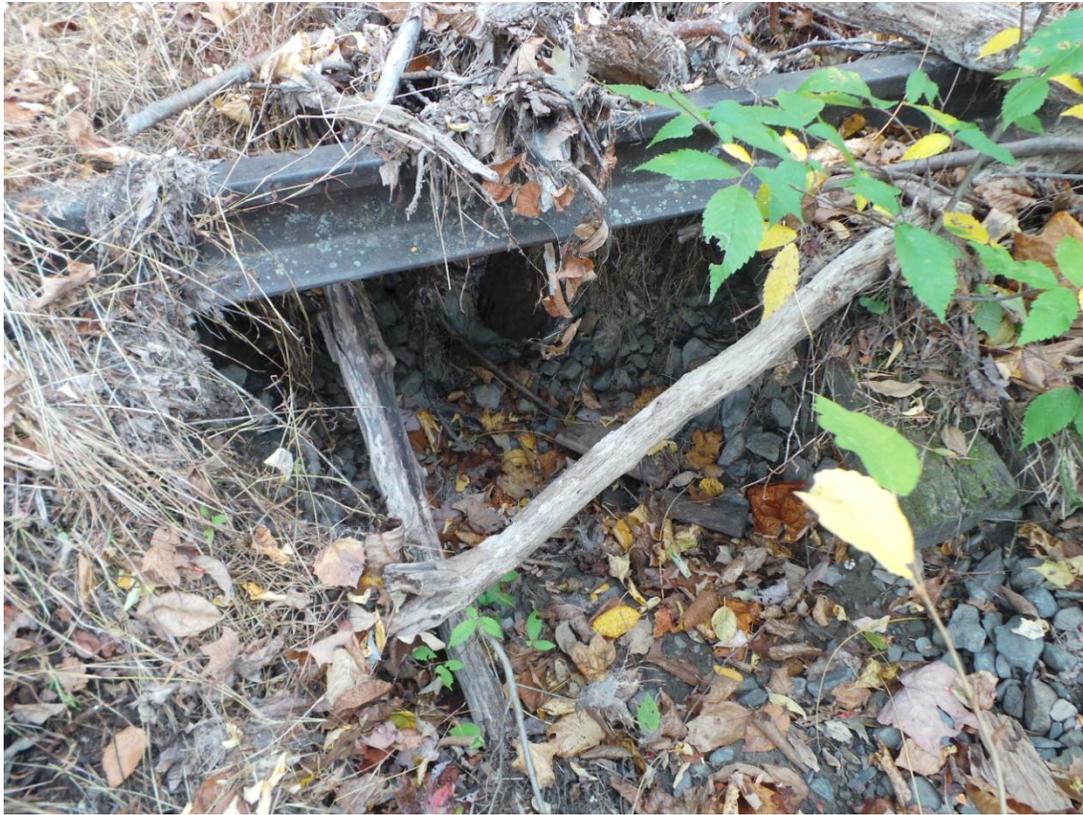
Photo 423 – Erosion of stone ballast and embankment below tracks

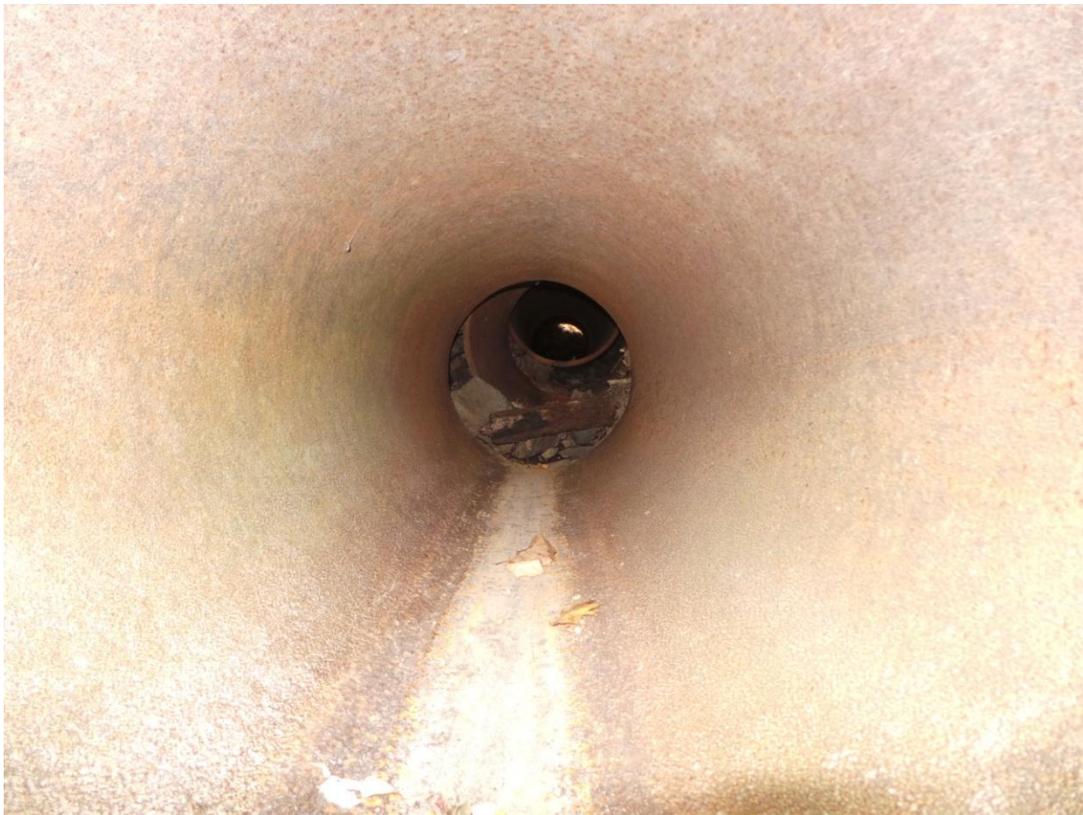
Photo 424 – Separation of three different culvert sections

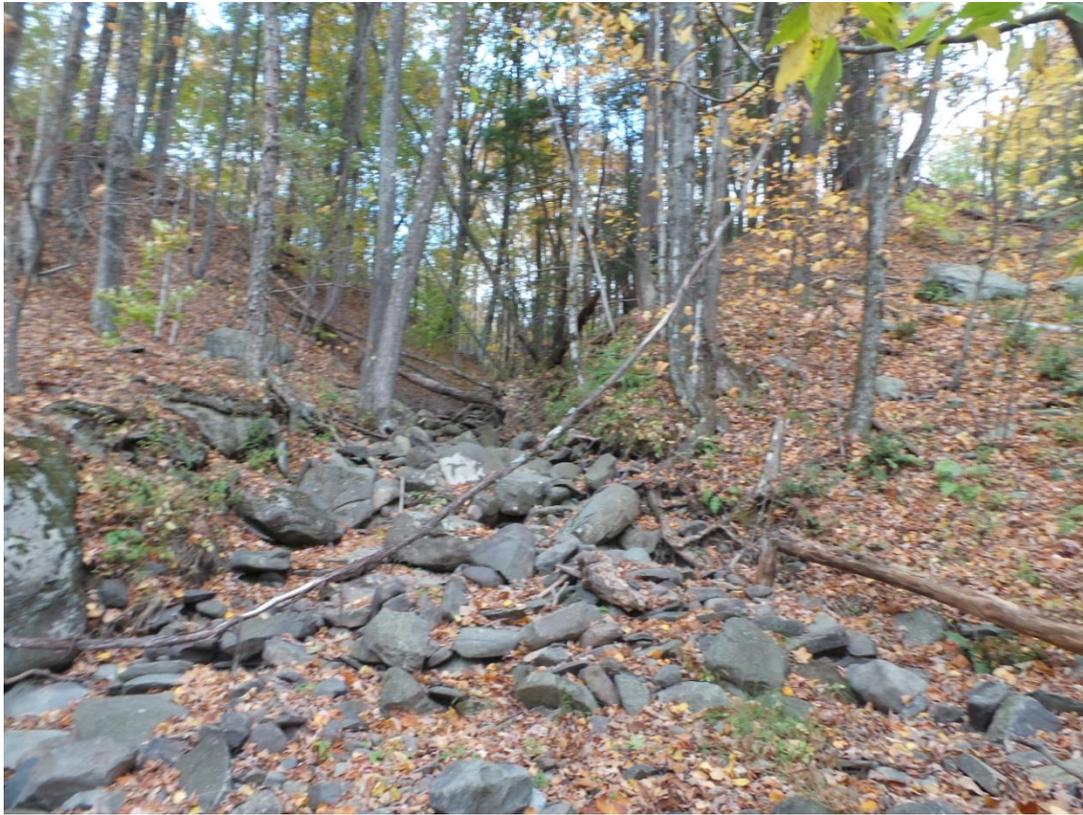
Photo 425 – Erosion of hillside draining into Ashokan Reservoir

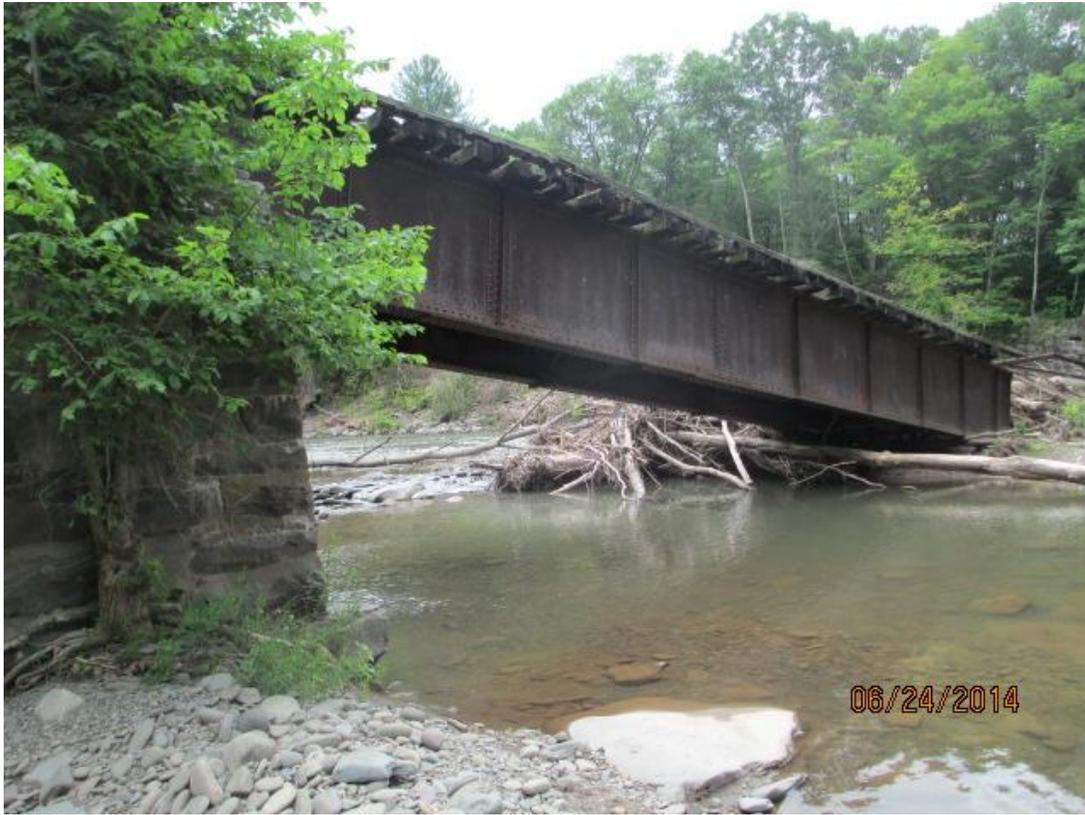
Photo 503 – Trestle section resting on stream bed

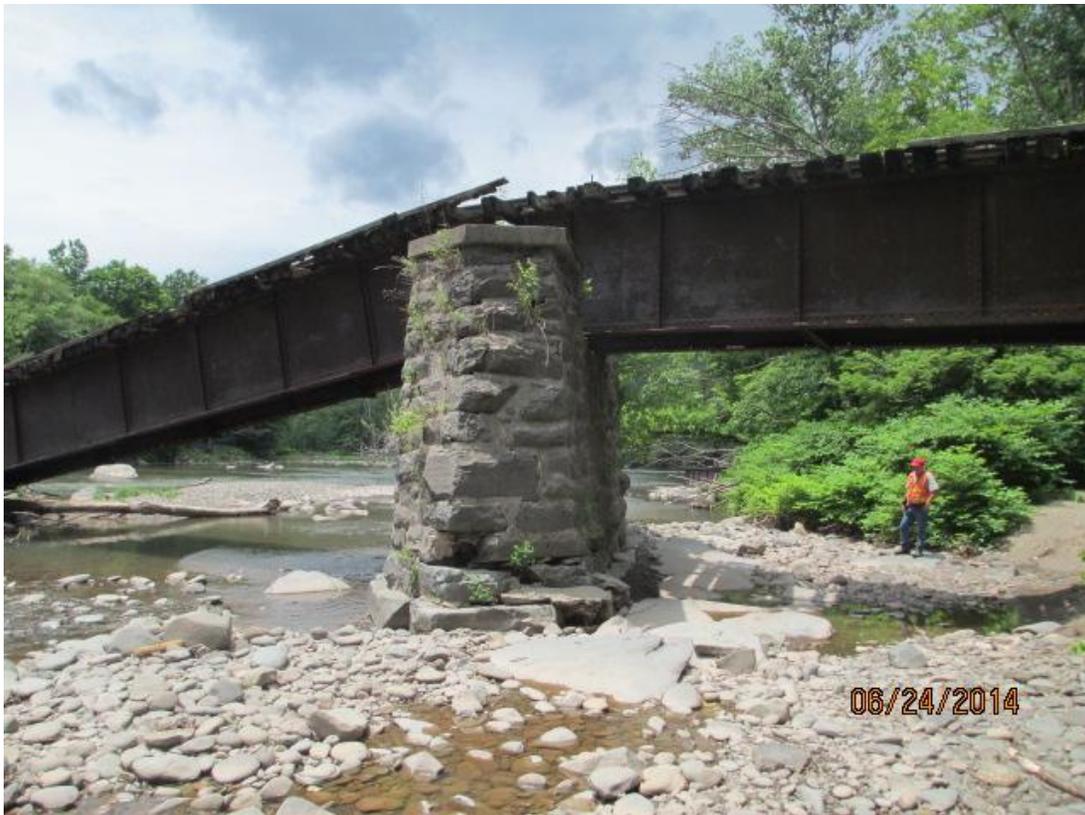
Photo 504 – Remaining Trestle section

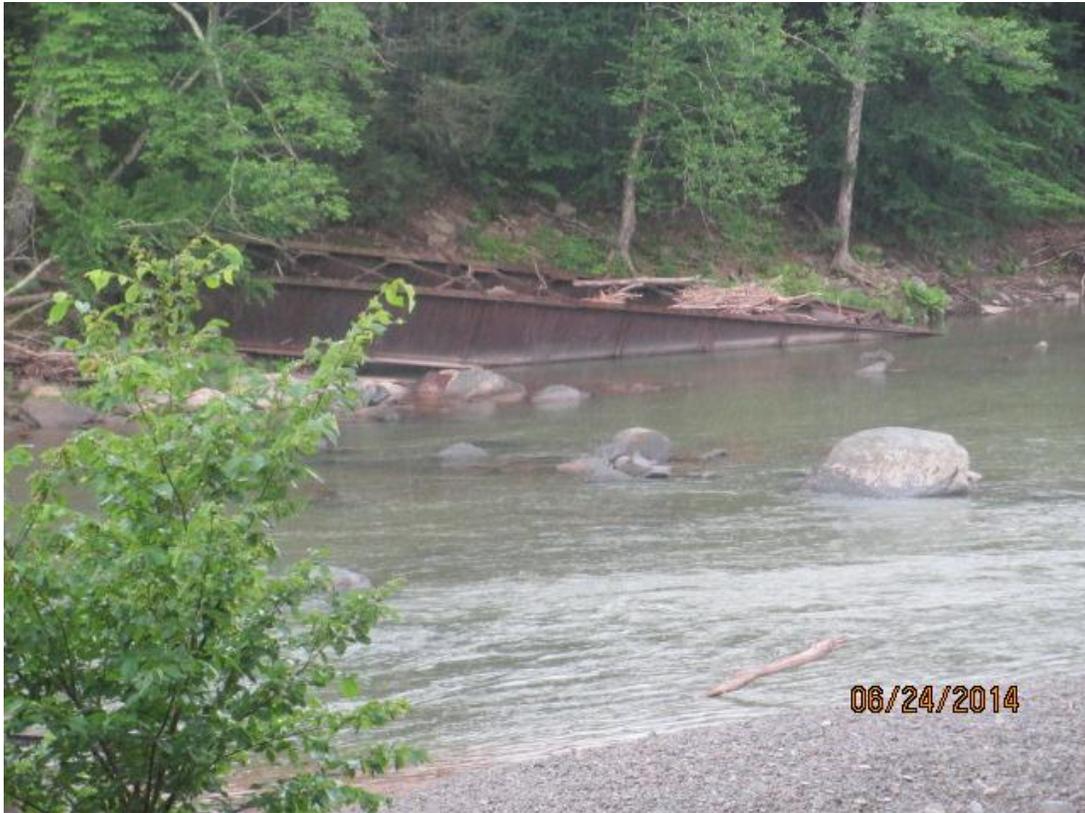
Photo 505 – Section of trestle washed up on shore

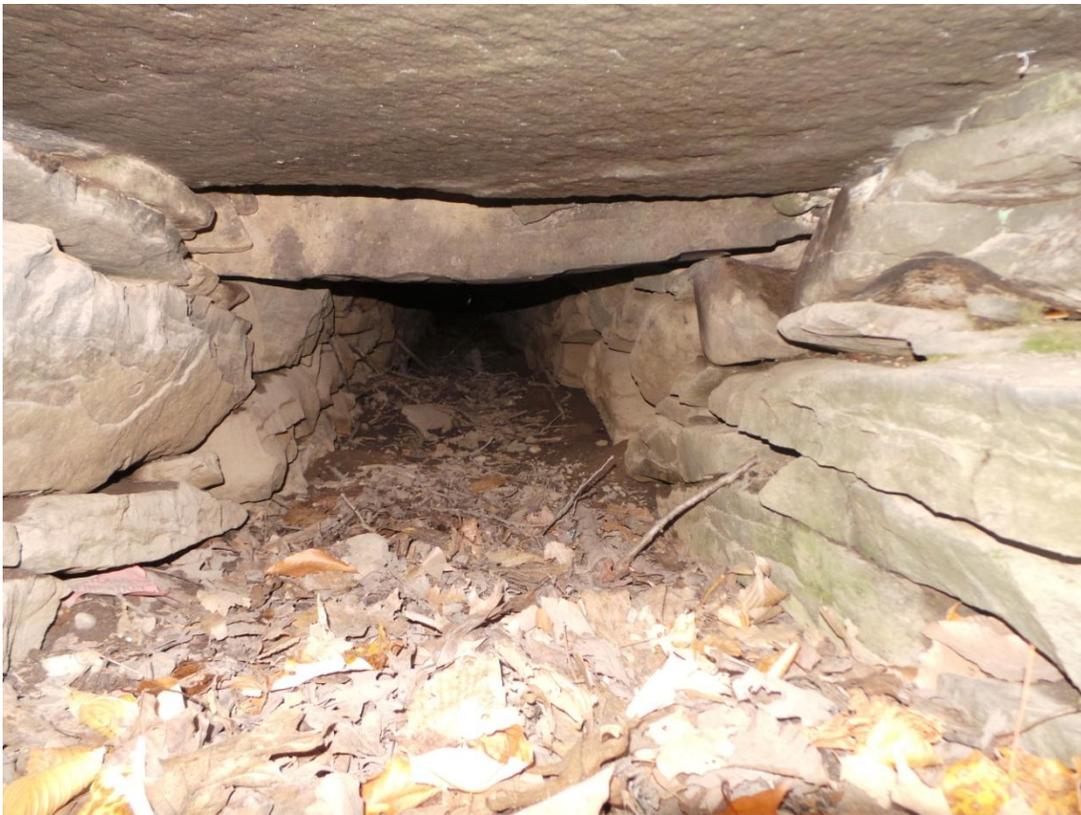
Photo 508 – Non-functional stone drainage structure

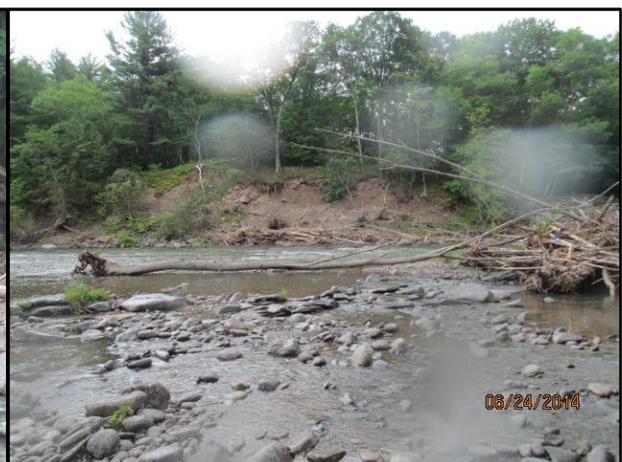
- Pier 2 and Pier 3 were completely destroyed and/or washed away during the storm events and there are only small remnants of these piers that remain intact or partially salvageable at the bridge site.
- The South Abutment exhibits large areas of scour and dislodged stones. The bridge seat has completely failed and is not usable. The South Abutment would require complete re-construction under any of the bridge replacement/rehabilitation alternatives.
- The stream banks of the Esopus Creek exhibit erosion, exposed root systems, and loss of vegetation due to apparent turbulent flow, most notably along the south creek bank.

South Stream Bank Erosion

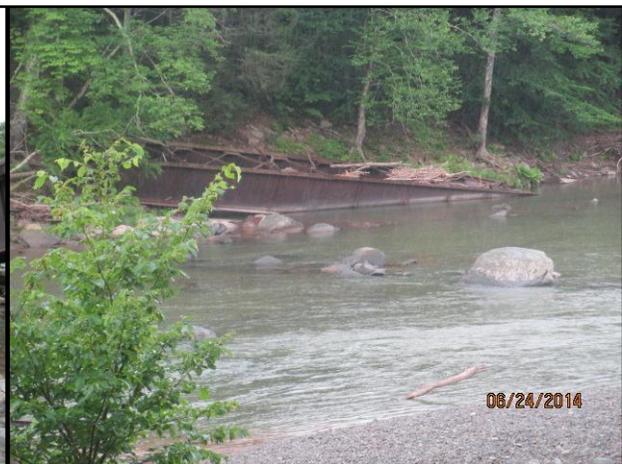
- The existing Span 3 and 4 girders were dislodged from the substructures and have since been washed several hundred feet downstream. The spans have been partially covered in stream flows since the storm events and we do not feel it is prudent to reuse these girder sections given the probability that significant deterioration has likely occurred due to rust and corrosion from wet conditions. In addition, there would likely be significant costs and environmental impacts associated with moving the girder sections from where they rest along the stream banks back in place on the new substructures.

Spans 3 & 4 Washed Downstream
